FIELD SERVICE BULLETIN

FSB Number: LVCCFSB2006-044
Authors: Darwin Garcia
Date: February 16, 2006
Total No. of Pages: 4
Subject: **V3 Main LCD Dust Ingress**
Model Affected: **V3**
Level of Repair: 2

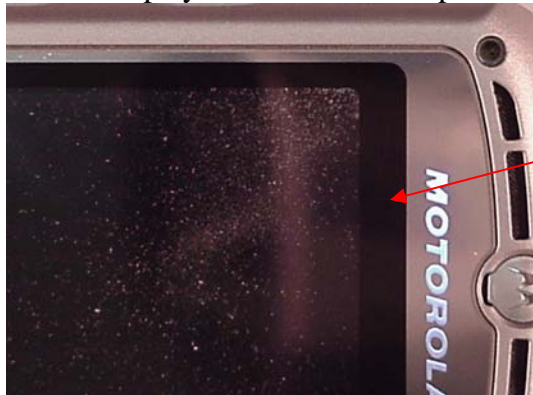
Service has been made aware of a V3 Sharp main LCD dust ingress issue that could cause “Display Main - Dust” complaints.

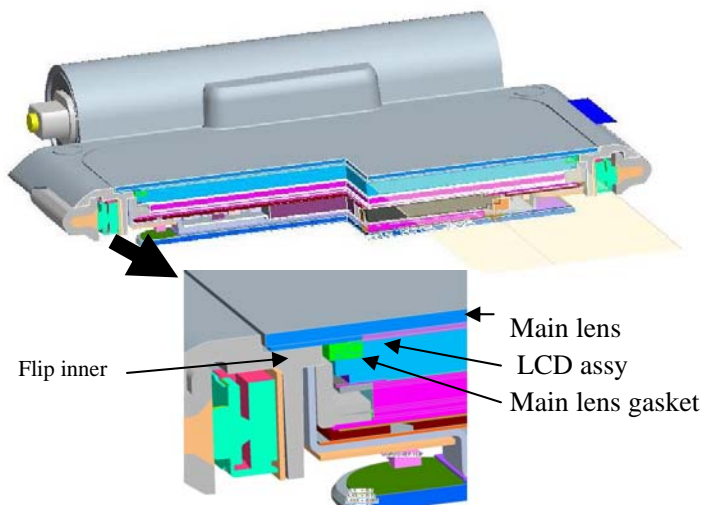
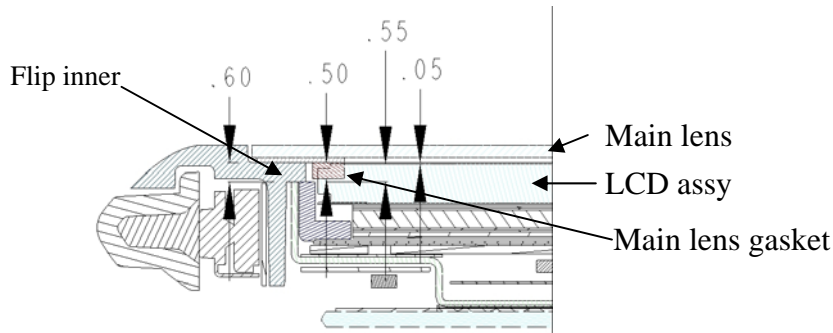
Dust Ingress

Contamination on the displays is predominantly dust and cellulose fibers. These are common environmental materials to which the product will inevitably be exposed during field use.

The root cause was glass position within LCD module being lower (away from dust seal) in Sharp displays (7290086N02) due to its stack-up being lower than specification causing less gasket compression which allowed dust to penetrate the seal.

The main lens dust gasket thickness was increase from 0.5mm to 0.7mm.

The part number for the gasket was change to 3287306Y05, which is part of the new main lens assembly part number **6190016N06** only to be applied on Sharp Displays.

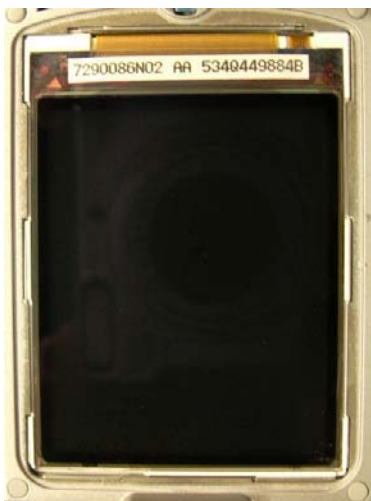
When removing the main lens, Sharp is the only vendor with a label on the display driver IC.

7290086N02
Note the label on display driver
Supplier: Sharp

When servicing any V3 customer phones with described issue remove the main lens and identify the vendor, if it is Sharp replace the main lens (1 = 6190016N06), if is not replace with (1 = 6190016N03).

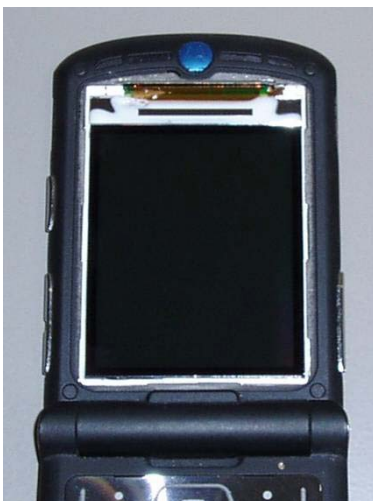
7290086N01 & N04
N04 replacing N01
Supplier: Sanyo

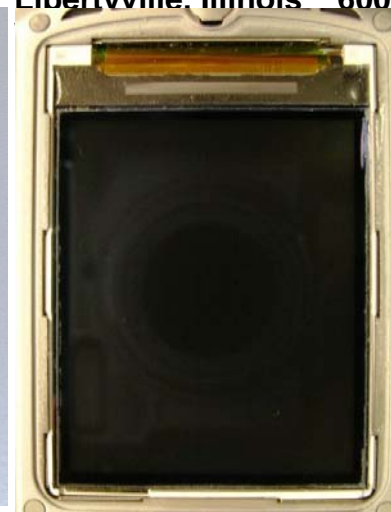
7290086N03 & N05
Supplier: Innolux
Difference is display driver
only

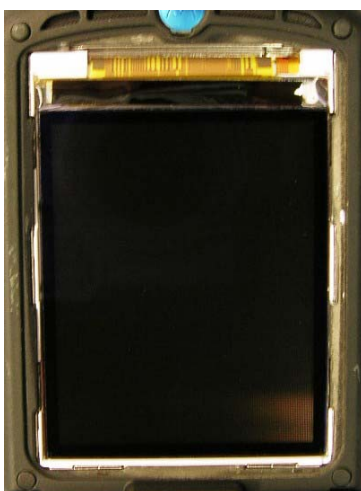
7290086N06
Supplier: Samsung
Just recently started
production

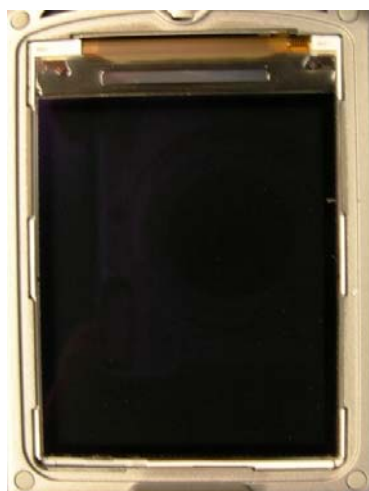
7290086N07
Supplier: Wintek
Not yet approved for
production
