CSB-1055-2
 Country : UK
 Date : 11/13/2006
 APC : ALL
 Repair Level : 2

Title V3V3_05 CR - GSM - Dust Under Main Lens -Double Sided Adhesive
 Model Effected V3 & V3_05

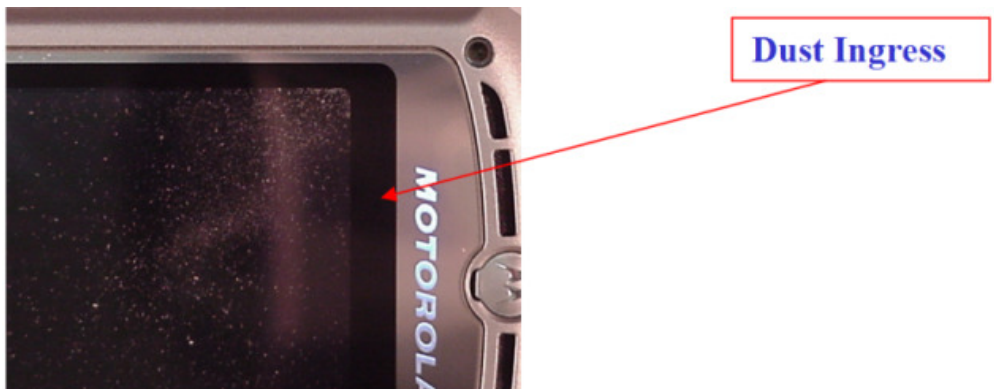
Contamination on the displays is predominantly dust and cellulose fibers. These are common environmental materials to which the product will inevitably be exposed during field use.

The root cause was glass position within LCD module being lower (away from dust seal) in Sharp displays (7290086N02) due to its stack-up being lower than specification causing less gasket compression which allowed dust to penetrate the seal.

The initial solution for Sharp display was to increase the main lens gasket thickness from 0.5mm to 0.7mm.

The final solution for all display suppliers including Sharp is to make the main lens gasket with double sided adhesive at 0.5mm thickness to improve the seal. The new part number for all displays is 6190016N11.

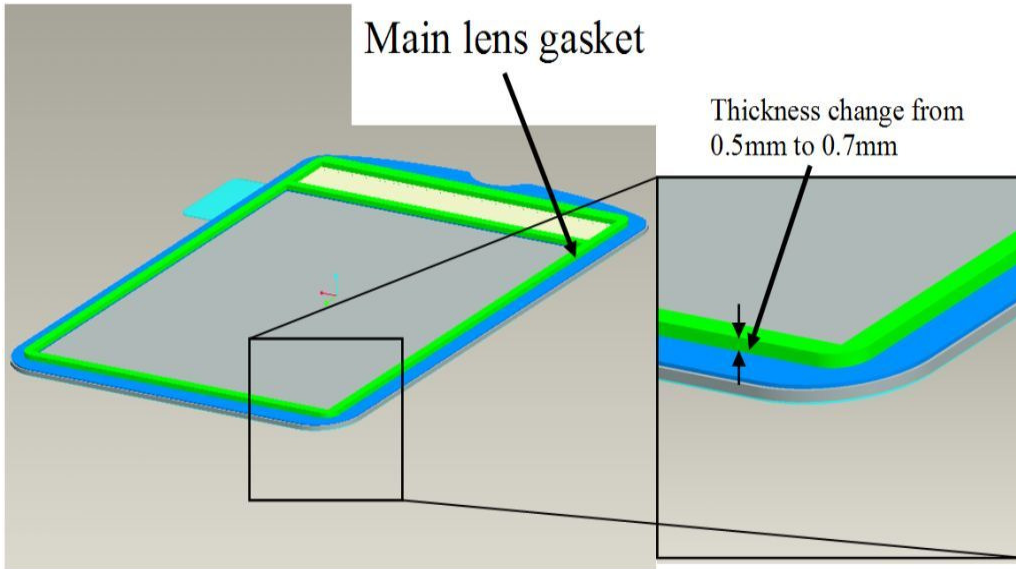
The part number for the gasket was changed to 3287306Y05, which is part of the main lens assembly part number 6190016N06 only to be applied on Sharp Displays.

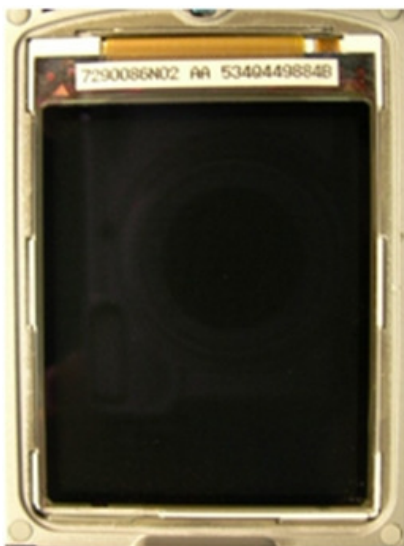
Display Identifiers:
When removing the main lens, Sharp is the only vendor with a label on the display driver IC.

7290086N02
Note the label on display driver
Supplier: Sharp

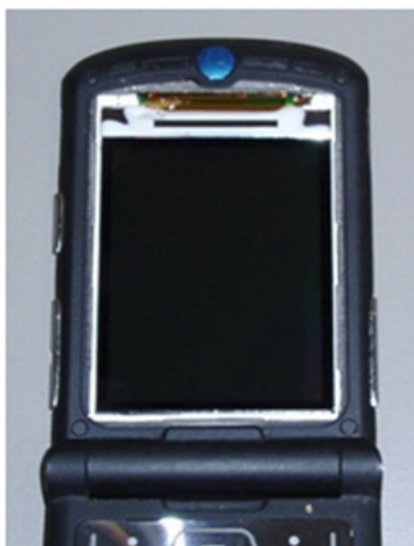
7290086N01 & N04
N04 replacing N01
Supplier: Sanyo

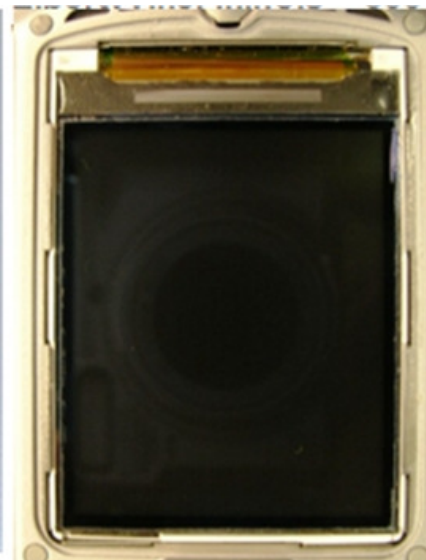
7290086N03 & N05
Supplier: Innolux
Difference is display driver
only

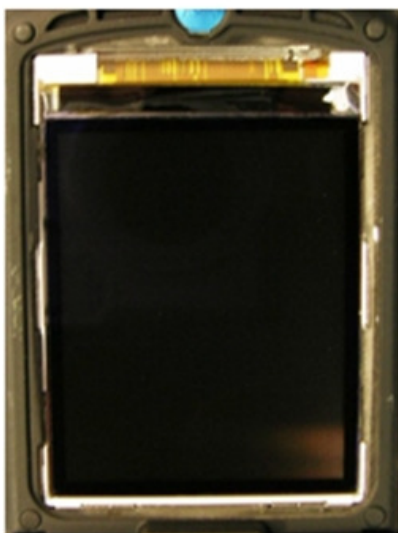
7290086N06
Supplier: Samsung
Just recently started
production

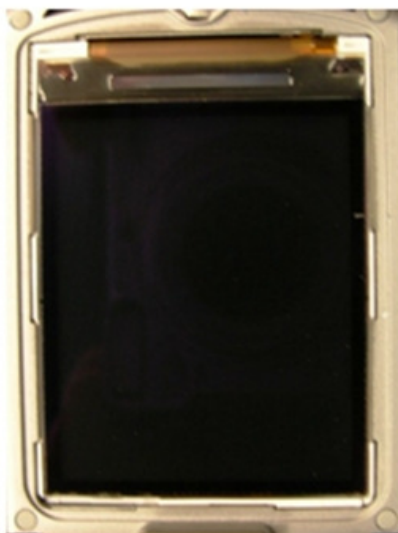
7290086N07
Supplier: Wintek
Not yet approved for
production
