MOTOROLA UK
 REDWOOD
 CROCKFORD LANE
 CHINEHAM BUSINESS PARK
 CHINEHAM
 BASINGSTOKE
 UNITED KINGDOM RG24 8WQ
 CSB-1168-2
 Country : UK
 Date : 11/2/2007
 APC : D54
 Repair Level : 2

Title V3V3 05 CR - GSM - Main Display Crack Driver IC
 Model Affected V3 & V3_05

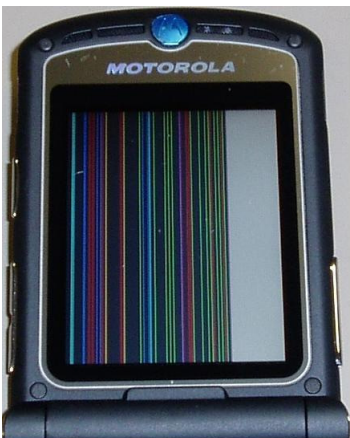
Service has been made aware of a V3 & V3_05 Main Display Crack Driver IC issue causing "Display Main - No display & Display Main - Missing Pixels / Icons" complaints.

When servicing any V3 & V3_05 customer phones with described issue, replace the display module.

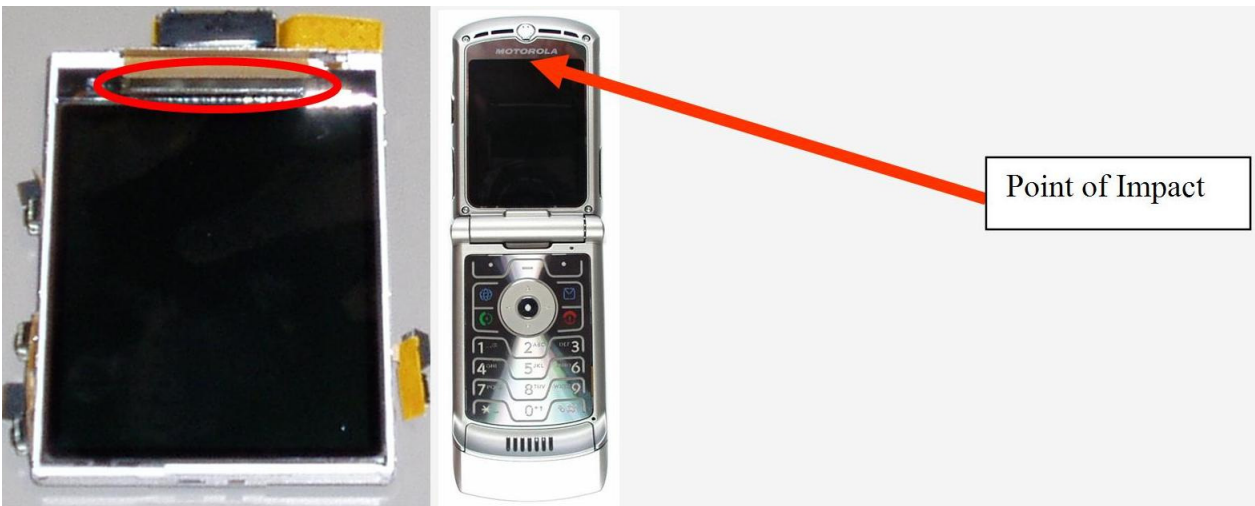
The cause of the crack driver IC was determined to be physical force being applied at the Main lens by the Motorola Logo. Sharp displays are more susceptible to this issue due to its mechanical characteristics.
