## **FIELD SERVICE BULLETIN**

FSB Number: BJCCFSB2004-93  
Author: Fang Hong  
Date: Apr 16. 2004  
Total No. Of Pages: 2  
Subject: **V878 (TCH) Keypad Peel Off**  
Model Affected: **V878 (TCH) GSM/DCS/PCS**  
Level of Repair: 1

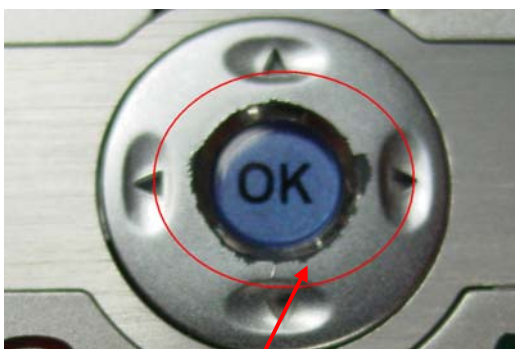
Some handsets have been returned with the customer complaint of “Keypad Peel Off “  
The symptom is that paint peel off around ‘ok’ key.

Paint Peel Off

This issue is a tooling design issue. New tooling, which is with 0.3mm round angle on the boundary of navigation key surface, has been finished. The new keypads have started to be provided. Data code is 050304-A or later. The part number of keypad is METCH07003C.

When V878 (TCH) handset returned to Service Center with the Customer Complaint of “Paint Peel Off” around ‘ok’ key, replace a new keypad (METCH07003C).

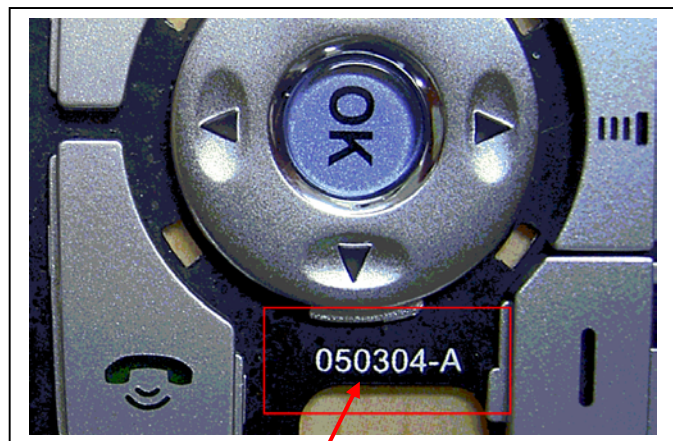
Data code number

The meaning of date code: 050304-A      This part was made on Mar 05 2004,
