CSB-1067-2
 Country : UK
 Date : 11/1/2006
 APC : F77
 Repair Level : 2

Title W220 - GSM - W220 LCD missing line
 Model Effected W220

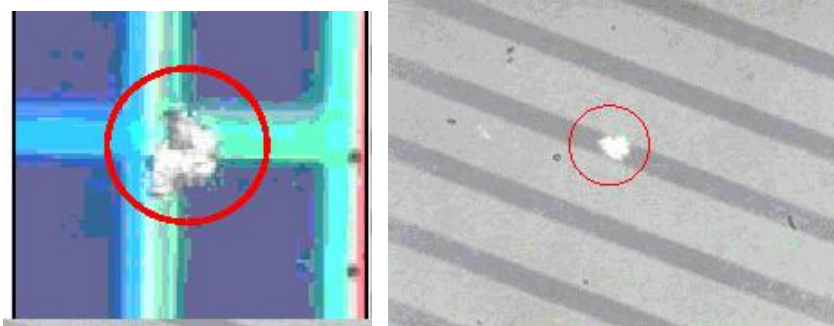
Root cause 1: There are metal particle in ITO cell. Via the SEM-EDS analysis, confirm it is Aluminum material.

Increase the diameter of sleeve to avoid the friction between sleeve and bearing on week 36.
 (LCM shipping date code: 40/06)

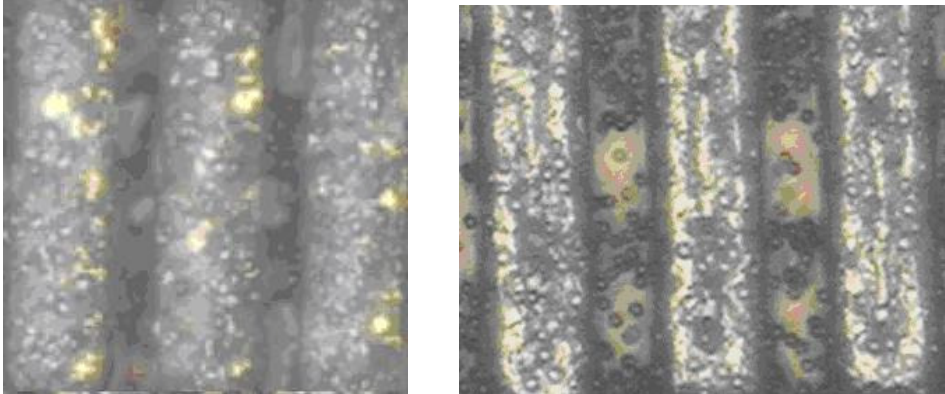
Root cause 2: There are conductive particle between OC golden bump and LCD ITO circuit.

conductive particle
incompletely breakable

Corrective action for root cause 2:
 Install a roller mechanism with rubber tape between IC and bonding head to avoid residual glue IC stick on bonding head. When bonding head do main bonding once, the roller mechanism would roll up once. (LCM implement shipping date code:40/06)

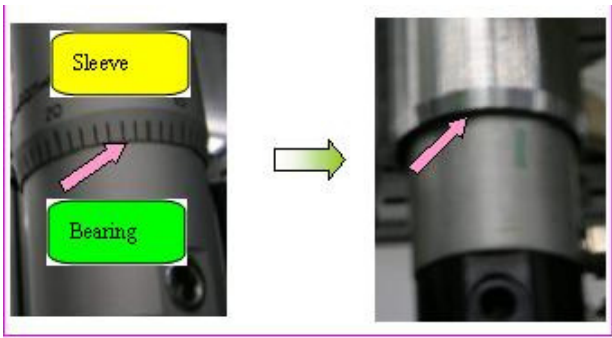
Increase the diameter of Sleeve

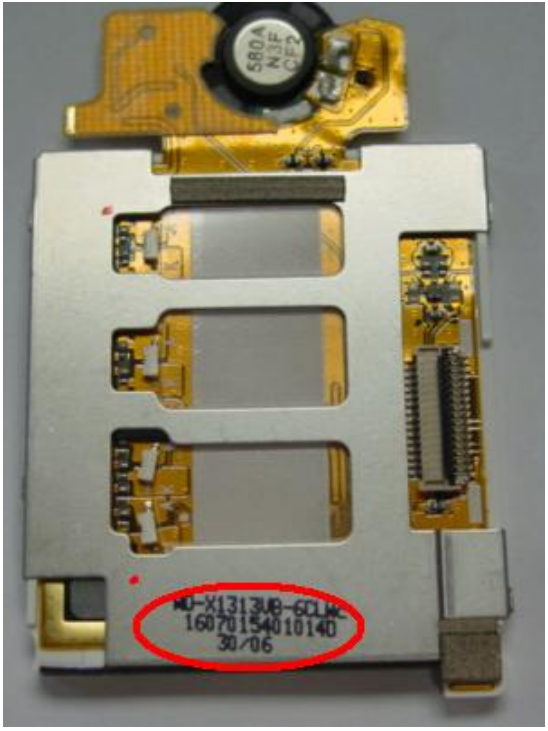
When W220 handsets returned to service center with the customer complaint of 'display, missing line', please replace a new LCM with date code of 40/06 or later. CMCS Part number is SLC13135700. Please see the location of date code of 30/06 on LCM
