CSB-1384-2
 Country : UK
 Date : 7/6/2007
 APC : G33
 Repair Level : 2

Title W510 - GSM - Hinge flex open trace issue
 Model Effected W510

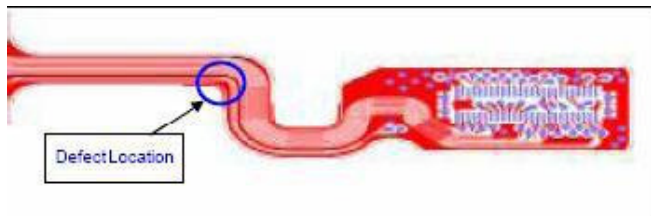
Service has been made aware of a hinge flex open trace issue during W510 NPI analysis. Some W510 units returned with customer complaints of "Audio, earpiece no", "Alert, ring tone no" or "Display main, no display", we found one common root cause - hinge flex open trace. High impedance or open can be measured from pins which related with ring tone, speaker or LCD data lines. Base on X_Ray analysis, surface nick can be observed at the trace layers. The surface nick is caused by air bubble entrapped between base copper and dry film.

The supplier has optimized the dry film lamination setting temperature. Change of the temperature setting for dry film lamination top platen temperature from 70C to 60C. Also implemented 100% AOI on all the layer by Installing a mirror image on the AOI machine from week25,2007.

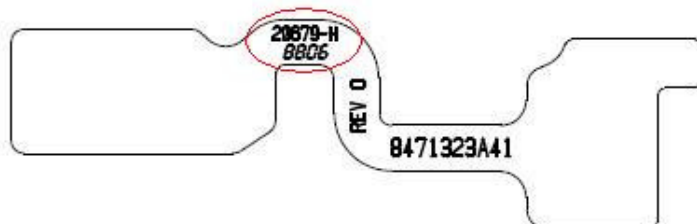
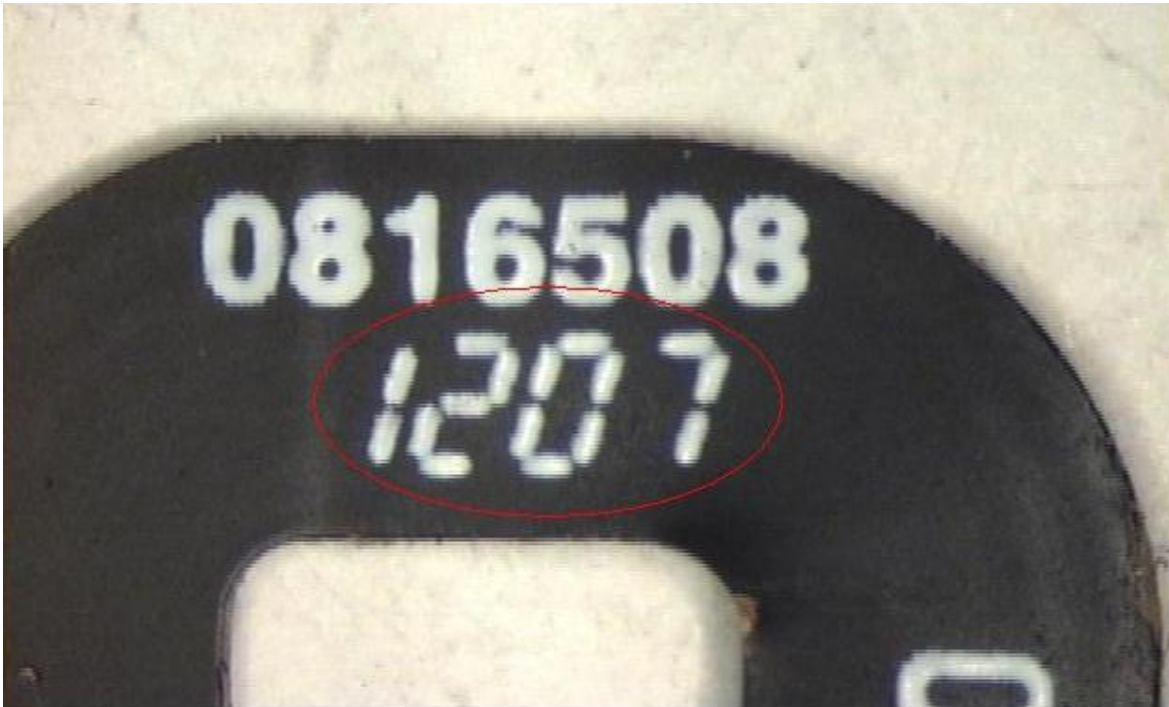
Suggest to purge the flex (P/N:8471323A41) inventory, affected date code is 0807&1107. Please ensure new flex with date code "2507" or later is available for service.

1. Verify the customer complaint;
2. Swap hinge flex with new date code 2507 or later if the flex is confirmed open trace;
3. Retest the unit, verify the complaint is corrected properly.
