Title: Troubleshooting-Guide **W220 Level 3**

Doc. No: tsg\_gsm\_w220\_level3

## Troubleshooting-Guide Level 3

# W220

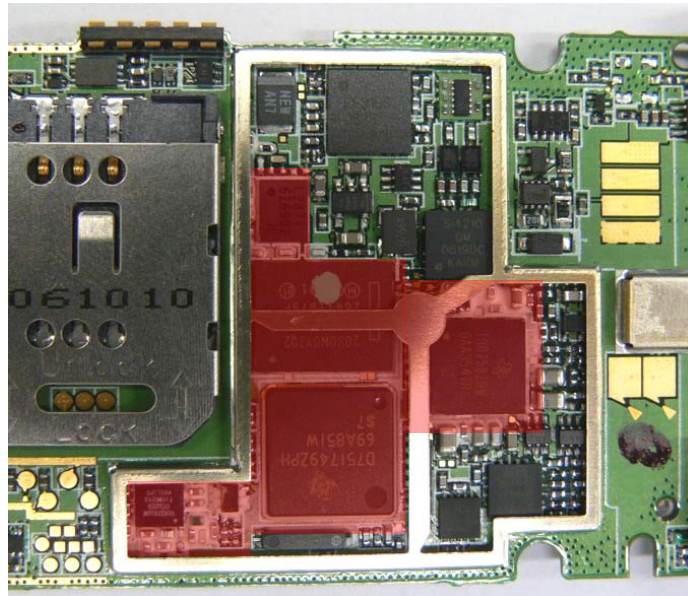
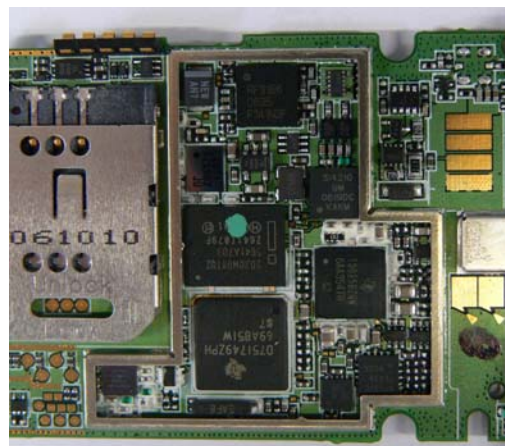
#### **Glued/underfilled areas on the W220 PCB:**

If you have to solder in underfilled areas, try to prevent other parts from heat by using cooling-blocks/-shields, because the habit of the glue causes a lift up of BGAs. When any repair-action under the clip-shield is necessary, you have to remove the bar inside the frame by cutting off. Now it should look like this:

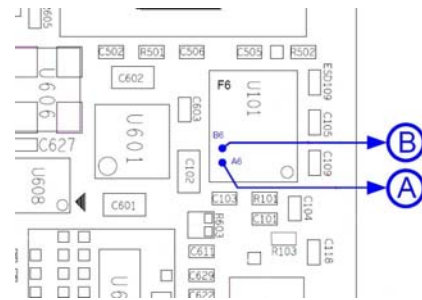
**Low-pass filter and ESD-protection**

If the alert is not the cause, check the parts direct to the contacts of the alert. This circuit filters out the high band noise and **ESD303** is an ESD-protect. Maybe there's too less solder or a broken/tombstone part. But mostly the melody IC **U101** is defective. When replacing the part please take care of the flash IC **U501** placed directly beside **U101**, use cooling shields!

If the sound of the alert speaker is very low and/or distorted, in the NPI-process a lot of defective alert speakers were detected. Just replace it and the failure is fixed. If the ring tone is still very low, check the circuit just as described upper and replace **U101**.

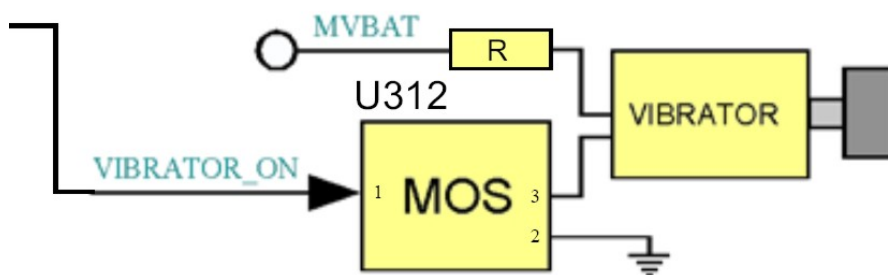
The **VIBRATOR\_ON** signal should be pulsing at ~2,8 V (in the CIT the vibrator works only pulsed). If it's missing or too low, replace **U201** and **U501**, because the signal comes directly from **U201**. If the signal is OK, replace **U312**, because the MOSFET doesn't switch contact 2 of vibrator to GND.

In the case that the vibrator works too low automatically after startup, check **U312** as well. It switches the vibrator on permanently with a low voltage (permanent internal resistance).

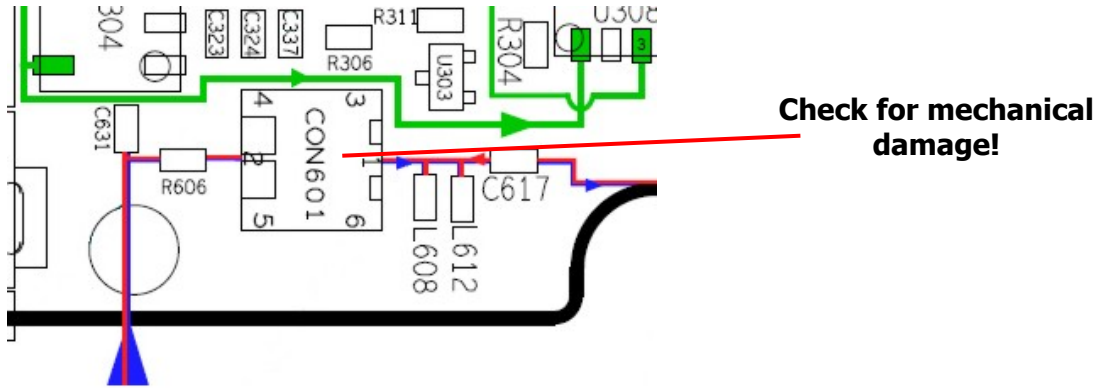
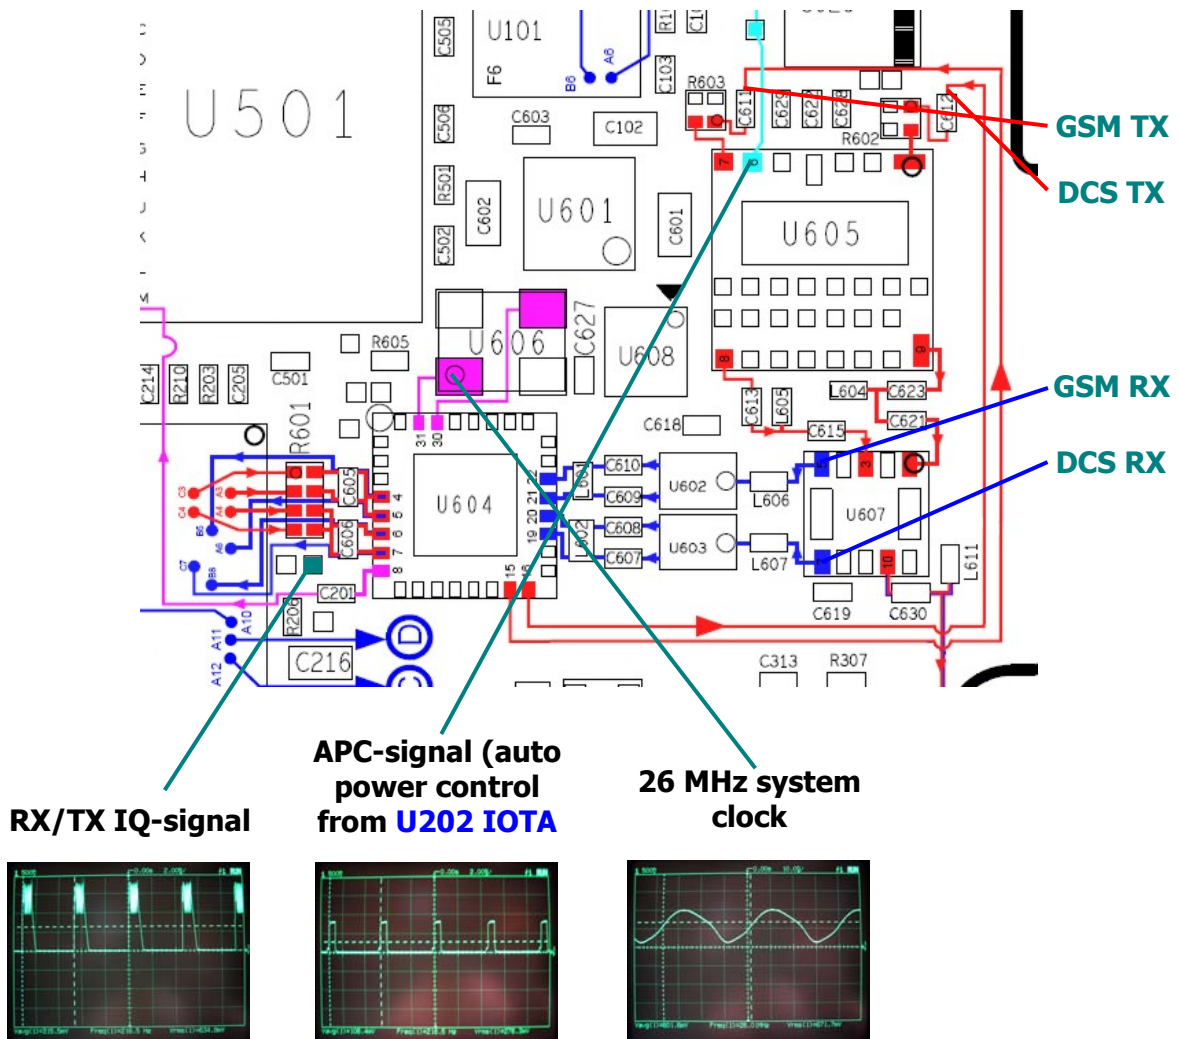
Overview of the RX/TX-area with important signals:

RX-TX problems are very rare at W220. We received some transceivers that failed in phasing-test, a defective PA **U605** was always the cause.

In some cases the RF-connector **CON601** was mechanically damaged. **CON601** switches the RF-signal for testing or to the antenna-connector **ANT601**.

- If the customer declares a network problem, just make a phasing – and callprocessing-test
- If the PCB fails in phasing, check the TX-signal at the faulty channels
- If the PCB fails in callprocessing, check the RX-circuit as well, often the problem is data-based (defective [U201 CalypsoLite](#)). Check as well the frontend module [U607](#)!

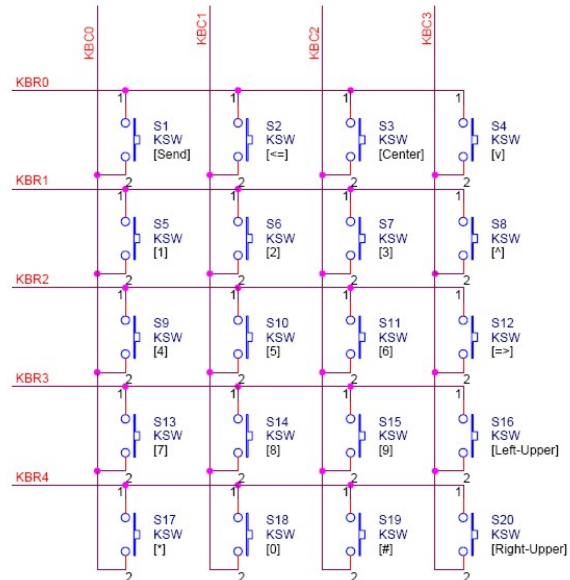
The keypad keyboard is directly connected to **U201** using:  
**KBR (4:0)** - input pins for row lines  
**KBC (3:0)** - output pins for column lines

So if some keys are not working and you excluded a failure due to the mylar or dirty contacts, you can measure the connections in the matrix. If there are interrupts, the PCB has an internal interruption and has to be replaced (forward PCB to a **Level 4 Hub!**).  
If **NO** key is working, **U201 CalypsoLite** is defective (forward PCB to a **Level 4 Hub!**).
