# Moto X Field Service Trouble Shooting Guide

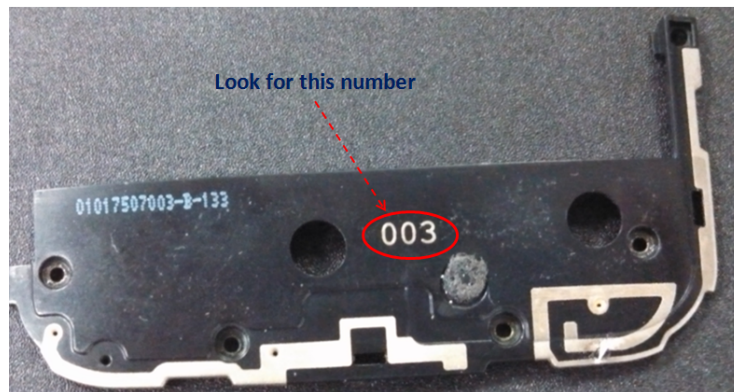
Figure: Antenna Carrier

Step 2: Check if the bottom antenna carrier is for the Verizon or not. If it is Verizon, 003 is printed on the Antenna carrier as shown below:

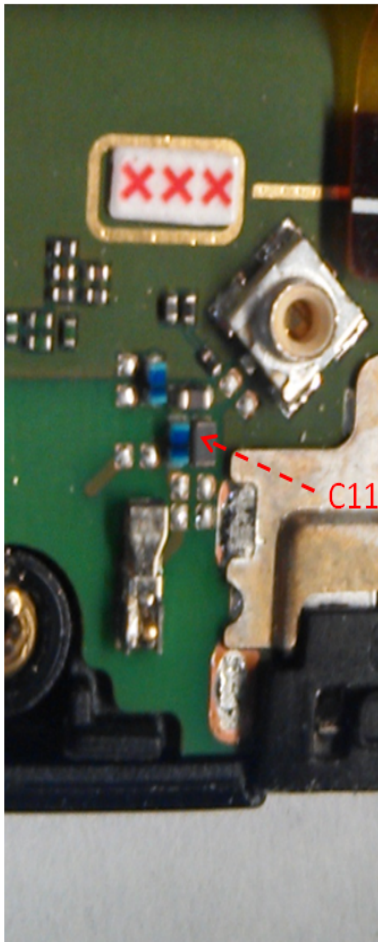
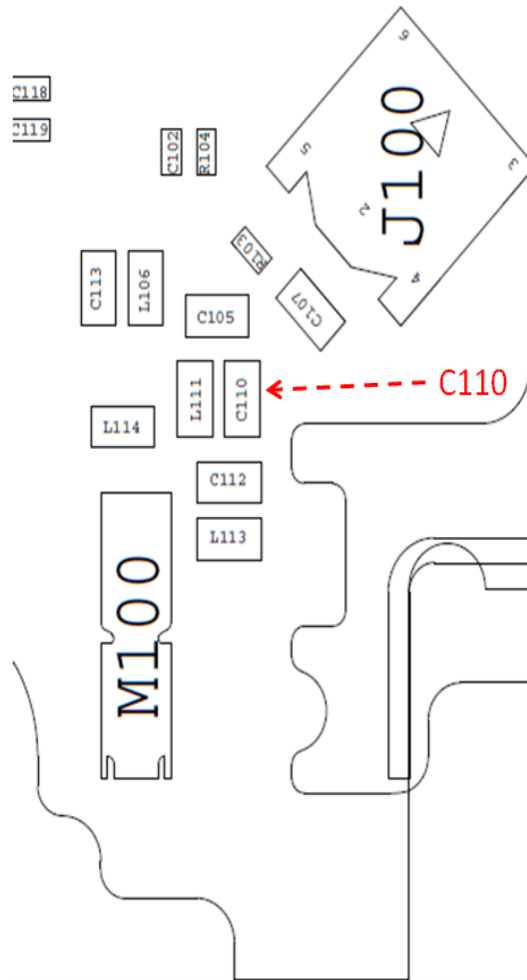
Figure: Component C110

Step 4: If step 3 does not resolve the problem check if components C110 is placed in the circuit

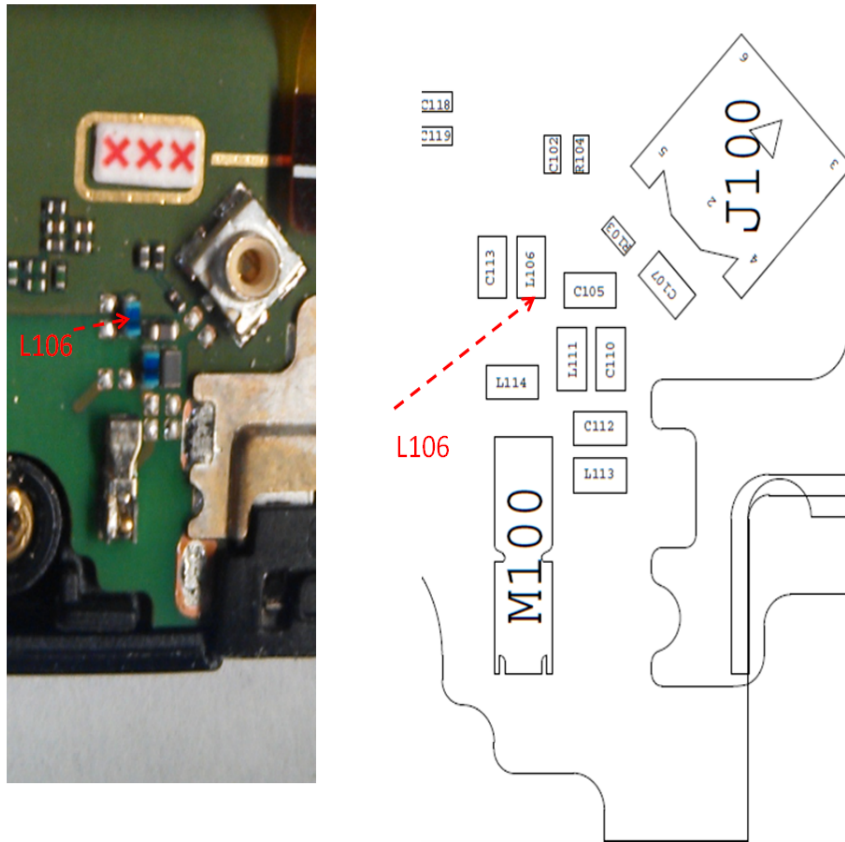
Figure: Component L106

Step 6: If Step 5 does not resolve the problem check if components L106 is placed in the circuit

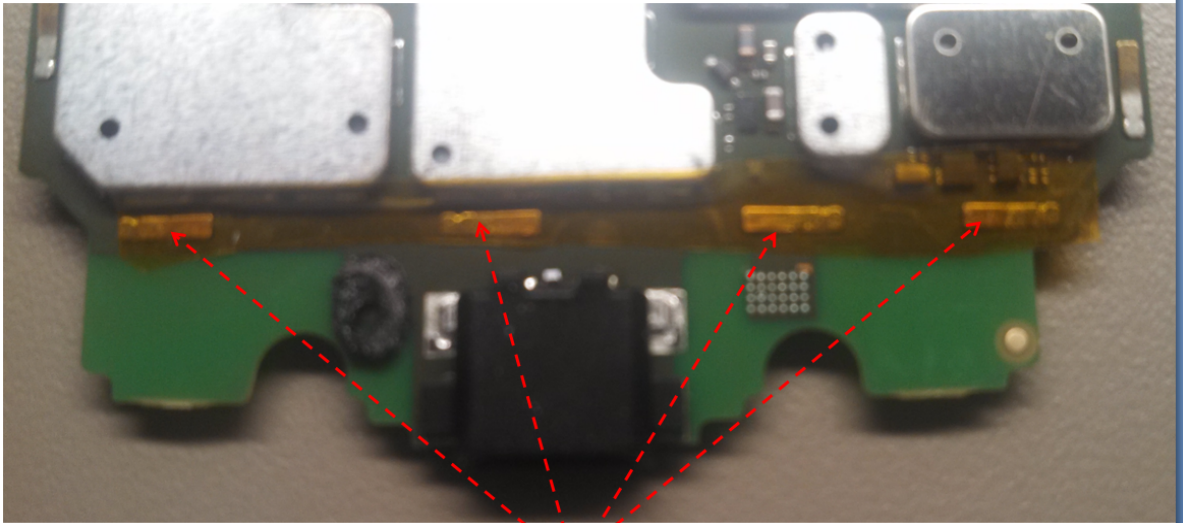
Figure: Moto X PCB board with ground clips

Step 7: If Step 6 does not resolve the problem check if the ground clips are placed on the board

Ground Clips on display side

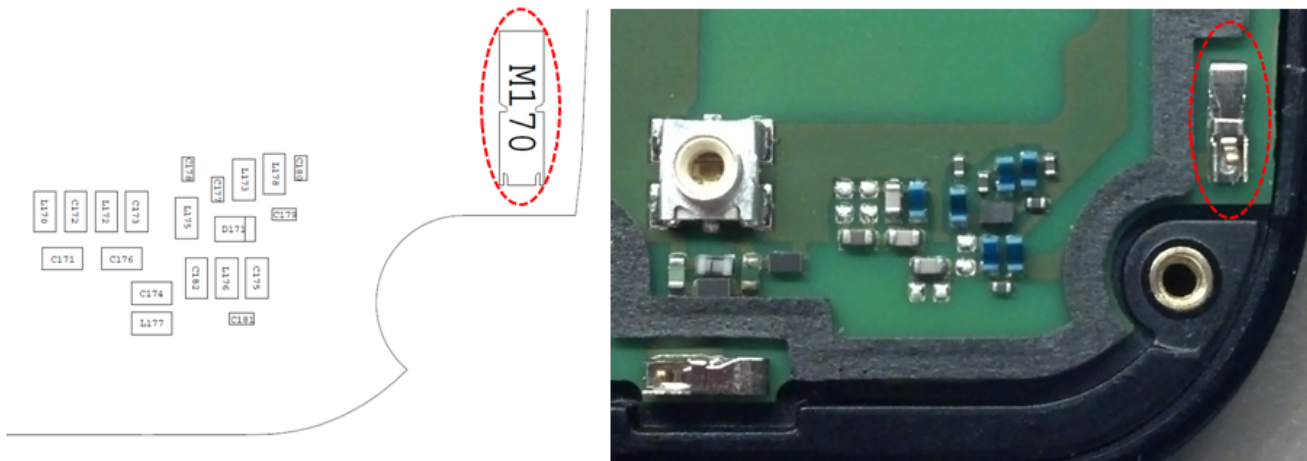
Figure: Antenna 3 Universal Contact

Step 2: If the failure persists, check the Antenna 3 universal contact, M170. If it is missing, misplaced, or damaged, place/replace the part and retest. Also check the contact pad of Antenna 3 on the diversity antenna carrier for a visible mark where the contact was touching the pad. If no mark is present, replace the universal contact M170 and retest.

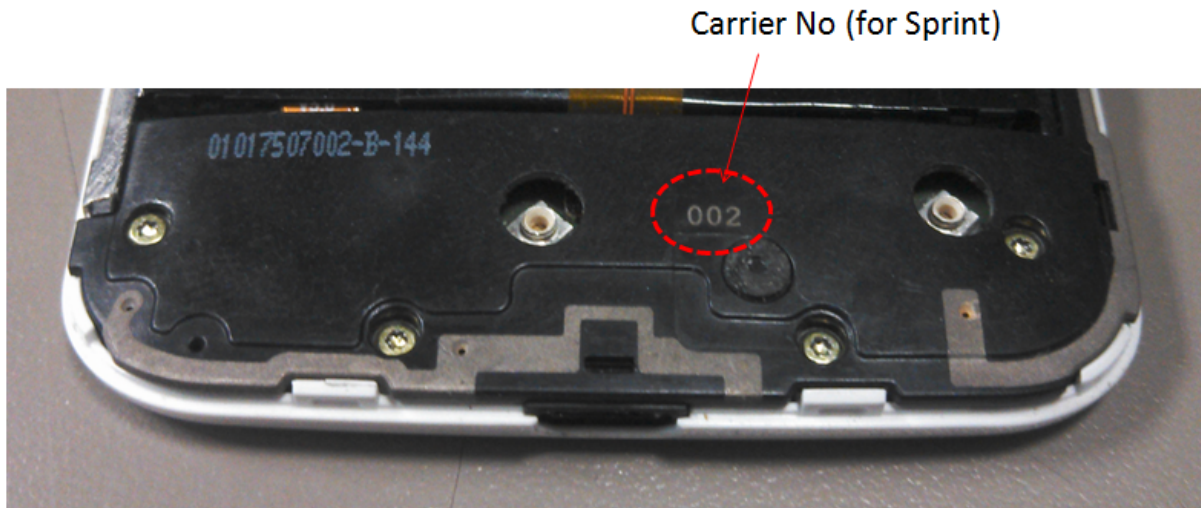
Step 2: Check if the bottom antenna carrier is for the Sprint or not. If it is Sprint, 002 is printed on the Antenna carrier as shown below:

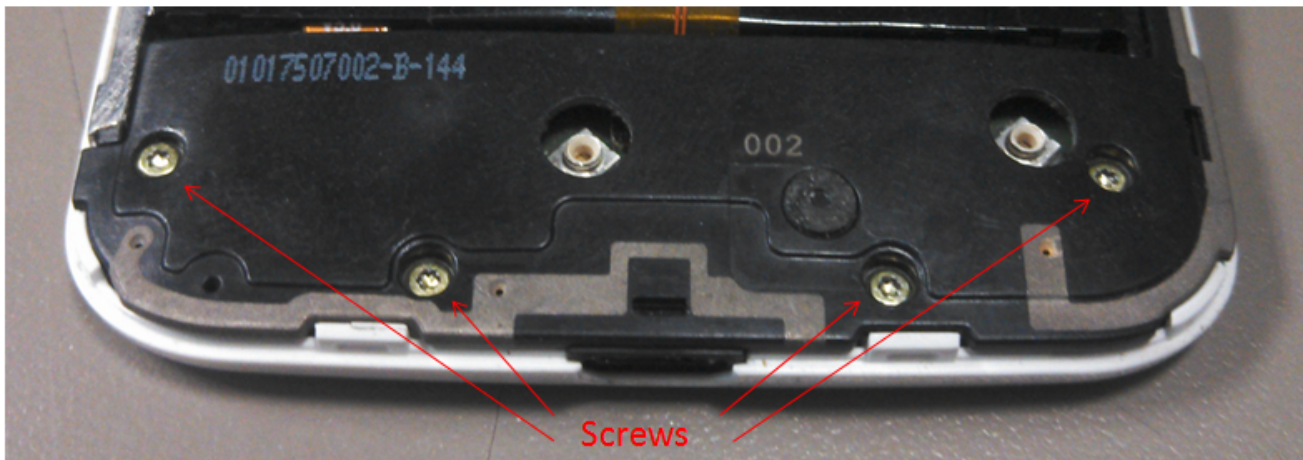
Step 3: Check if all the screws are present or not (see the picture below)

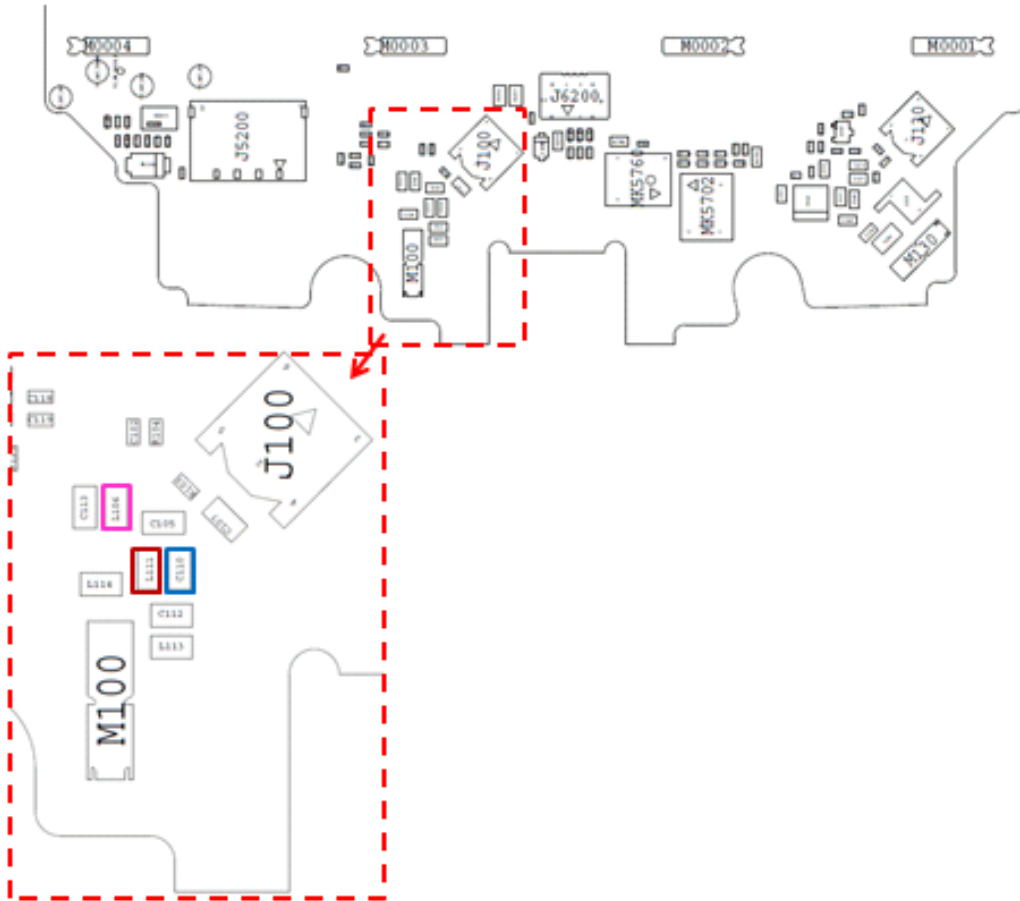
Step 4: Check if the antenna contact (M100) is present there or not. The location of the contact is shown in the PCB layout below:

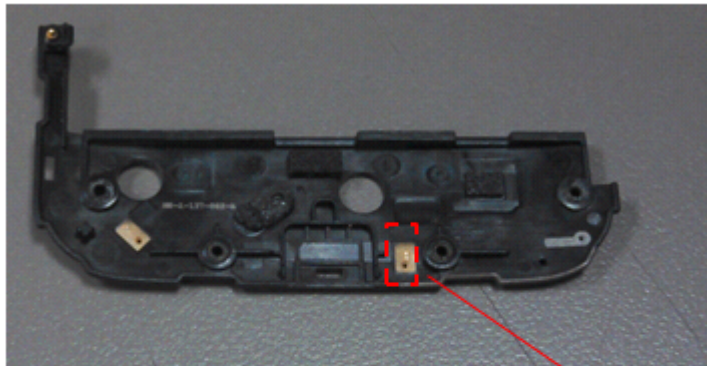
Contact mark

Step 5: Check if the antenna feed for ANT1 is touching the antenna contact or not. The photograph of the antenna feed area is shown below. You cannot see whether it is touching or not, but if the carrier is touching you would see touch mark on the feed of the antenna as shown below:

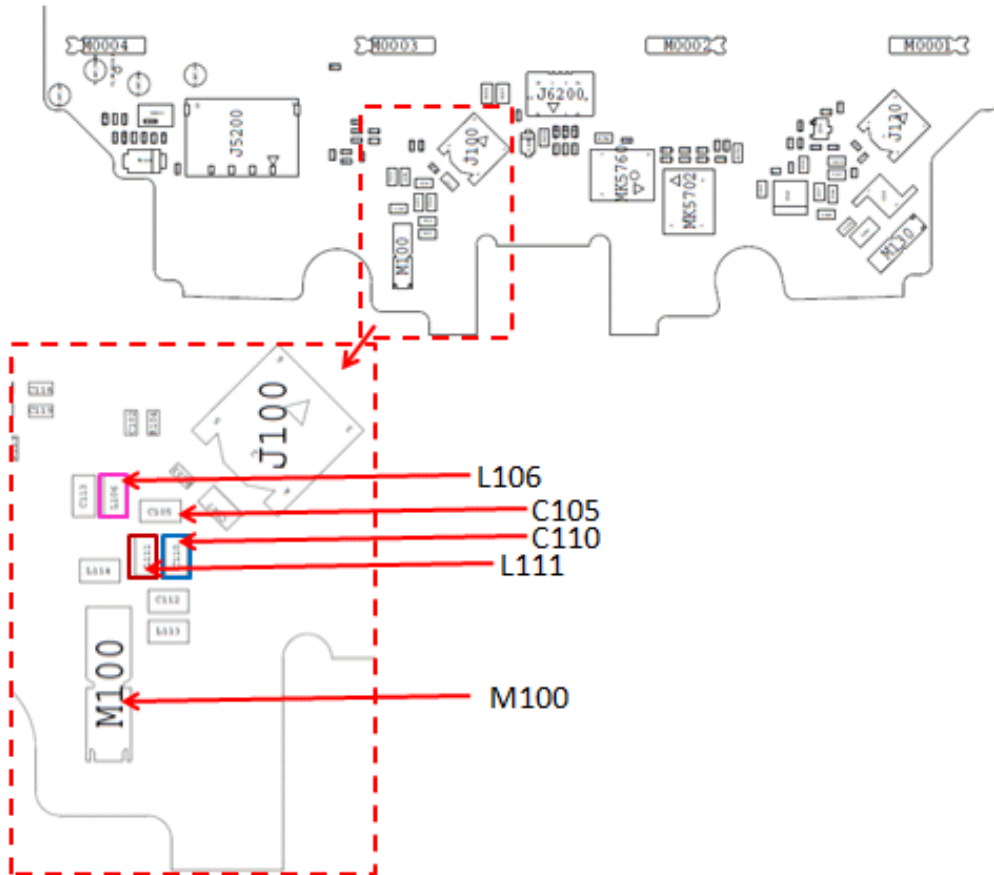
Step 6: Check for the missing, misplaced, crashed parts for the following matching components:

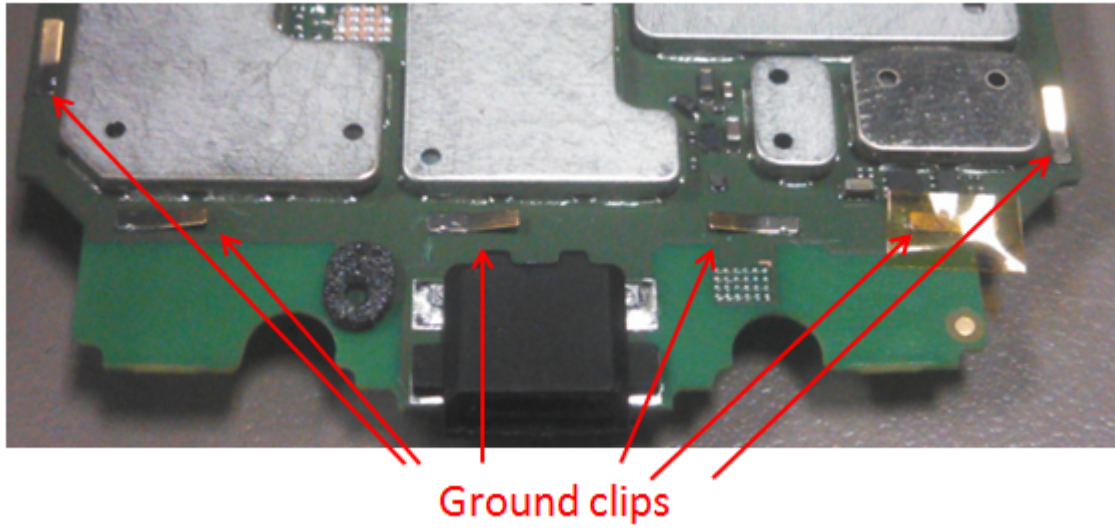
Step 7: Check for the ground clips connecting display bezel to the PCB

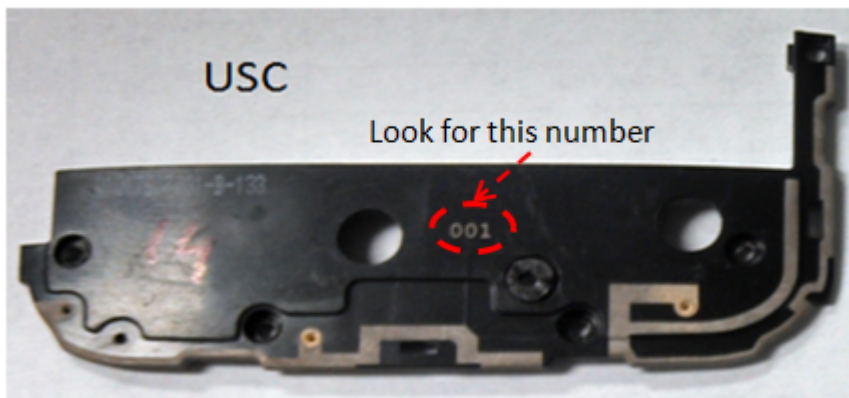
Figure: Antenna Carrier

Step 2: Check if the bottom antenna carrier is for the USC or not. If it is USC, 001 is printed on the Antenna carrier as shown below:

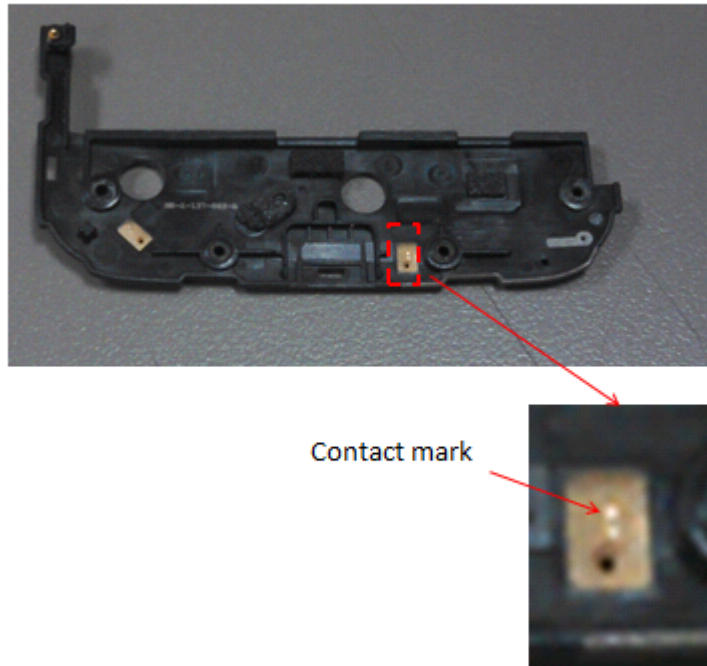
Figure: Antenna contact pad

Step 3: if Step 2 does not resolve issue. Check if the antenna feed for ANT1 is touching the antenna contact or not. The photograph of the antenna feed area is shown below. You cannot see whether it is touching or not, but if the carrier is touching you would see touch mark on the feed of the antenna as shown below:

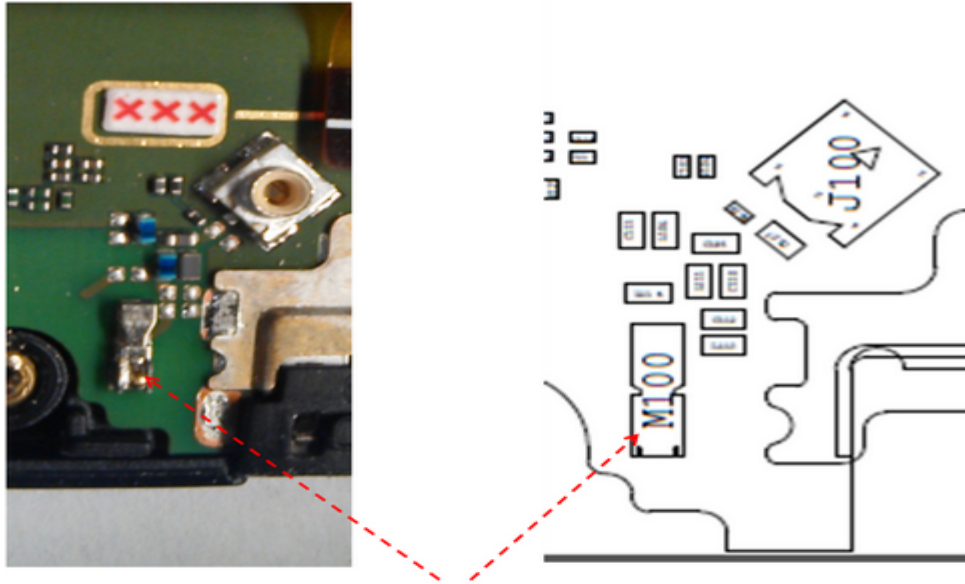
Figure: Antenna contact

Step 4: If Step 3 fails, check if universal contact on the PCB is damaged. Is it touching the antenna pad? If the contact is twisted or not making contact, this is a problem. The contact should look like this picture below:

This is the clip to check

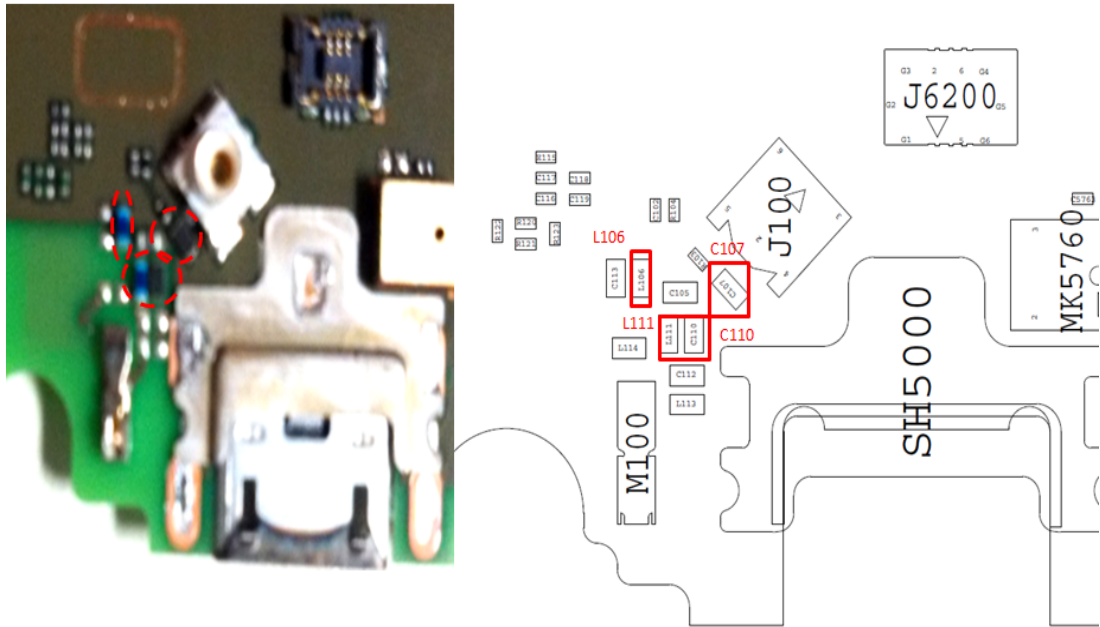
Figure: Matching components

Step 5: If step 4 does not resolve the problem check if components L111, C110, C107 and L106 are placed in the circuit.

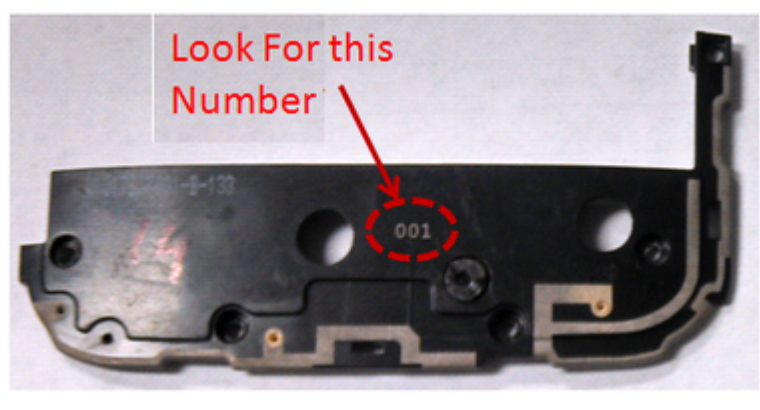
Fig: Moto X Americas Bottom Antenna Carrier

Step 2: If retest does not pass, check if the unit has correct bottom antenna carrier. The AT&T bottom antenna carrier should look like following:

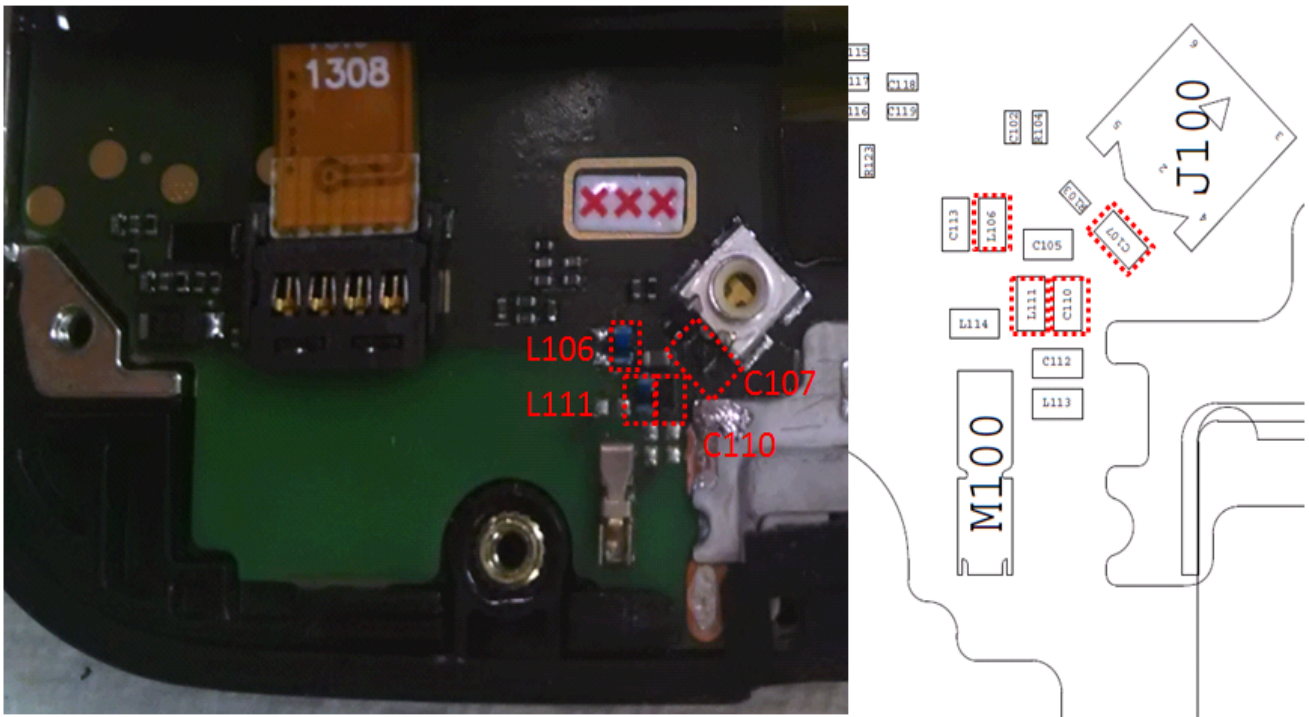
Figure: Antenna matching components and universal clip for WCDMA Antenna

Step 4: If Step 3 does not resolve the problem check if components RefDes = L106, L111, C107 and C110 are placed correctly on PCB as shown below:

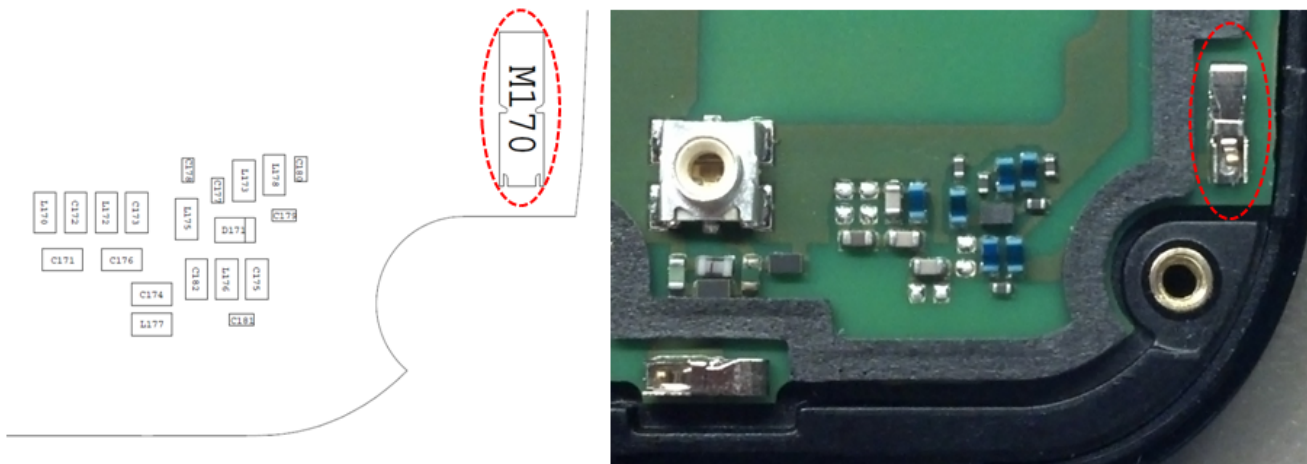
Figure: Antenna 3 Universal Contact

Step 2: If the failure persists, check the Antenna 3 universal contact, M170. If it is missing, misplaced, or damaged, place/replace the part and retest. Also check the contact pad of Antenna 3 on the diversity antenna carrier for a visible mark where the contact was touching the pad. If no mark is present, replace the universal contact M170 and retest.

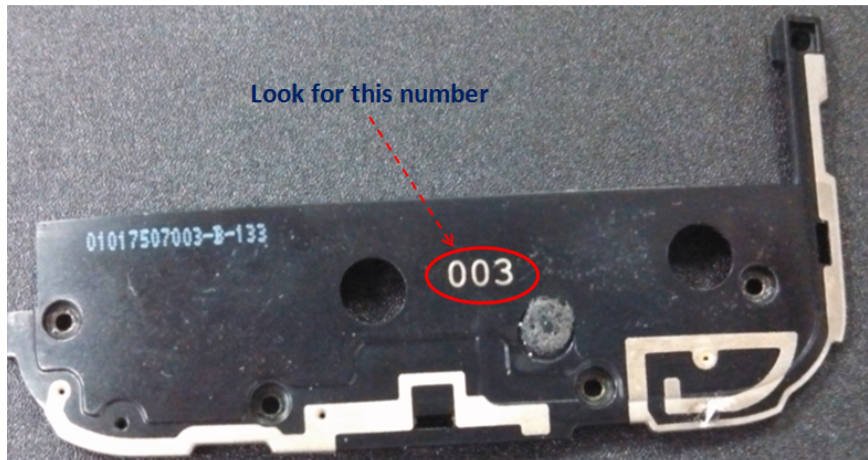
Fig: Carrier

Step 2: If failure persists, check if we have the right carrier. The carrier is as shown in figure below

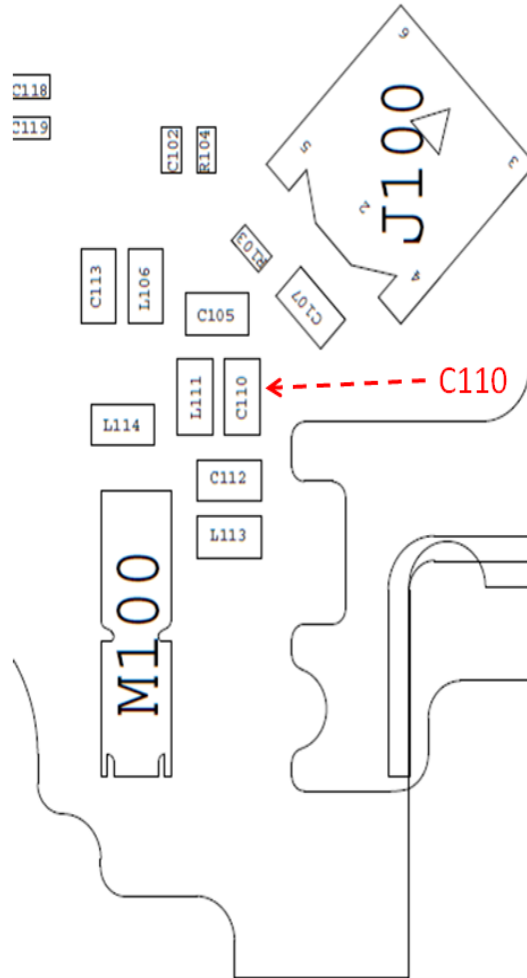
Figure: Component C110

Step 4: If step 3 does not resolve the problem check if components C110 is placed in the circuit

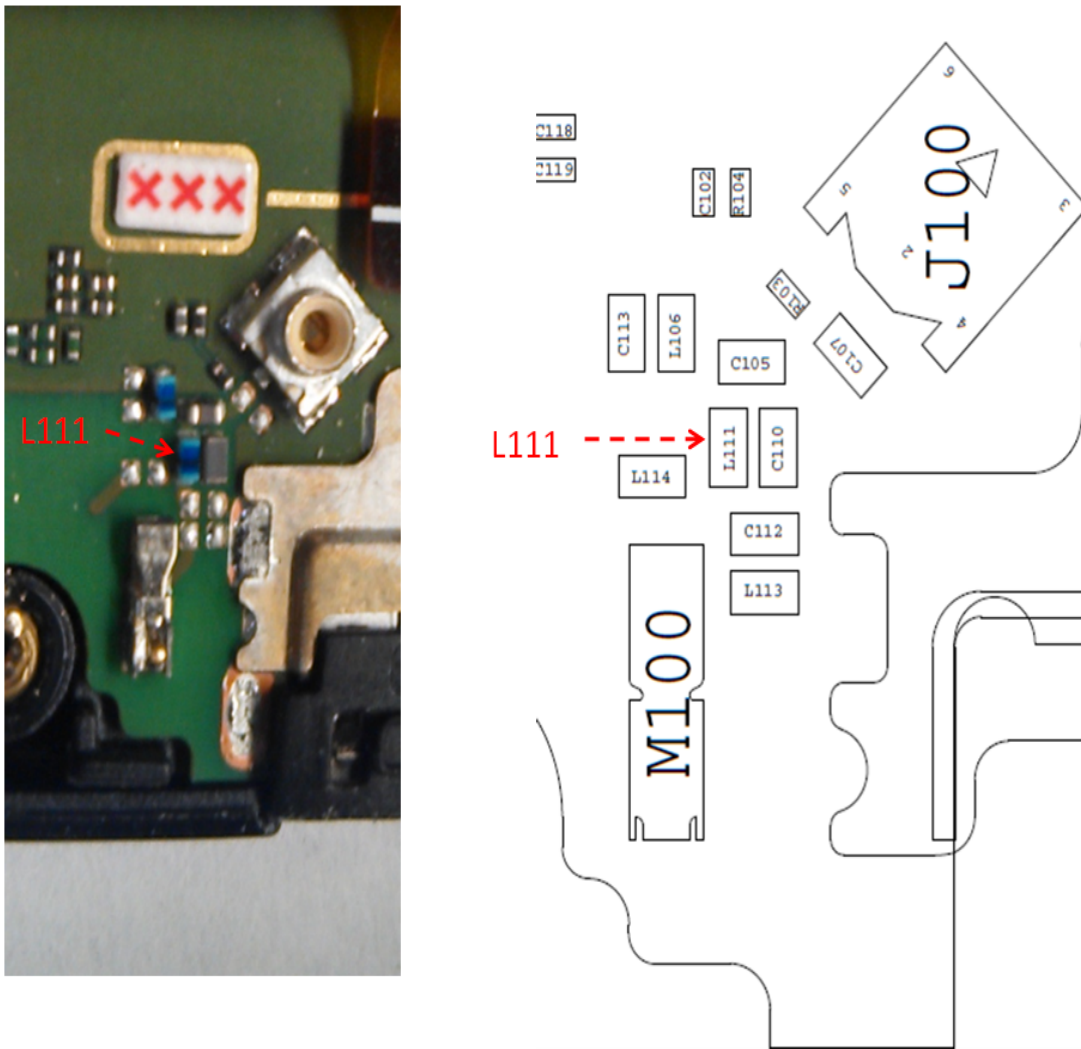
Figure: Component L111

Step 5: If Step 4 does not resolve the problem check if components L111

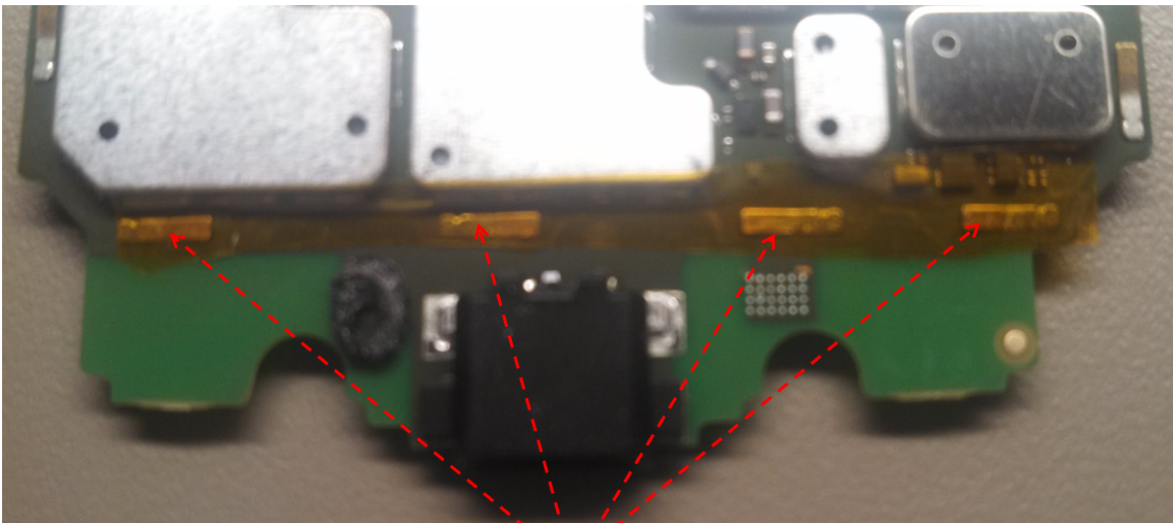
Figure: Moto X PCB board with ground clips

Step 7: If Step 6 does not resolve the problem check if the ground clips are placed on the board

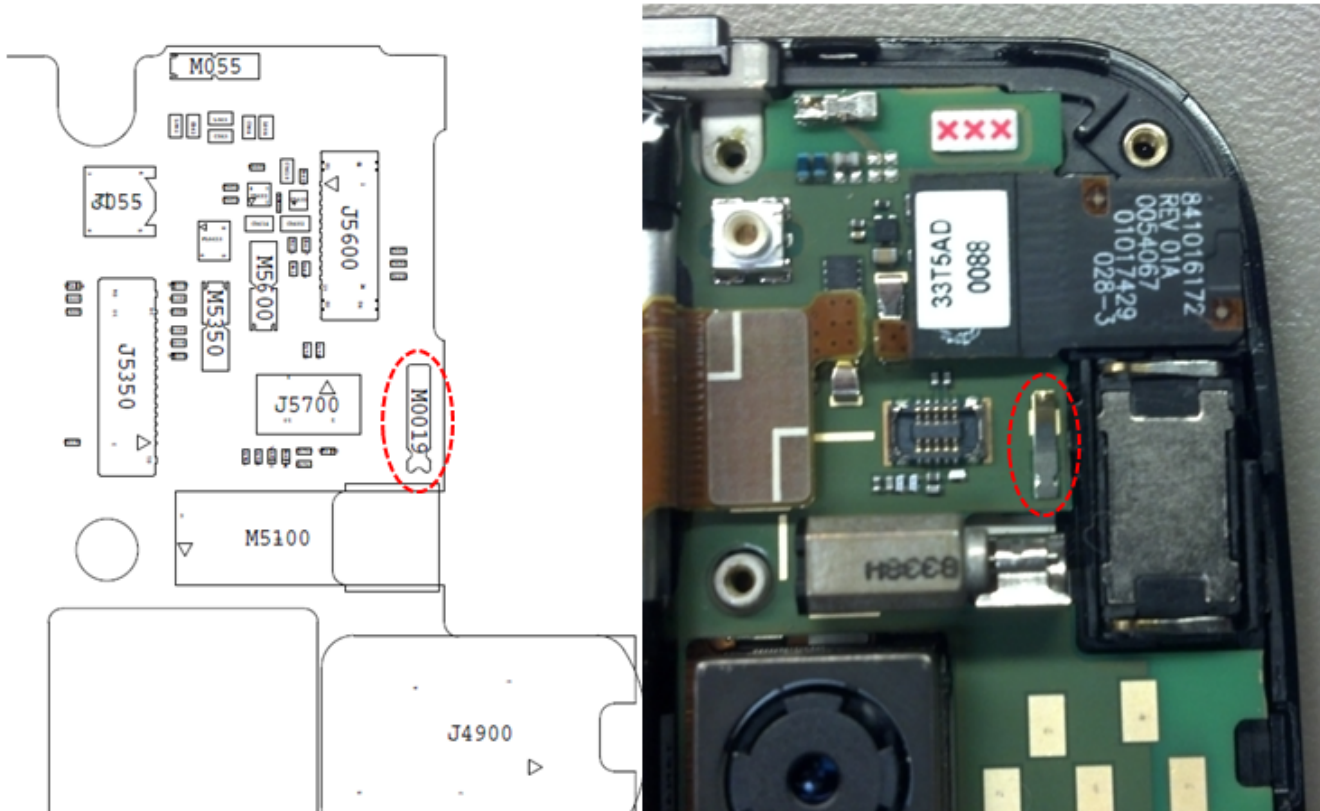
Figure: Grounding Clip Between PCB and Audio Flex Bracket

Step 5: If Step 4 does not resolve the issue, check the grounding clip between the PCB and the audio flex bracket, M0019. If the clip is missing, misplaced, or damaged, place/replace the part and retest.

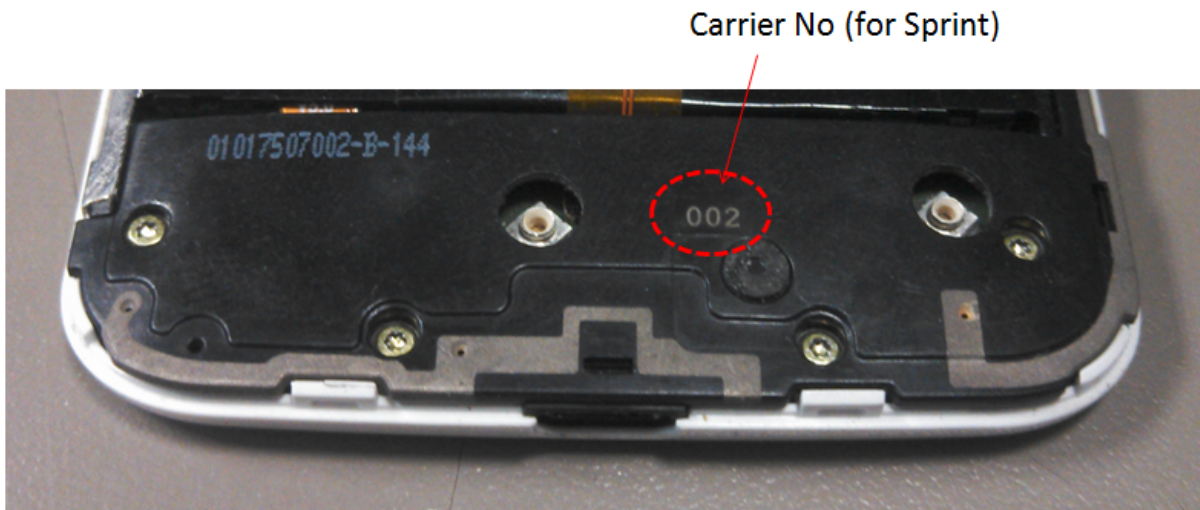
Step 2: Check if the bottom antenna carrier is for the Sprint or not. If it is Sprint, 002 is printed on the Antenna carrier as shown below:

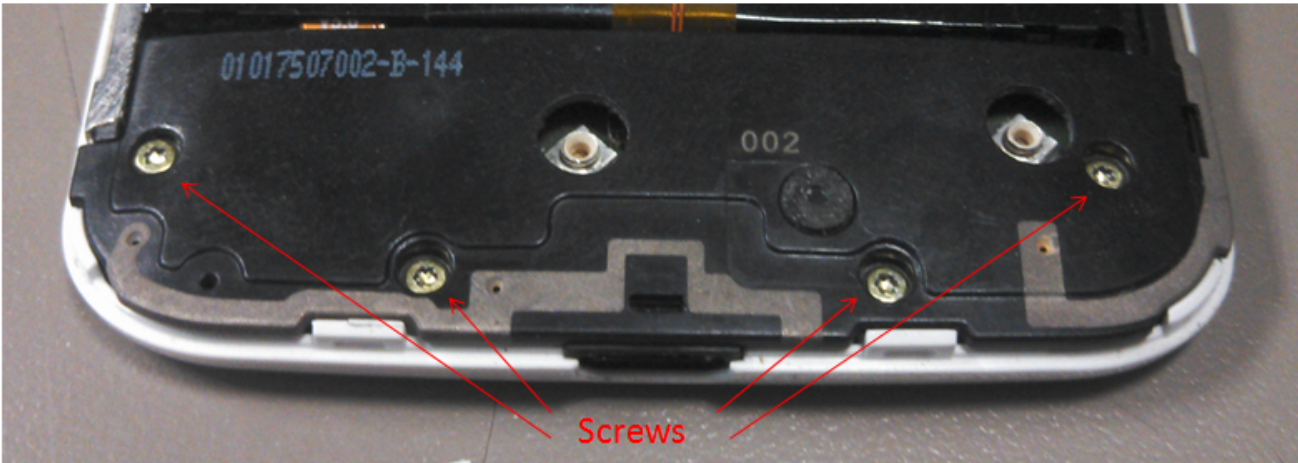
Step 3: Check if all the screws are present or not (see the picture below)

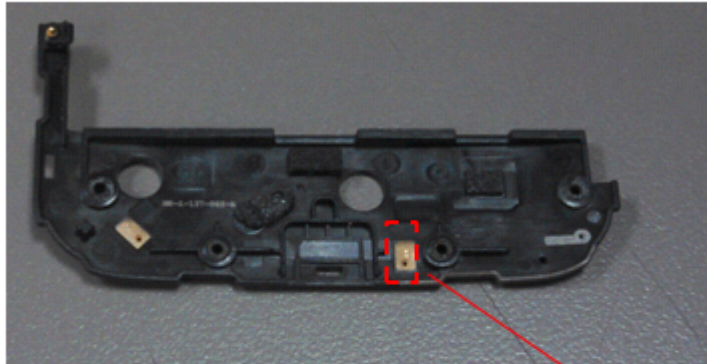
Contact mark

Step 5: Check if the antenna feed for ANT1 is touching the antenna contact or not. The photograph of the antenna feed area is shown below. You cannot see whether it is touching or not, but if the carrier is touching you would see touch mark on the feed of the antenna as shown below:

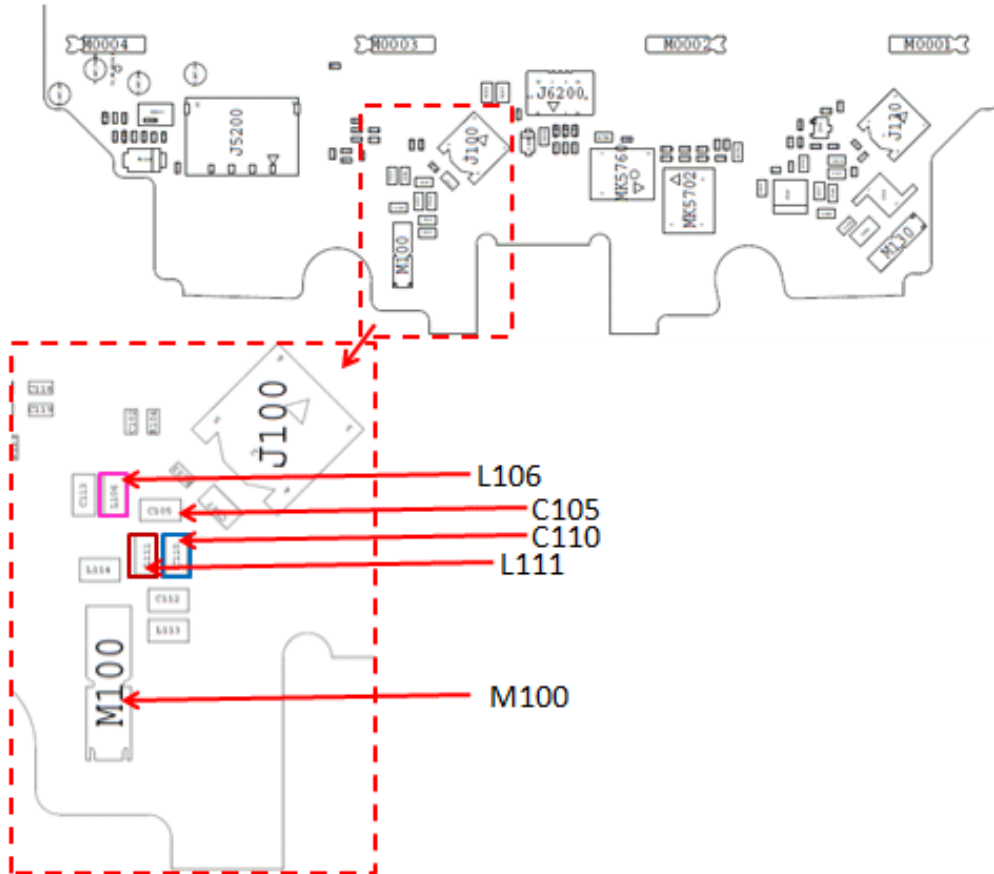
Step 6: Check for the missing, misplaced, crashed parts for the following matching components:

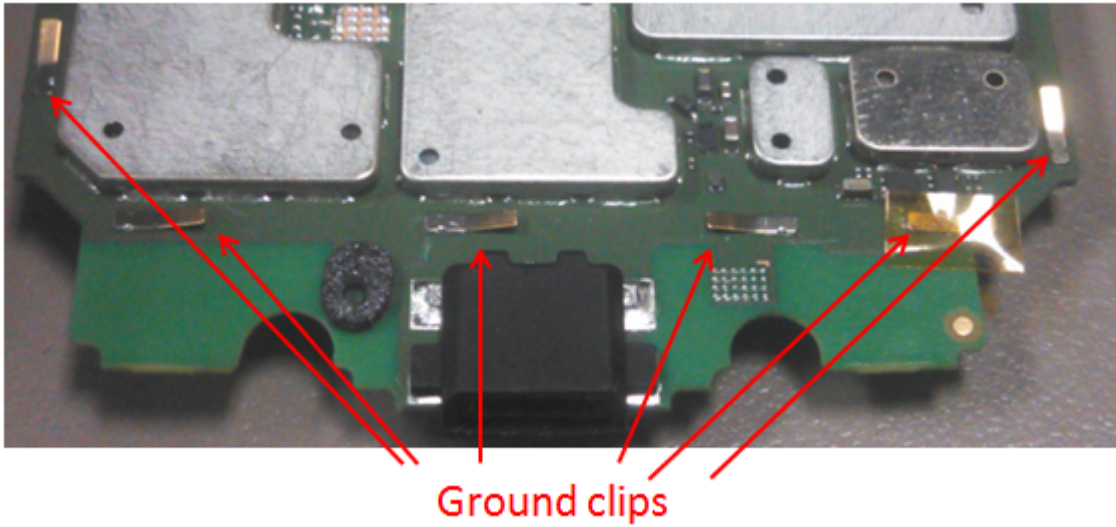
Step 7: Check for the ground clips connecting display bezel to the PCB

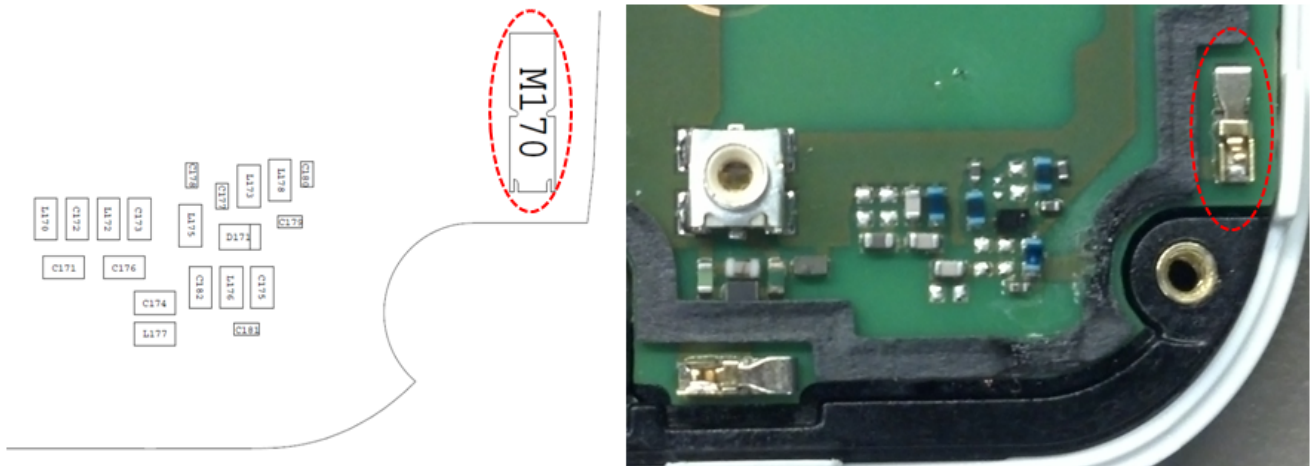
Figure: Antenna 3 Universal Contact

Step 2: If the failure persists, check the Antenna 3 universal contact, M170. If it is missing, misplaced, or damaged, place/replace the part and retest. Also check the contact pad of Antenna 3 on the diversity antenna carrier for a visible mark where the contact was touching the pad. If no mark is present, replace the universal contact M170 and retest.

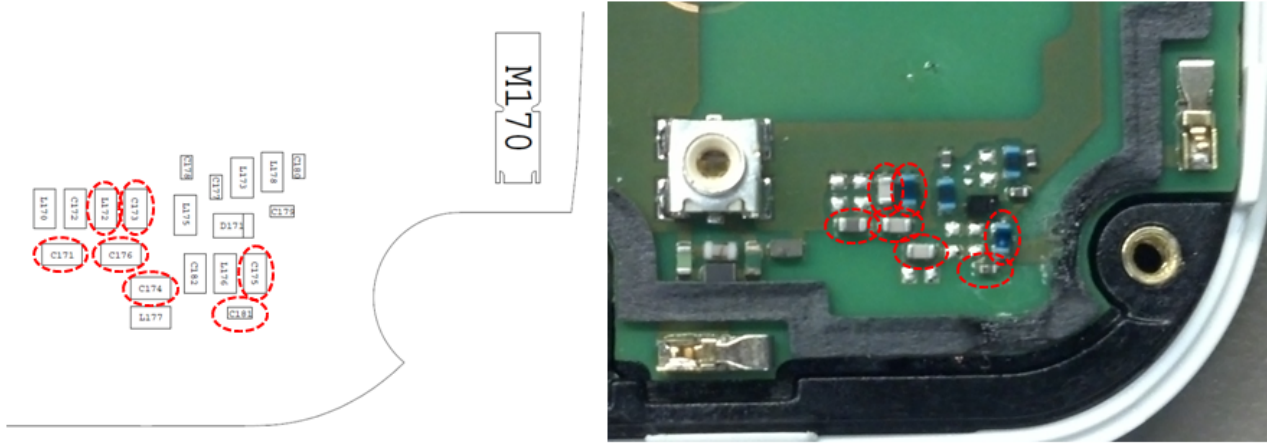
Figure: Antenna 3 Matching Components and PIN Diode Biasing Components

Step 3: If Step 2 does not resolve the issue, check all Antenna 3 matching components and PIN diode biasing components: C171, L172, C176, C173, C174, C181, and C175. If any component is missing, misplaced, or damaged, place/replace the part and retest.

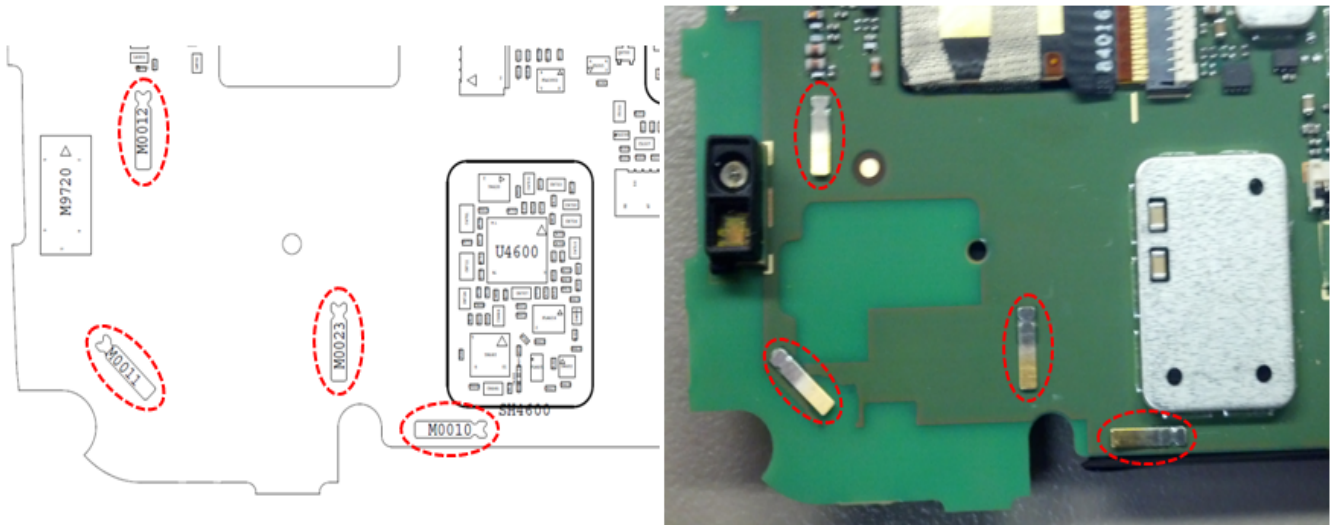
Figure: PCB Grounding Clips Near Antenna 3 Matching

Step 4: If Step 3 does not resolve the issue, check the PCB grounding clips on the display side of the PCB: M0010, M0011, M0012, and M0023. If any clip is missing, misplaced, or damaged, place/replace the part and retest.

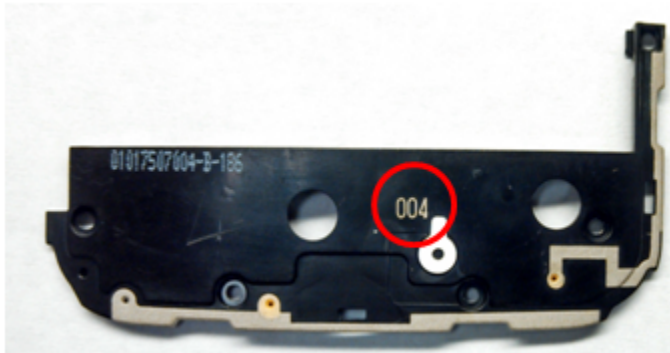
Step 2: Check if the bottom antenna carrier is the correct carrier for TMO. TMO antenna has marking '004' as shown below

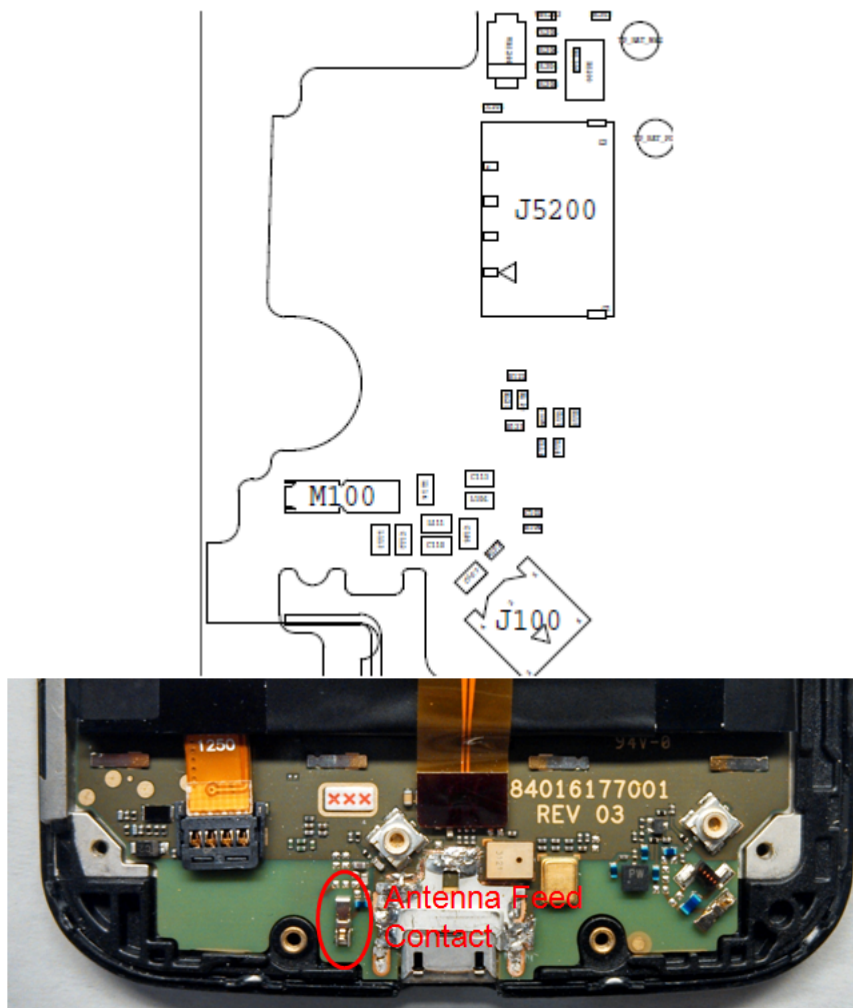
Step 3: If the failure persists, check the Antenna 1 universal contact, M100. If it is missing, misplaced, or damaged, place/replace the part and retest. Also check the contact pad of Antenna 2 on the main antenna carrier for a visible mark where the contact was touching the pad. If no mark is present, replace the universal contact M100 and retest.

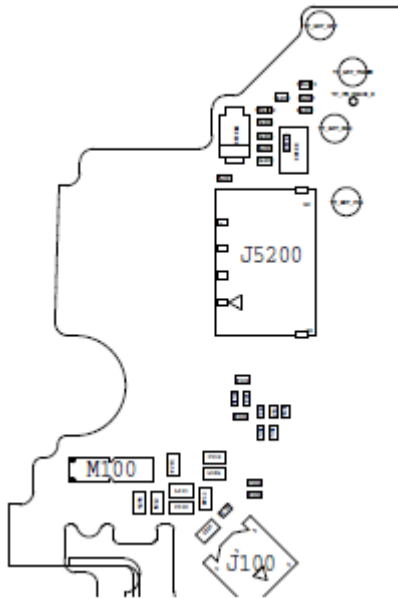
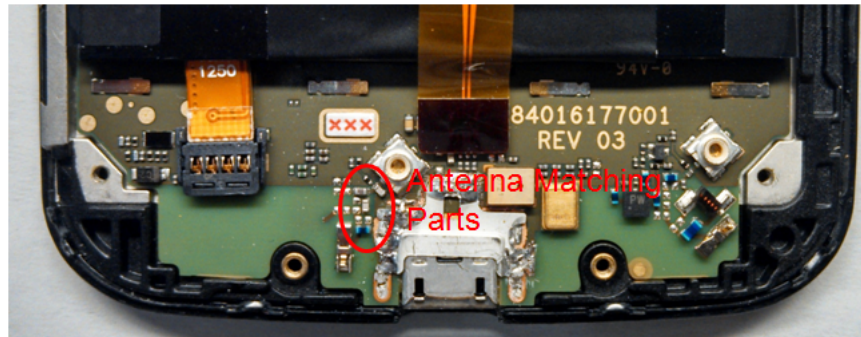
Step 4: If Step 3 does not resolve the issue, check all Antenna 1 matching components L113, C110, C107 and C105. If any component is missing, misplaced, or damaged, place/replace the part and retest.
