# Moto X Field Service Trouble Shooting Guide

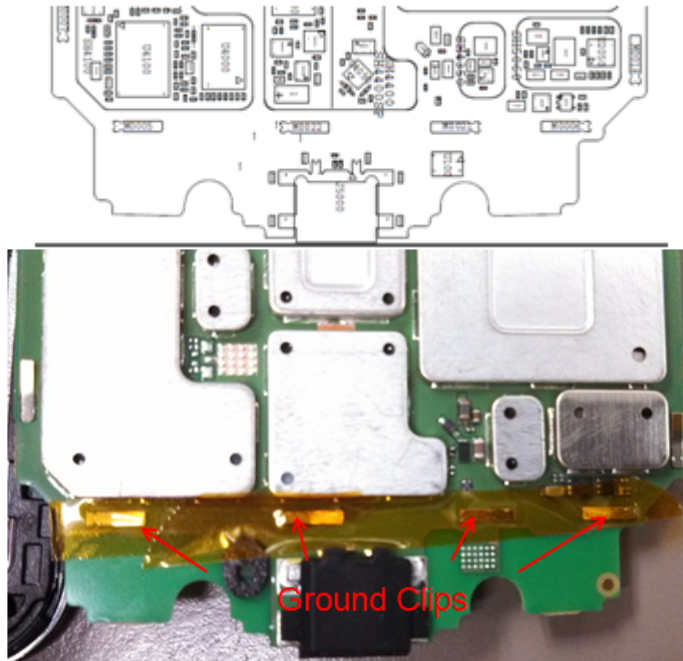
Step 5: If Step 4 does not resolve the issue, check the PCB grounding clips on the display side of the PCB: M0005, M0022, M0021, and M0006. If any clip is missing, misplaced, or damaged, place/replace the part and retest.

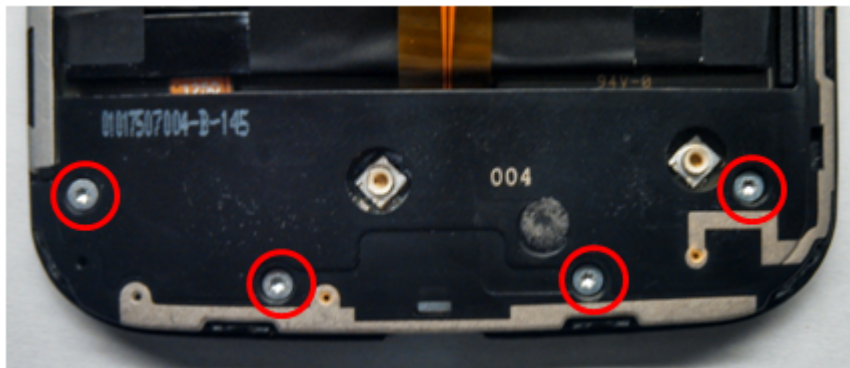
Step 6: If Step 5 does not resolve the issue, check the screw holding the antenna carrier to the front housing near the Antenna 1 feed. If the screw is missing or not fully inserted, place/replace the screw and retest.

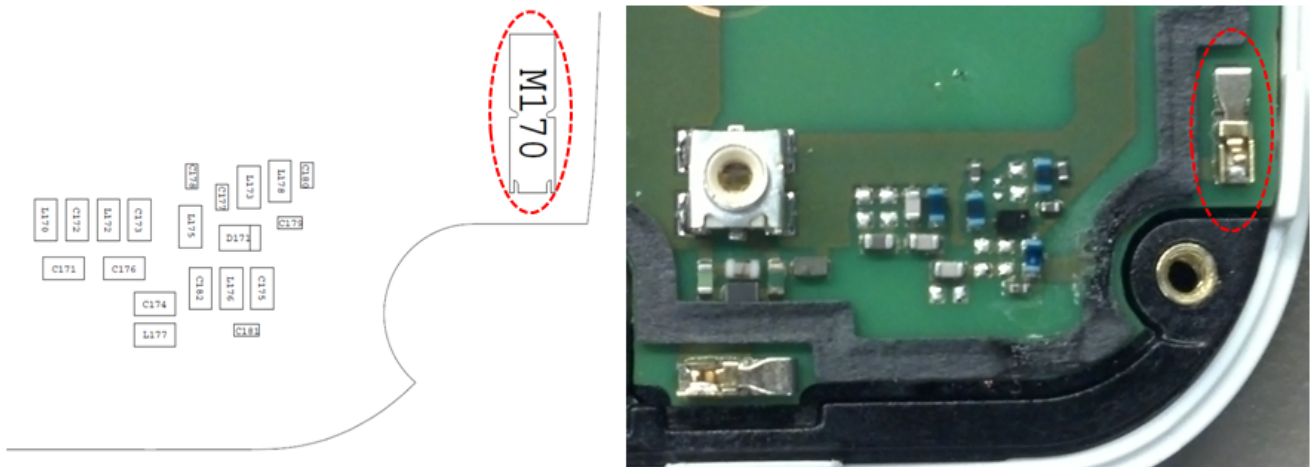
Figure: Antenna 3 Universal Contact

Step 2: If the failure persists, check the Antenna 3 universal contact, M170. If it is missing, misplaced, or damaged, place/replace the part and retest. Also check the contact pad of Antenna 3 on the diversity antenna carrier for a visible mark where the contact was touching the pad. If no mark is present, replace the universal contact M170 and retest.

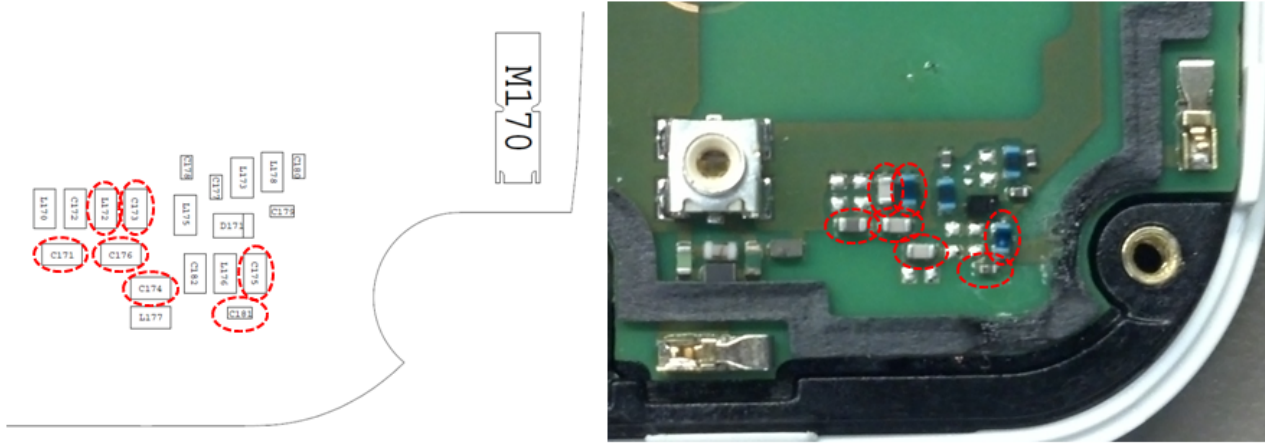
Figure: Antenna 3 Matching Components and PIN Diode Biasing Components

Step 3: If Step 2 does not resolve the issue, check all Antenna 3 matching components and PIN diode biasing components: C171, L172, C176, C173, C174, C181, and C175. If any component is missing, misplaced, or damaged, place/replace the part and retest.

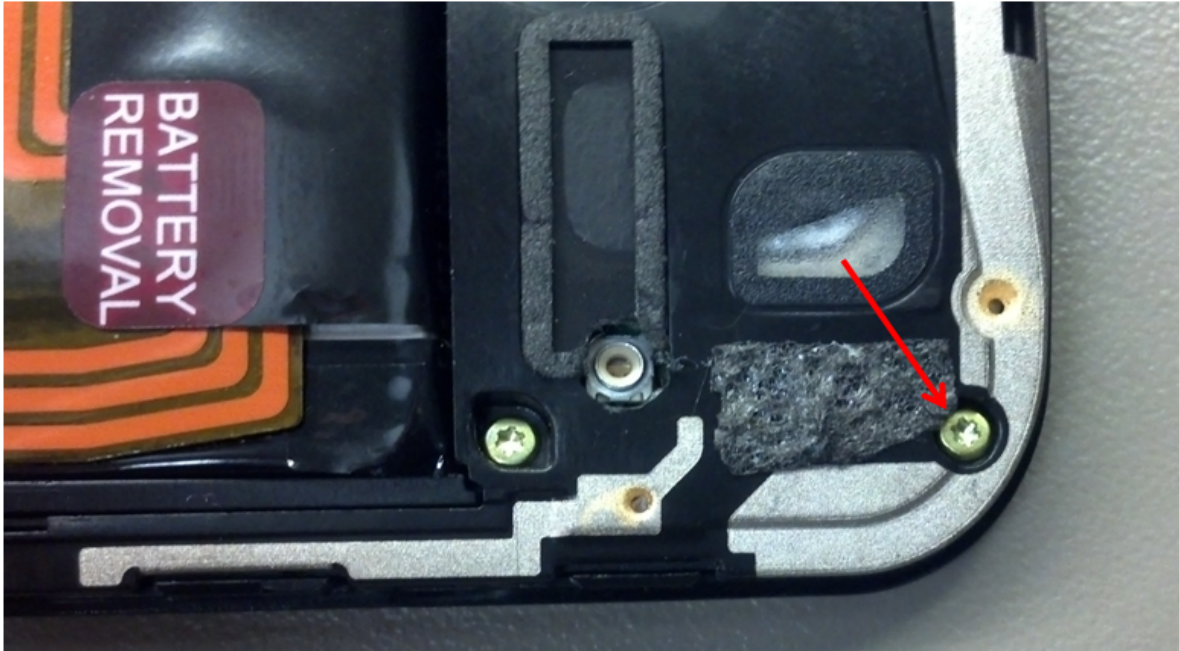
Figure: Screw Holding Diversity Carrier near Antenna 3 Feed

Step 6: If Step 5 does not resolve the issue, check the screw holding the antenna carrier to the front housing near the Antenna 3 feed. If the screw is missing or not fully inserted, place/replace the screw and retest.

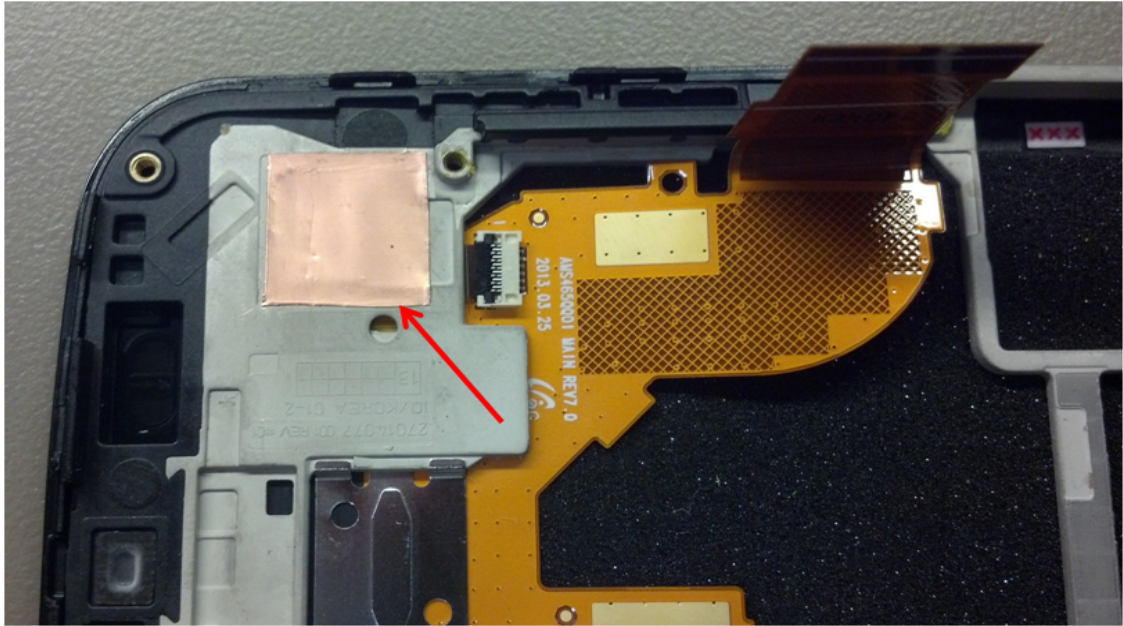
Figure: Copper Tape over Touch IC on Chassis

Step 7: If Step 6 does not resolve the issue, check the square piece of copper taped placed over the touch IC on the chassis. If the copper tape is missing, misplaced, or not fully adhered, place/replace the copper tape and retest.

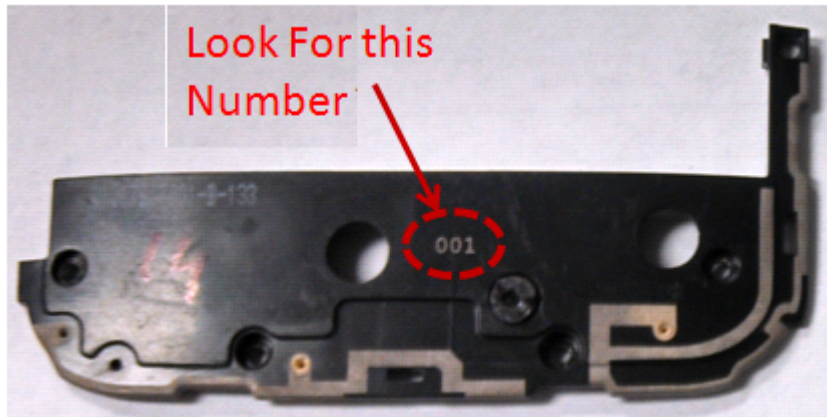
Fig: Moto X Americas Bottom Antenna Carrier

Step 2: If retest does not pass, check if the unit has correct bottom antenna carrier. The AT&T bottom antenna carrier should look like following:

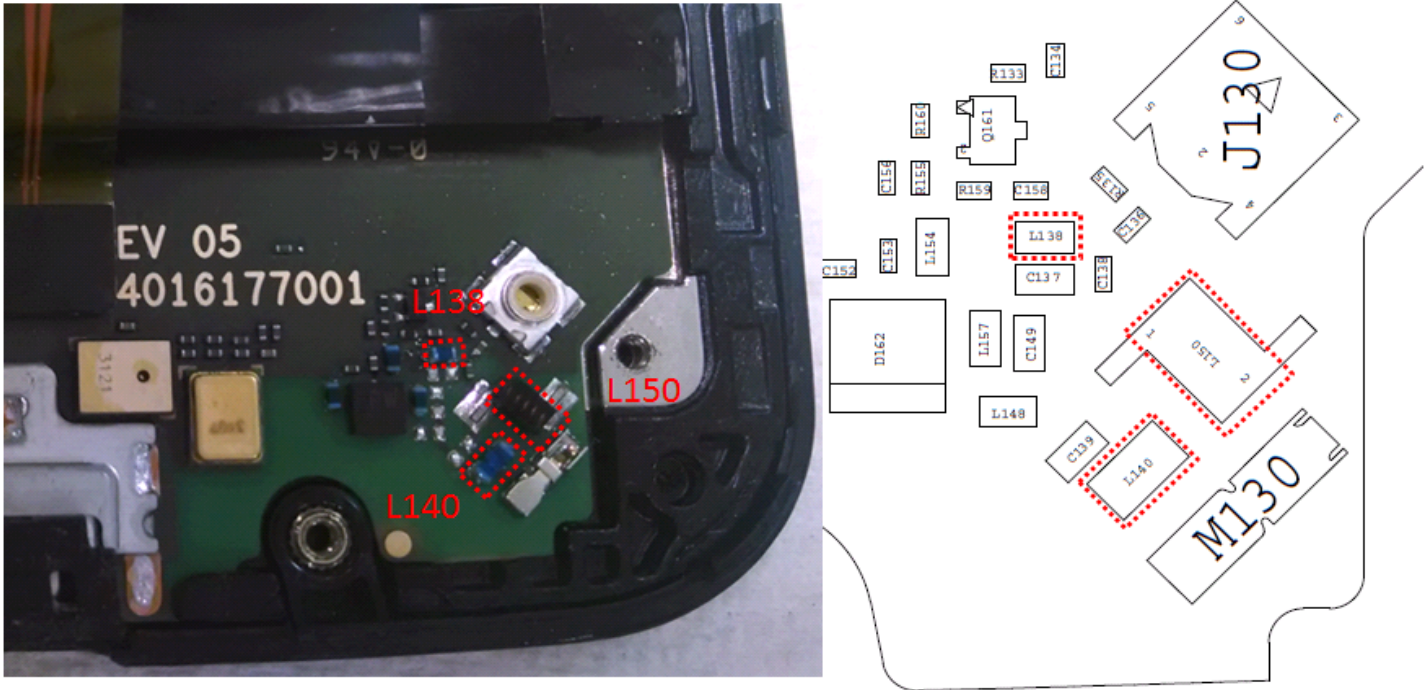
Figure: Antenna matching components and universal clip for LTE B17 Antenna

Step 4: If Step 3 does not resolve the problem check if components RefDes = L140, L150 and L138 are placed correctly on PCB

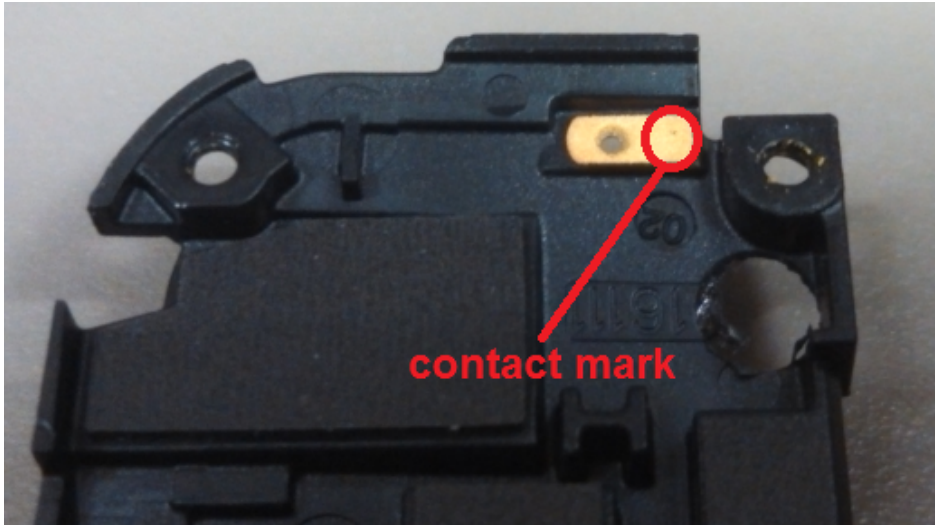
Figure: contact mark

Step 3: If failure persists, check if the antenna made a contact with antenna feed contact (contact mark). There should be a dot next to via on the antenna carrier (see figure below).

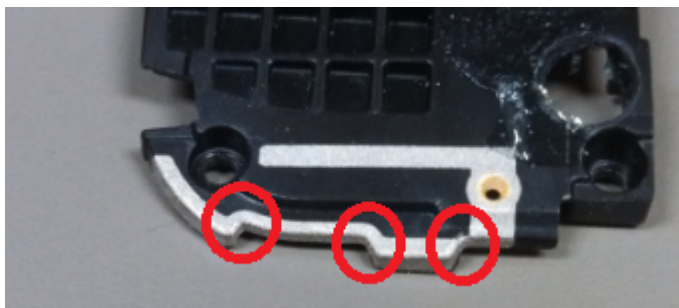
Figure: Antenna 5

Step 5: If failure persists, check if there is any crack in the antenna, especially in the snap location area.

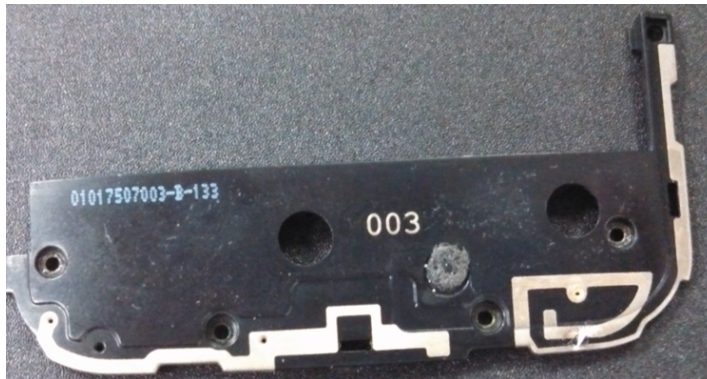
Fig: Carrier

Step 2: If failure persists, check if we have the right carrier. The carrier is as shown in figure below

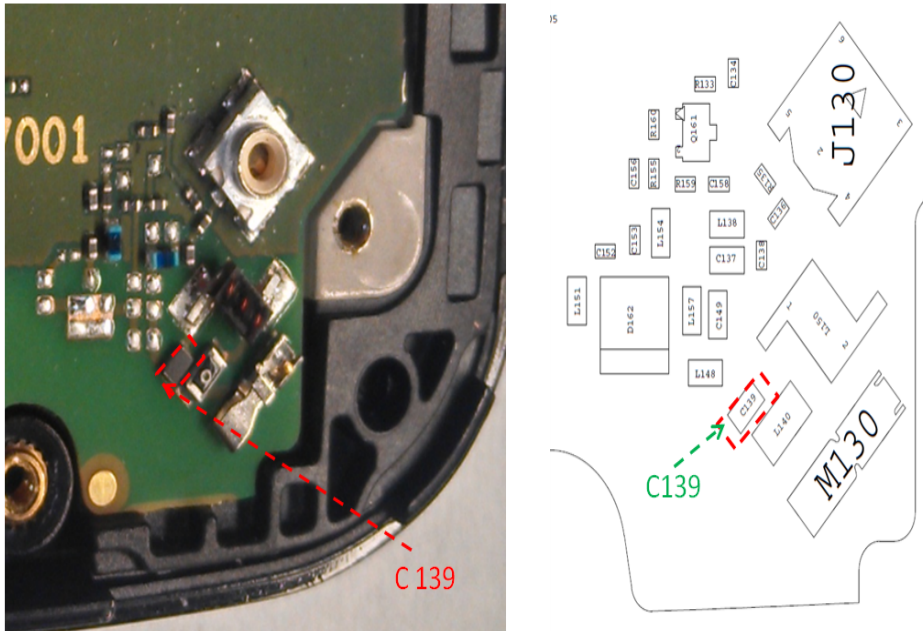
Figure: Component C139

Step 4: If step 3 does not resolve the problem check if components C139 is placed in the circuit

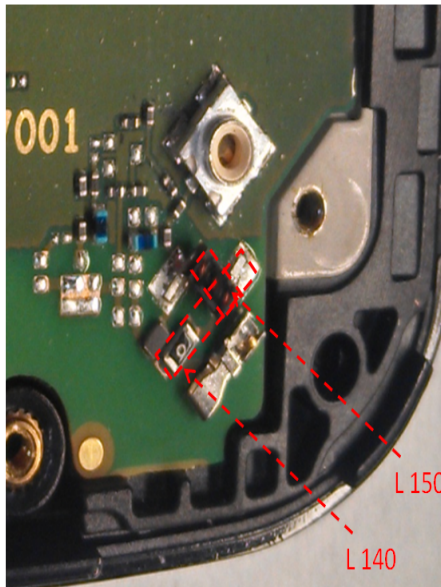
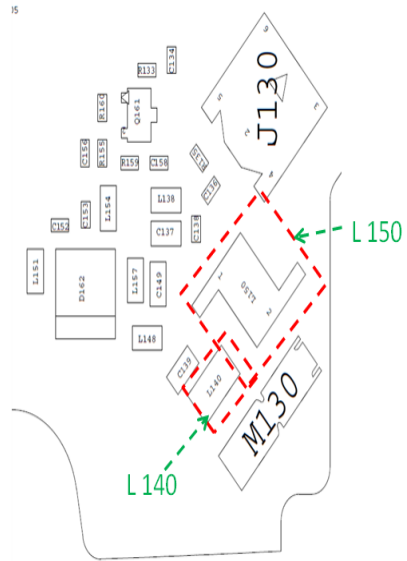
Step 5: If Step 4 does not resolve the problem check if components L140 and L150 is placed in the circuit

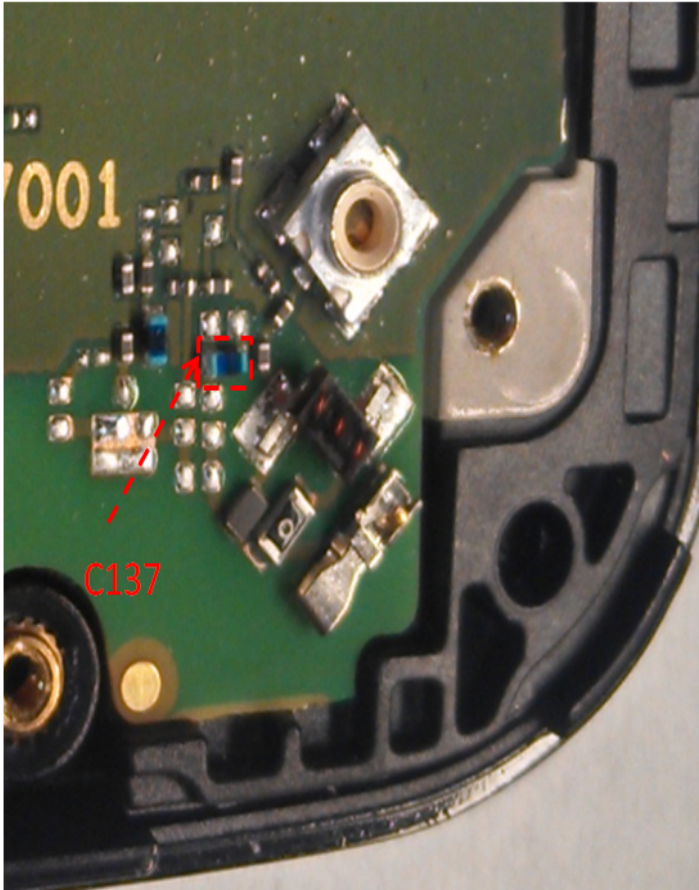
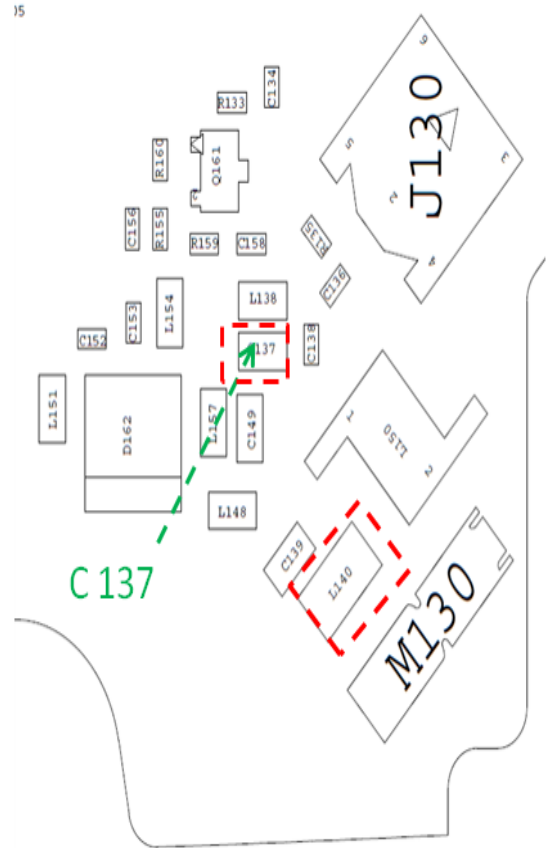
Step 6: If Step 5 does not resolve the problem check if components C137 is placed in the circuit

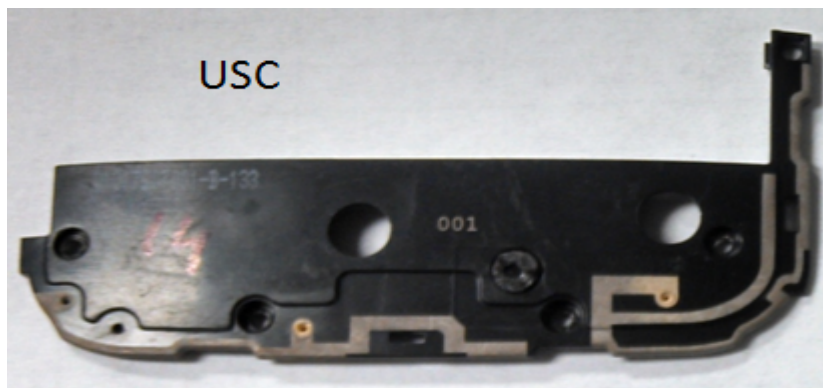
Figure: Antenna carrier

Step 2: If retest does not pass, check if the unit has correct bottom antenna carrier. The USC bottom antenna carrier should look like following:

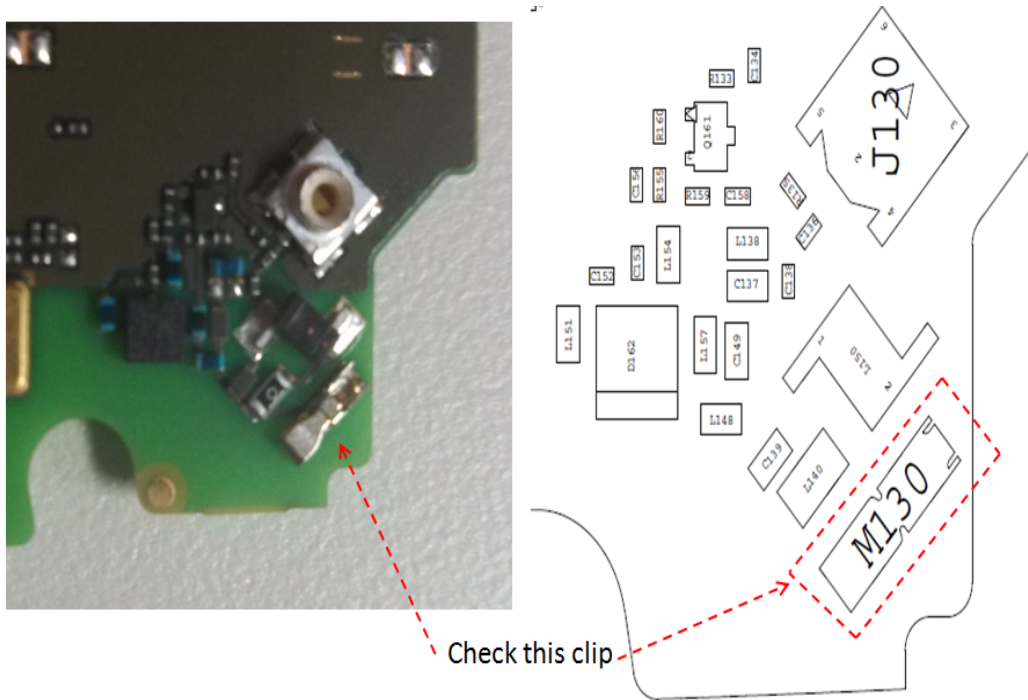
Figure: Antenna clip

Step 3: if Step 2 does not resolve issue, check if universal contact on the PCB is damaged. Is it touching the antenna pad? If the contact is twisted or not making contact, this is a problem. The contact should look like this picture below:

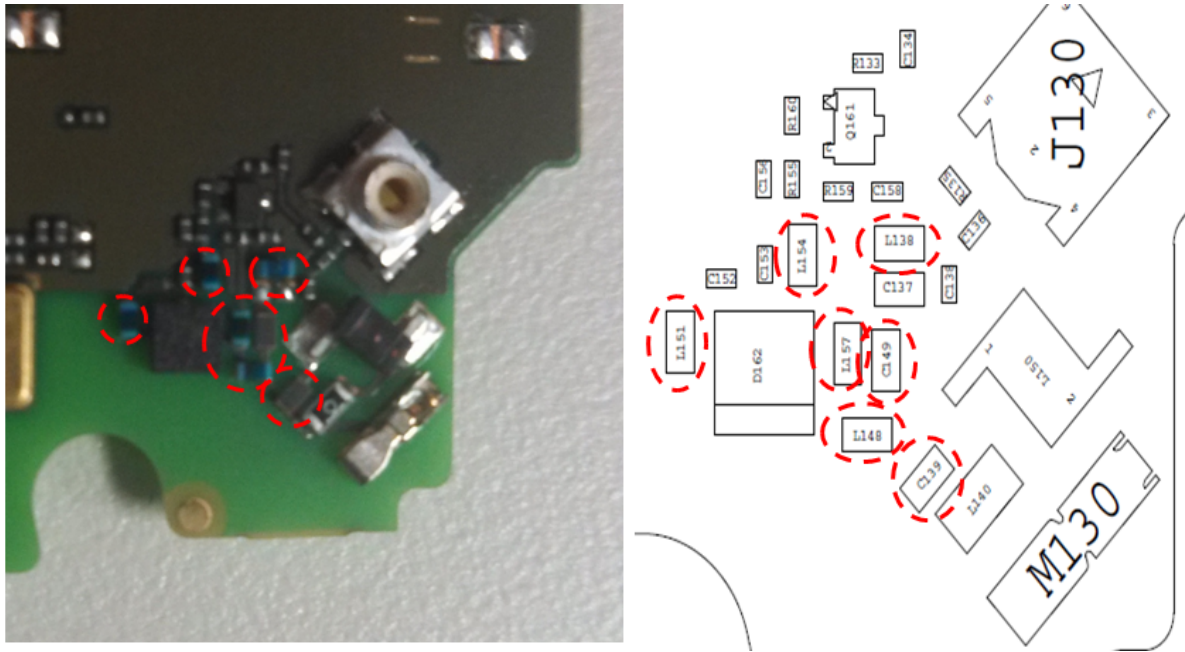
Figure: Matching components

Step 5: If step 4 does not resolve the problem check if components with Ref Des = L148, C139, C149, L138, L151, L154 and L157 are all placed in the PCB

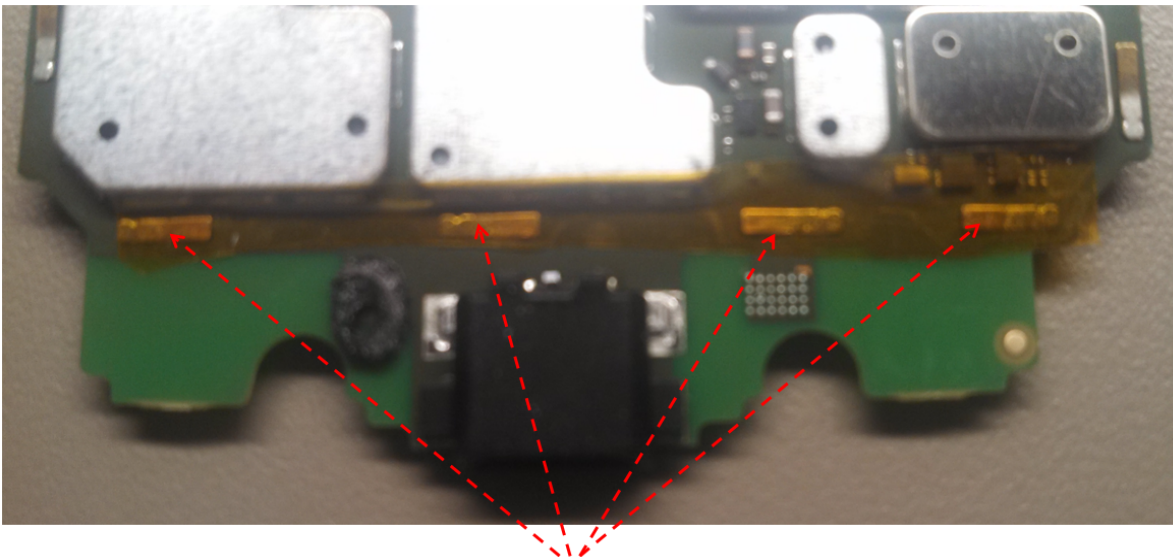
Figure: Moto X PCB board with ground clips

Step 6: If Step 5 does not resolve the problem check if the ground clips are placed on the board

Step 7: If the unit still fails, change the bottom antenna carrier with a new one and retest.

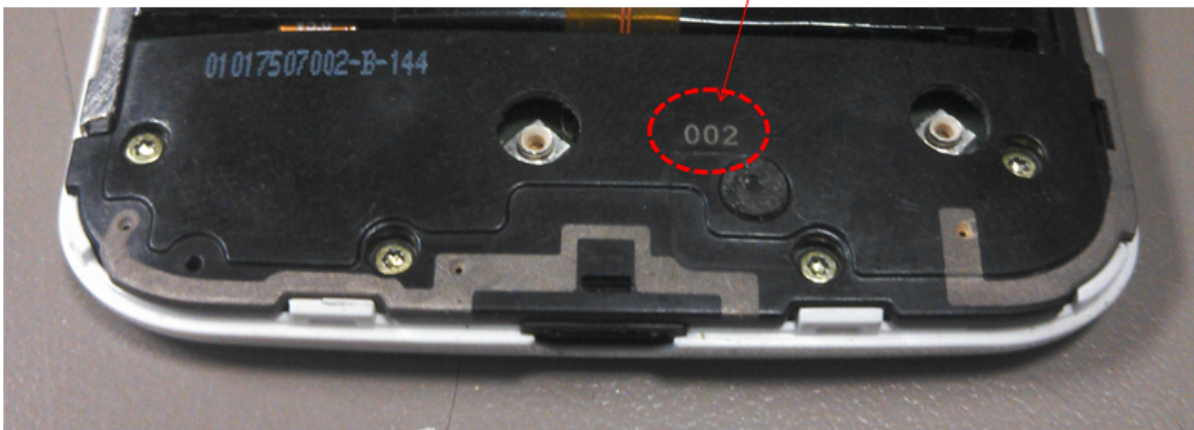
Carrier No (for Sprint)

Step 2: Check if the bottom antenna carrier is for the Sprint or not. If it is Sprint, 002 is printed on the Antenna carrier as shown below:

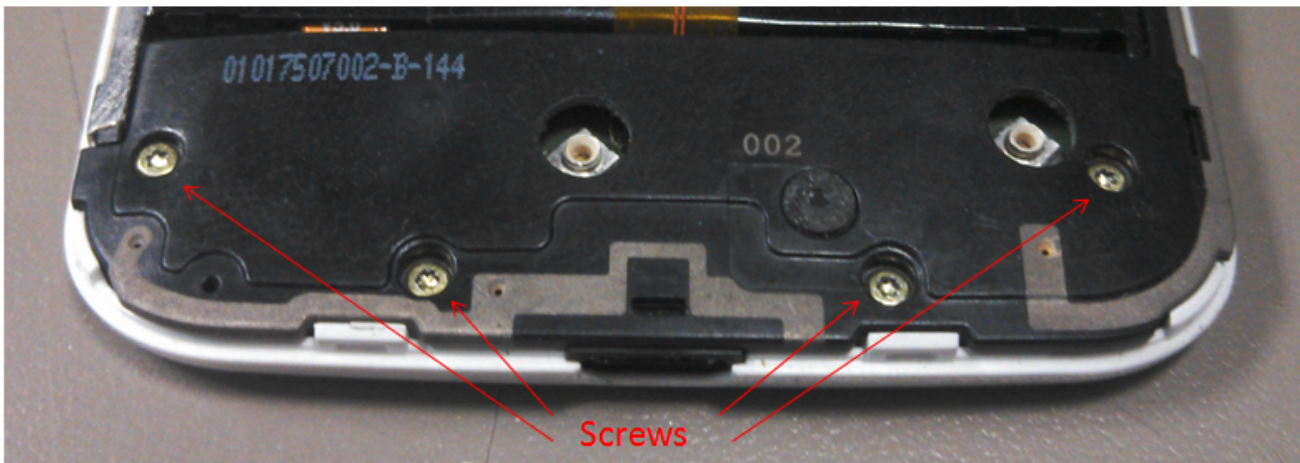
Step 3: Check if all the screws are present or not (see the picture below)

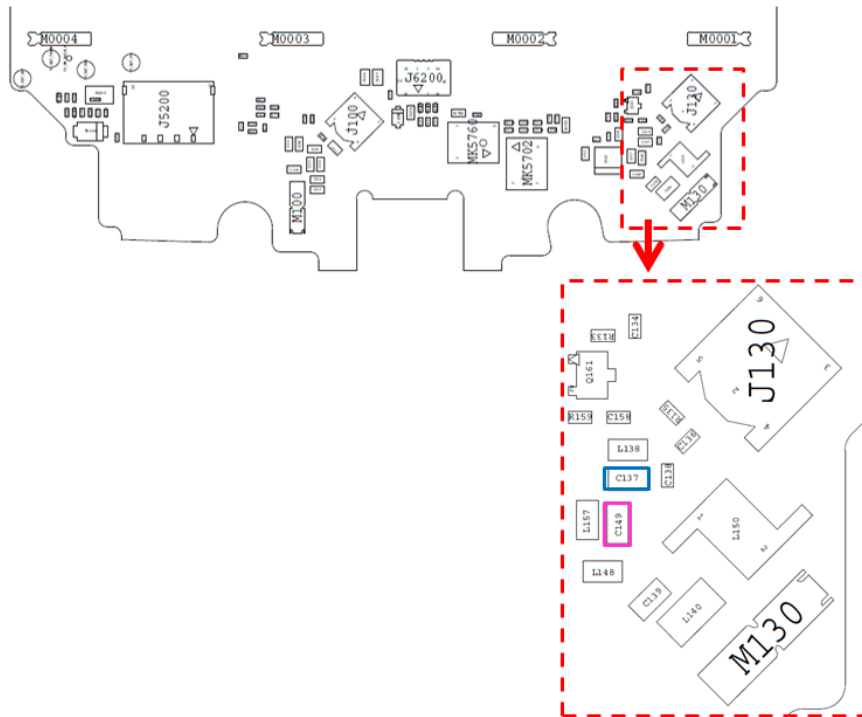
Step 4: Check if the antenna contact (M130) is present there or not. The location of the contact is shown in the PCB layout below:

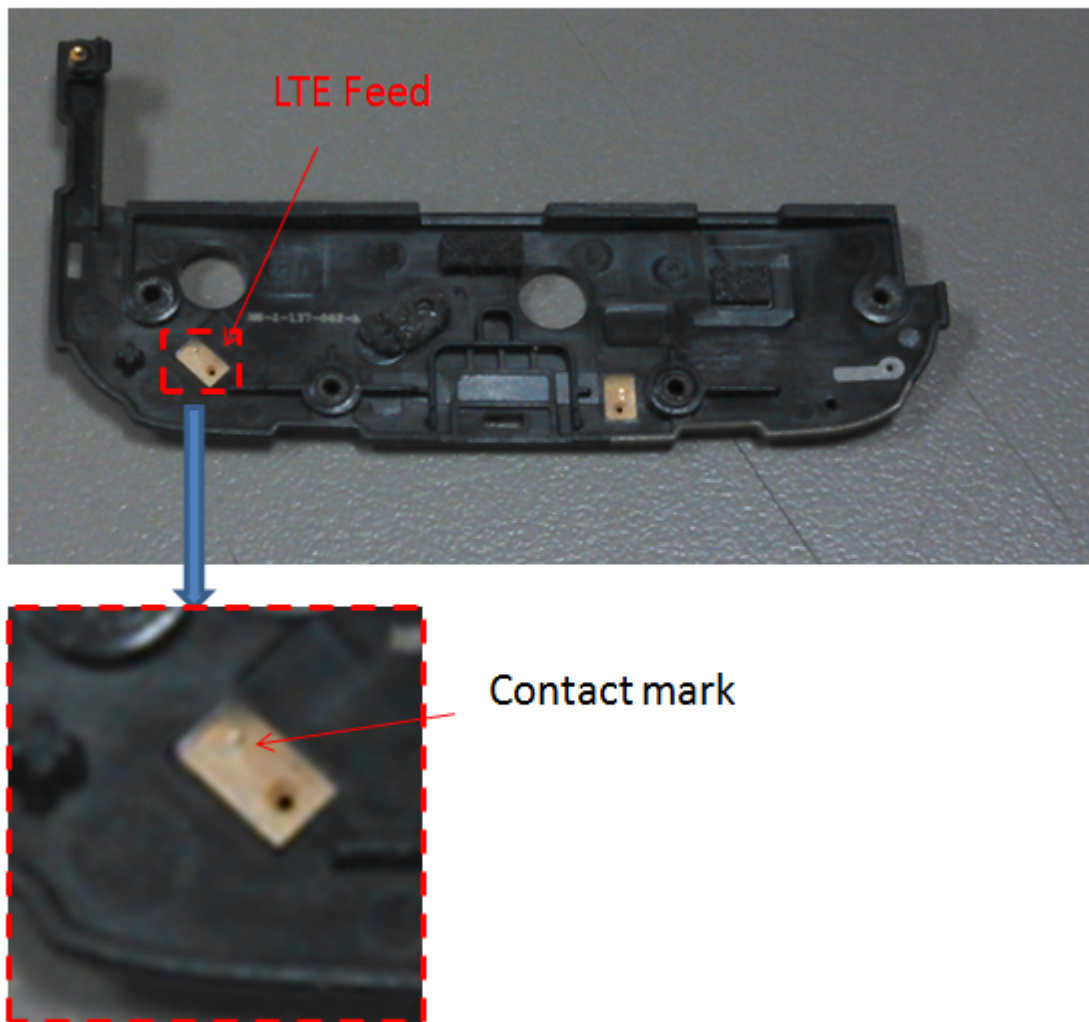
Step 5: Check if the antenna feed for ANT2 is touching the antenna contact or not. The photograph of the antenna feed area is shown below. You cannot see whether it is touching or not, but if the carrier is touching you would see touch mark on the feed of the antenna as shown below:

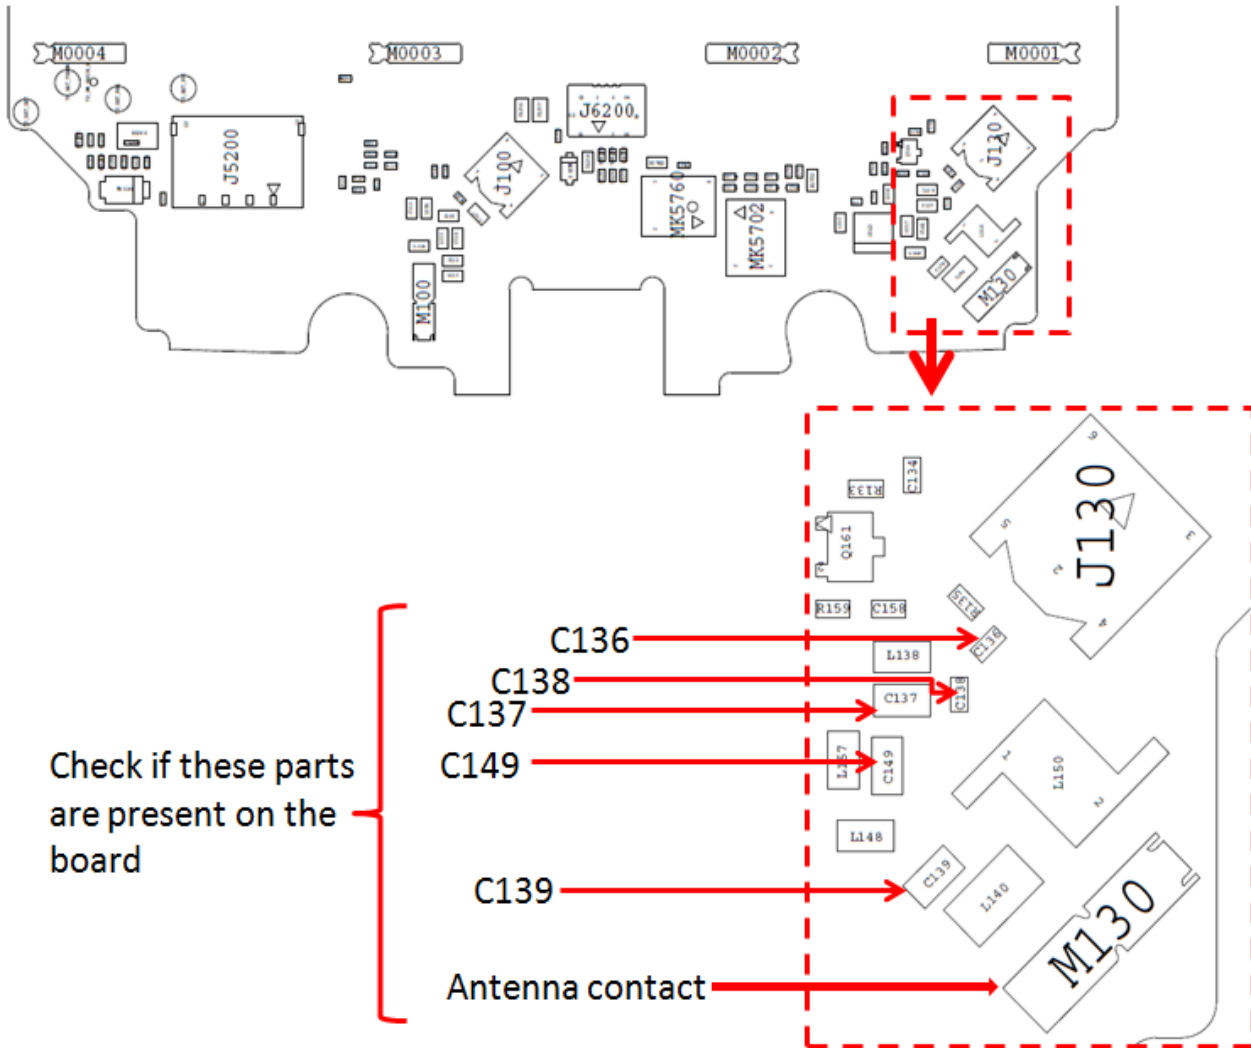
Step 6: Check for the missing, misplaced, crashed parts for the following matching components:

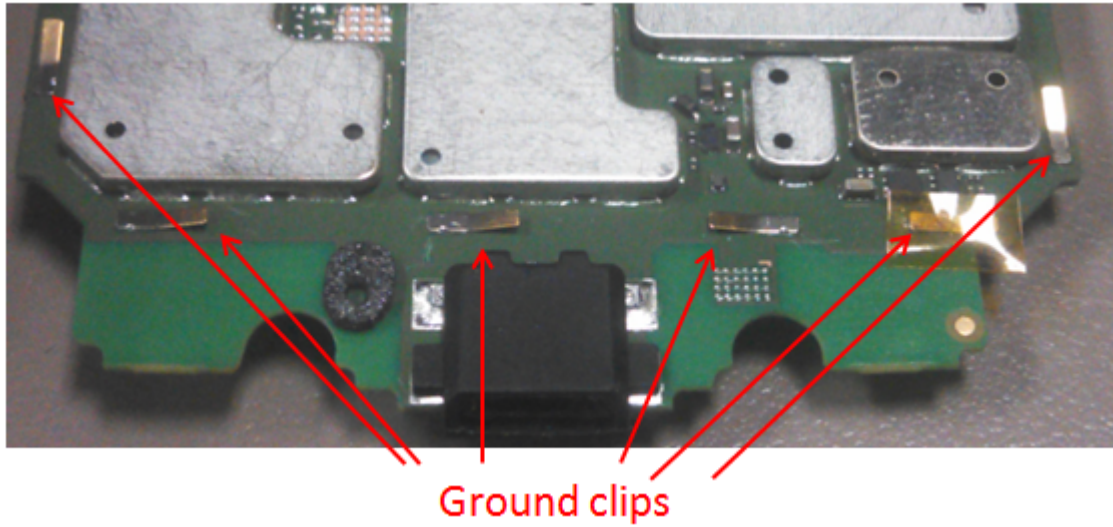
Step 7: Check for the ground clips connecting display bezel to the PCB

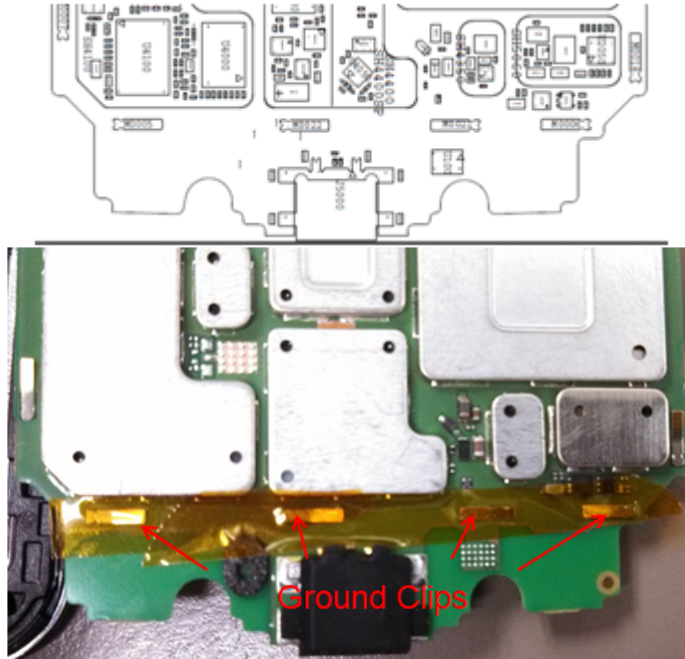
Step 5: If Step 4 does not resolve the issue, check the PCB grounding clips on the display side of the PCB: M0005, M0022, M0021, and M0006. If any clip is missing, misplaced, or damaged, place/replace the part and retest.

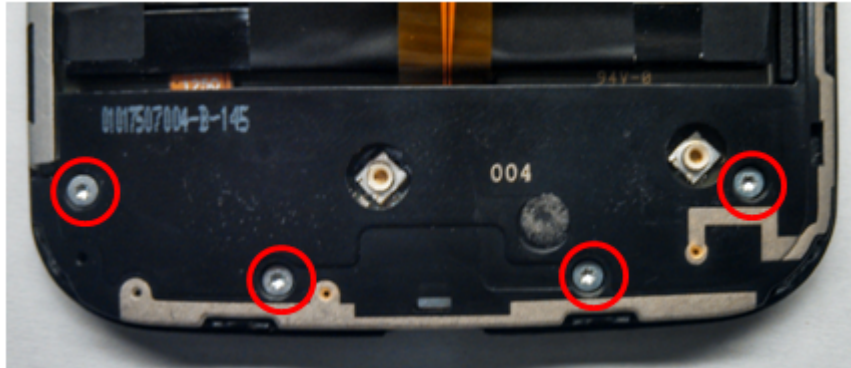
Step 6: If Step 5 does not resolve the issue, check the screw holding the antenna carrier to the front housing near the Antenna 1 feed. If the screw is missing or not fully inserted, place/replace the screw and retest.

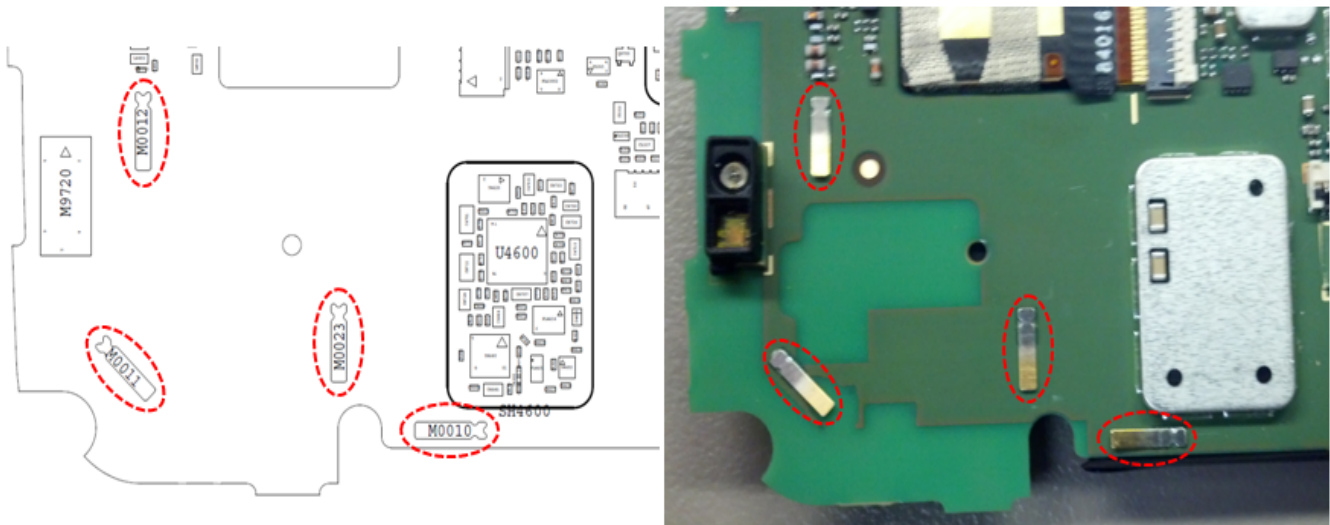
Figure: PCB

Step 4: If Step 3 does not resolve the issue, check the PCB grounding clips on the display side of the PCB: M0010, M0011, M0012, and M0023. If any clip is missing, misplaced, or damaged, place/replace the part and retest.

Grounding Clips Near Antenna 3 Matching

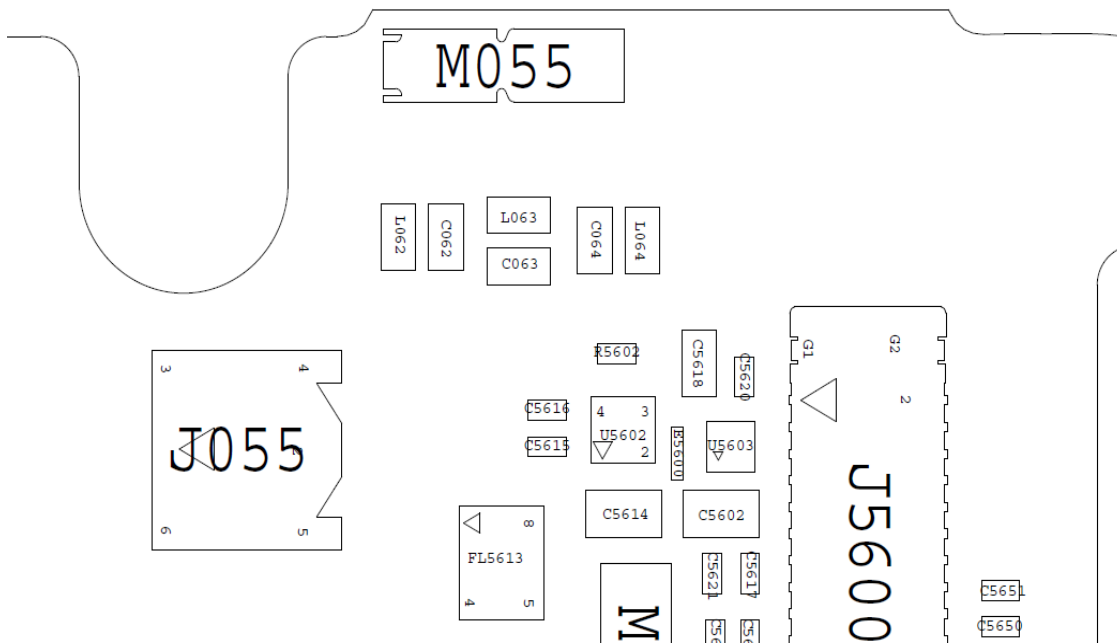
Figure: Overlays close to Ant 5

Step 2: If failure persists, please check whether antenna feed contact is in good condition or not (M055, see figure overlays above).

Step 4: If failure persists, check if matching components are soldered properly (L064, L063, C062, see figure overlays above).

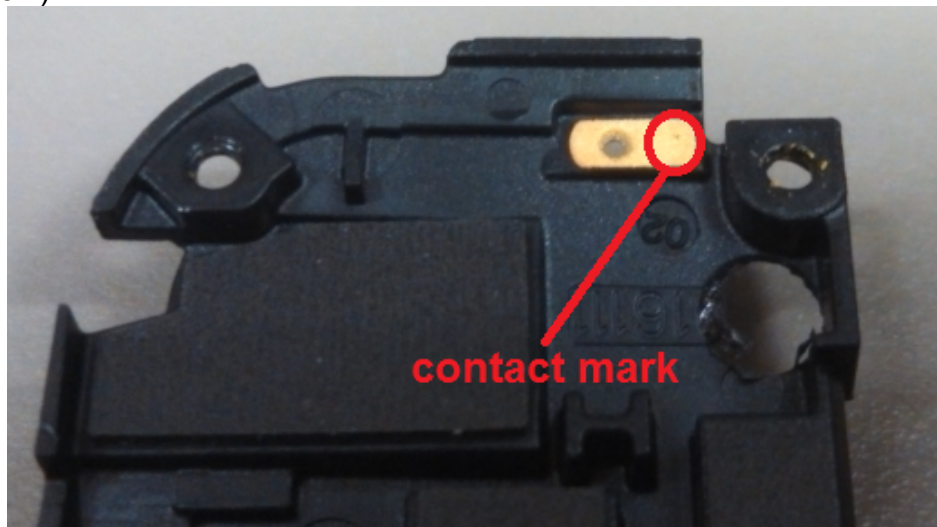
Figure: Contact Mark in Antenna 5, near Front Facing Imager side

Step 3: If failure persists, check whether the antenna made a contact (contact mark, see figure below)

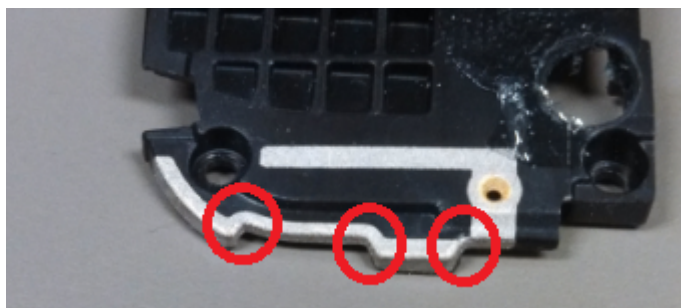
Figure: Antenna 5

Step 5: If failure persists, check if there is any crack in the antenna, especially in the snap location area.

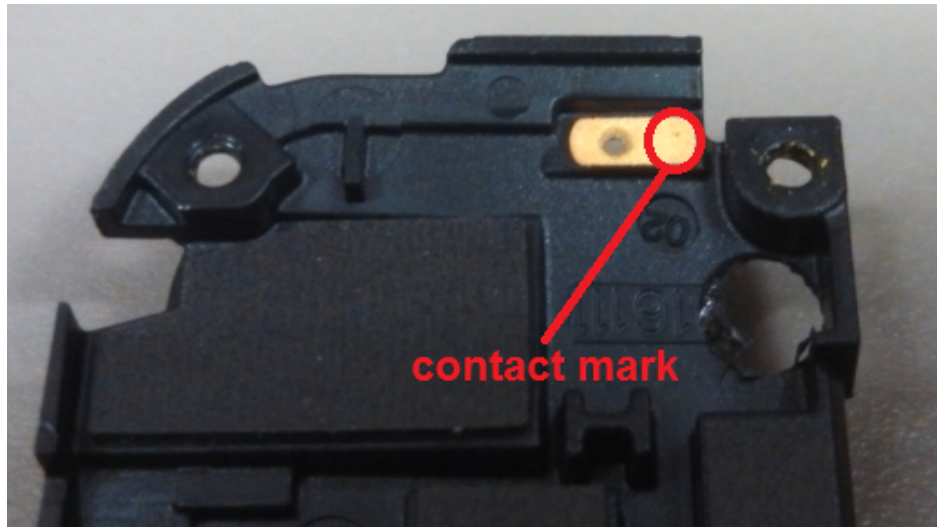
Figure: contact mark

Step 3: If failure persists, check whether the antenna made a contact with the antenna feed contact (contact mark, see figure below).

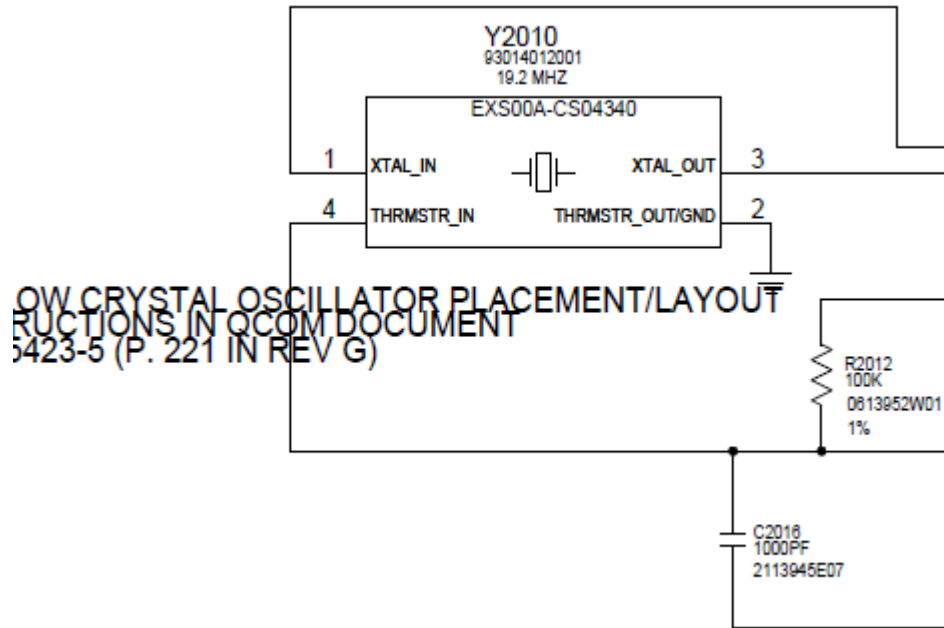
Figure: Y2010 XTAL

Step 2: see if Y2010 XTAL19.2MHz is soldered properly

Step 1: re-phase TC\_XO

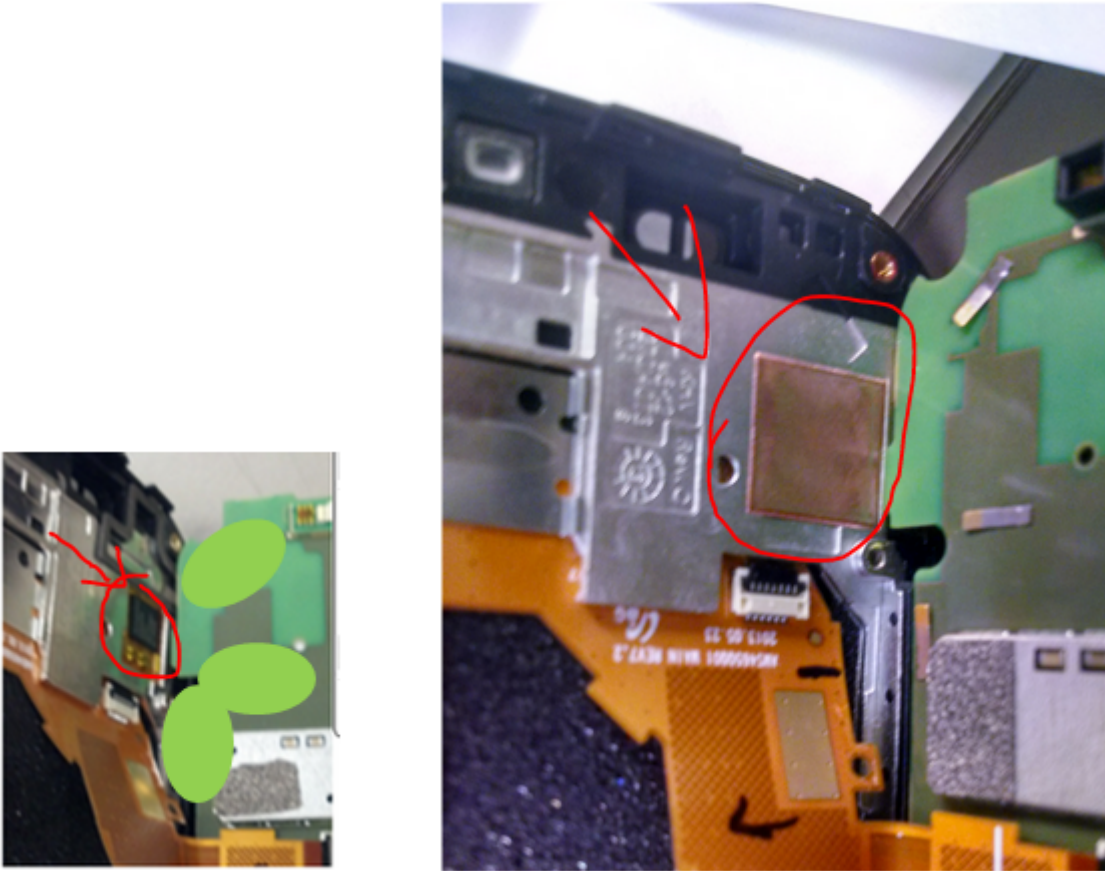
If unit fails 5 GHz WiFi for high power (drastically outside of limits)

Disassemble the phone, check the copper tape on opposite side of PCB.

Make sure tape is covering hole. Reassemble, retest.

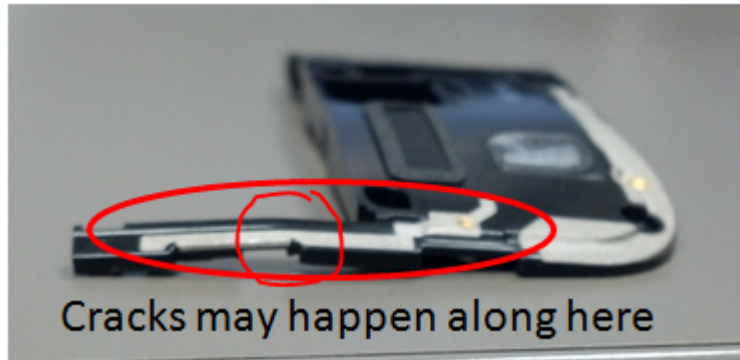
Step 1: If Bluetooth (2.4 GHz) fails low (**less than -5, usually -8 or lower**), check for cracks in the WIFI leg.

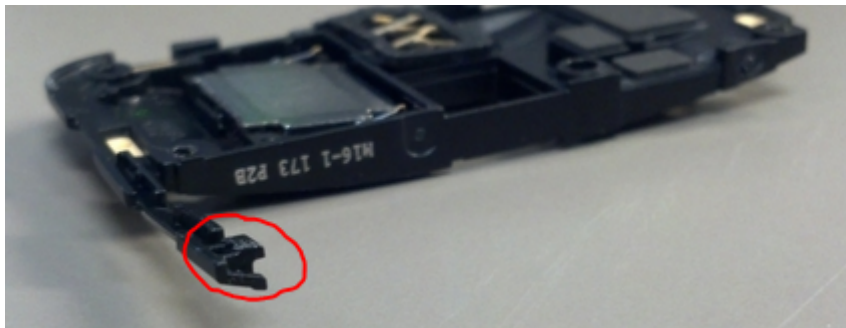
This leg can bend easily and crack if mishandled during placement or removal of top antenna carrier. There is a post at the end of the leg that snaps into the plastic of the chassis that must be inserted and removed with great care in order not to stress and crack the antenna. See post below

Cracks will only be visible under a microscope. A known “good” top carrier should be placed and the phone re-tested. This should fix the failure.

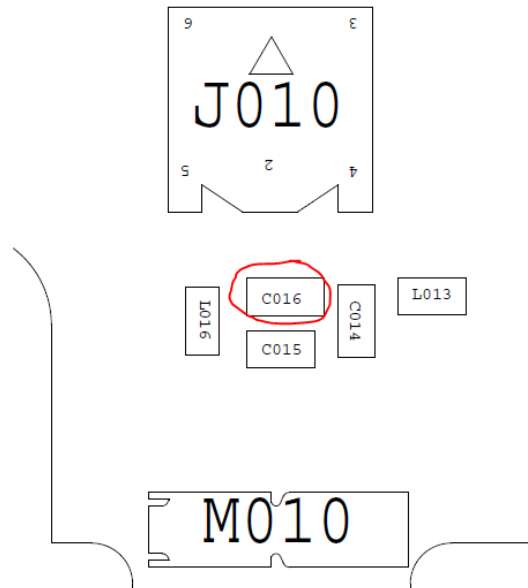
Step 3: Check RefDes C016. Make sure it is soldered down on each side, and not damaged.

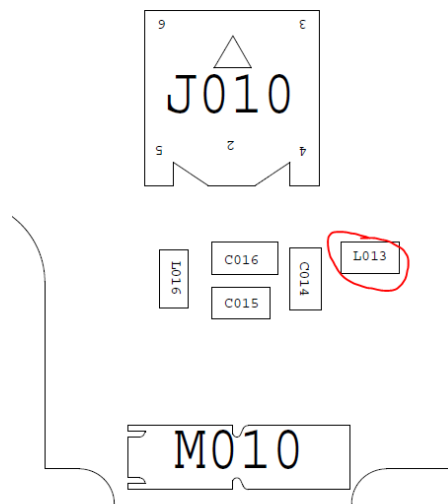
Step 4: Check RefDes L013 as shown. Make sure it is soldered down on each side, and not damaged.

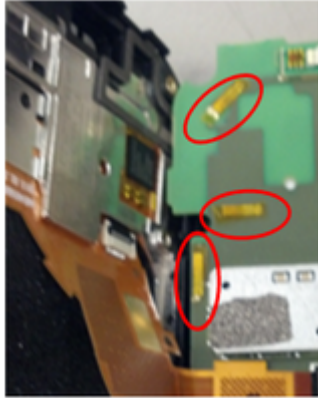
Step 5: Check grounding clips on opposite side of board as shown in picture. Note, the contacts should touch the chassis.

The contacts should be able to touch the board (not completely smashed).
