# Moto X Field Service Trouble Shooting Guide

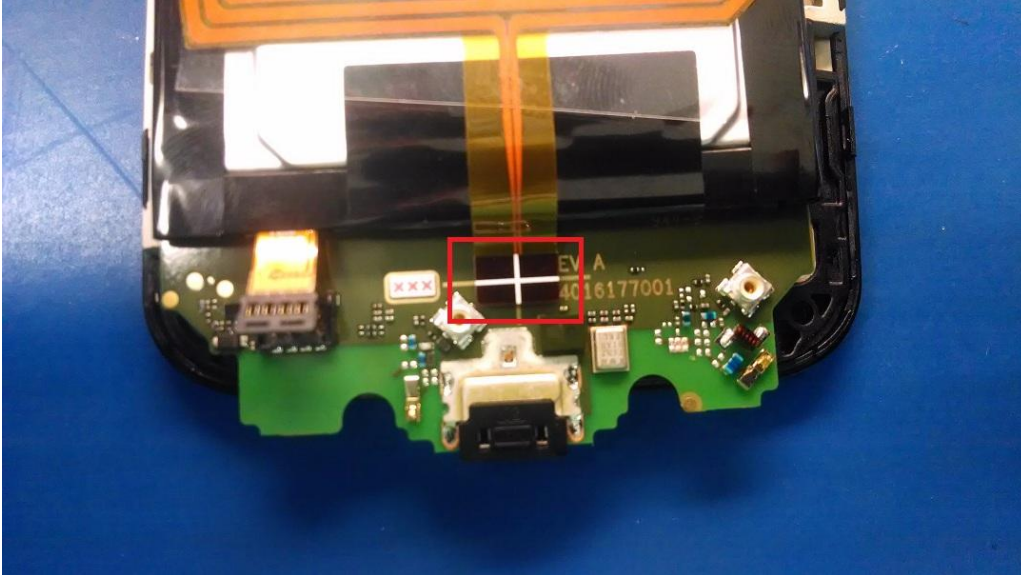
1. Verify NFC antenna exists, is connected, and verify it is properly seated.

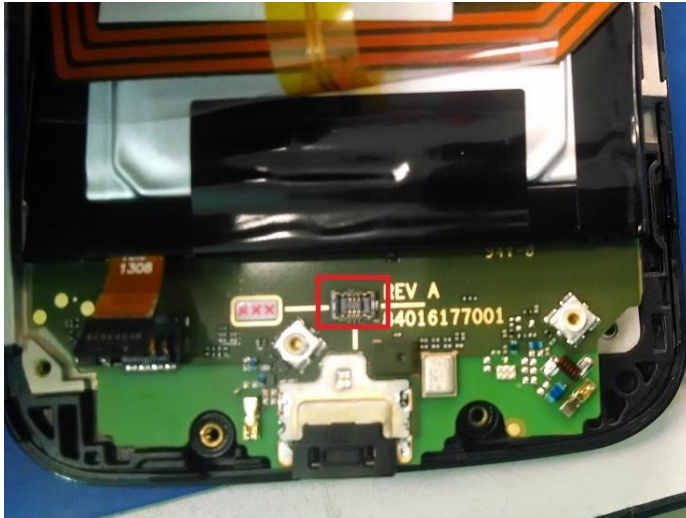
4. Verify NFC antenna connector is not damaged on flex or on PCB. There may be soldering defects, such as shorts, broken pads. There may also be broken pins within the connector. Often broken pins can occur through improper insertion of connector.

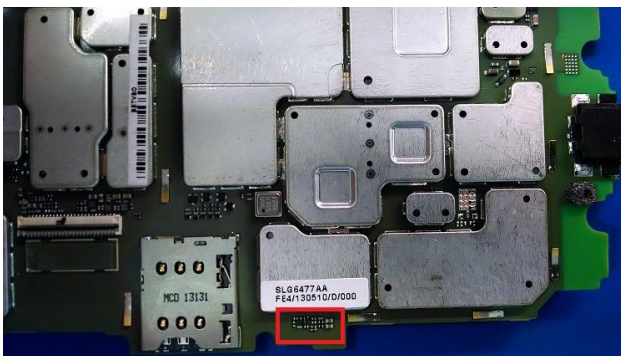
7. Ensure NFC antenna matching components are not damaged.

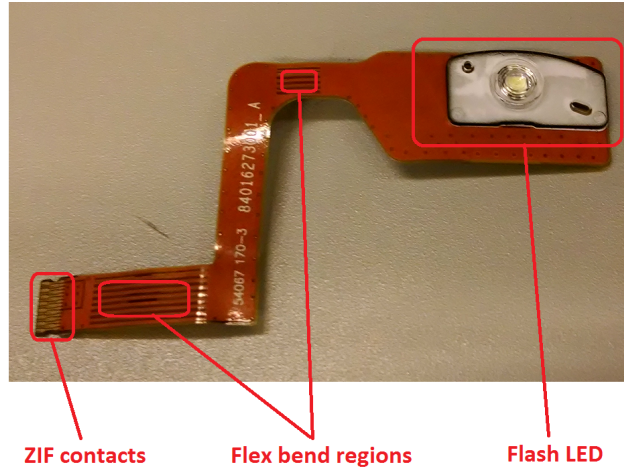
### Flash LED Flex

- Follows LED flex
  - Refer to the following figure: “Flash LED Flex”
  - Inspect the ZIF contacts for shorts or foreign material.
  - Inspect the flex for cracked traces, especially in the bend regions.

- Inspect the Flash LED for damage.
- Follows Bridge flex
  - Refer to the following figure: “Flash and Power Key Bridge Flex”
  - Inspect the ZIF connector for damage.

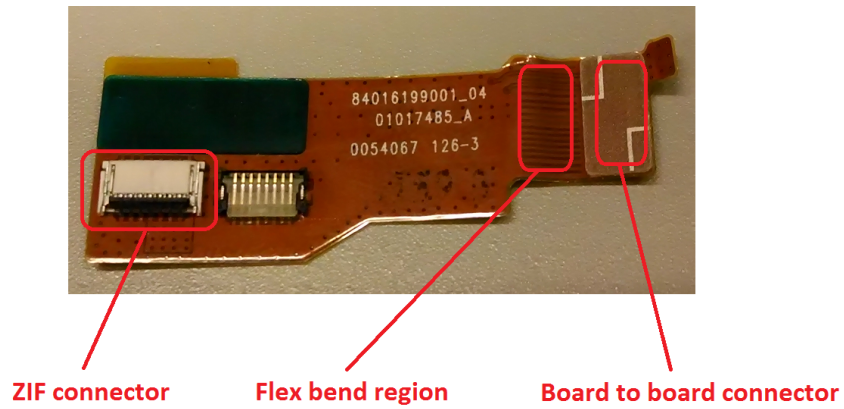
### Flash and Power Key Bridge Flex

- Inspect the board to board connector for damage.
  - Inspect the flex for cracked traces, especially in the bend regions.
- Follows Main PCB
  - Refer to the following figures: “Flash Driver Circuit Locations”, “Flash Driver Circuitry”, and “Additional Flash Driver Circuitry”

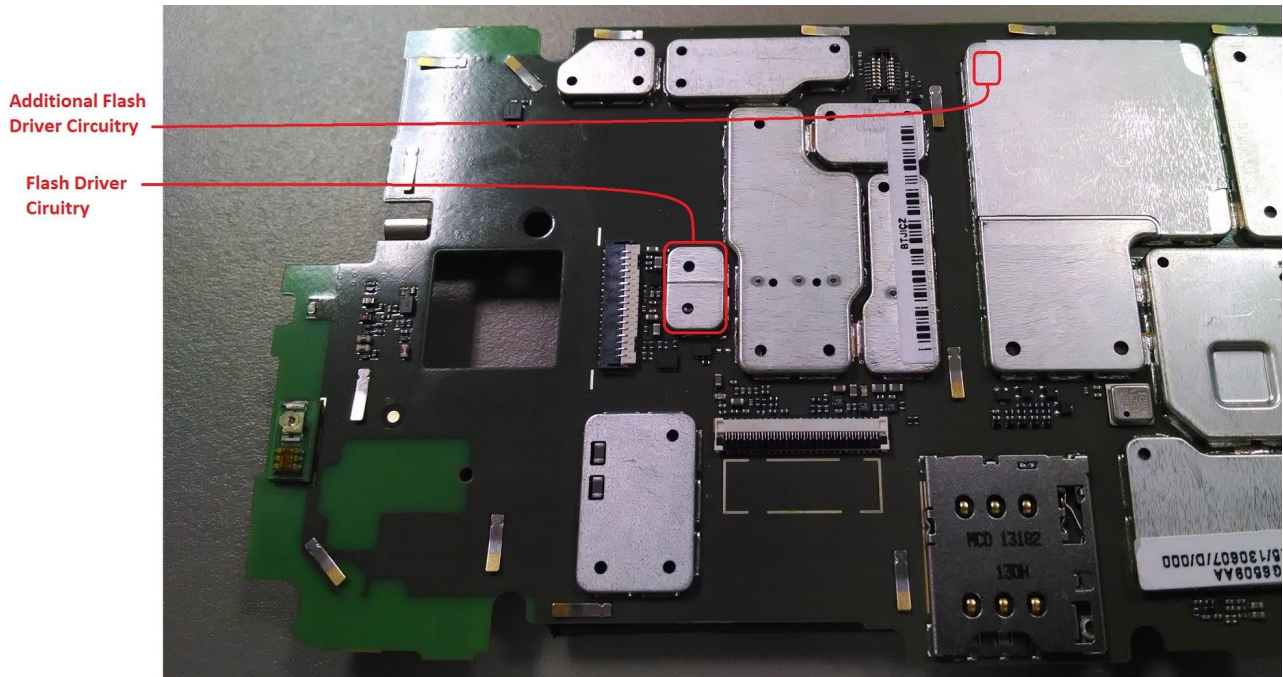
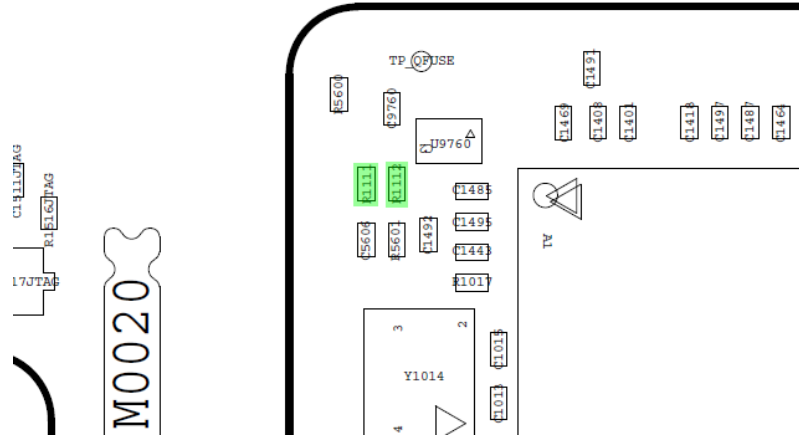
### Flash Driver Circuit Locations

- Remove the appropriate shields without using heat.
  - Inspect the highlighted components for correct placement and proper solder joints.

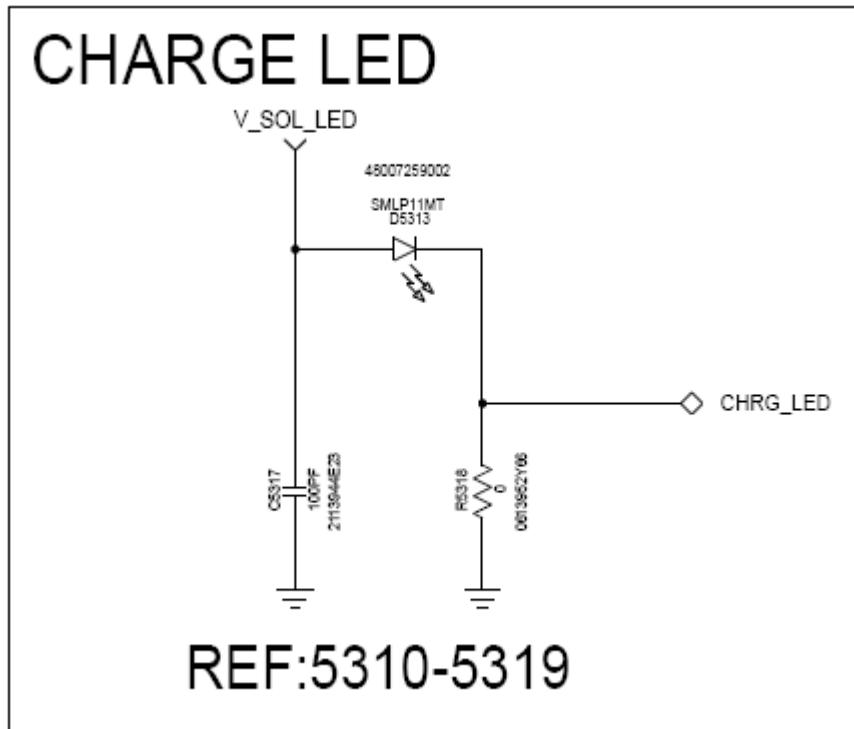
- Analyzer has checked MQS Failure Code with spec limits.

- Use raw test command (003E2001) to enable the LED.
- Check for part visibility through front housing.
  - If visible, and measured value at Vision is high, check that front housing assembly has metal mesh installed and rubber diffuser is installed.

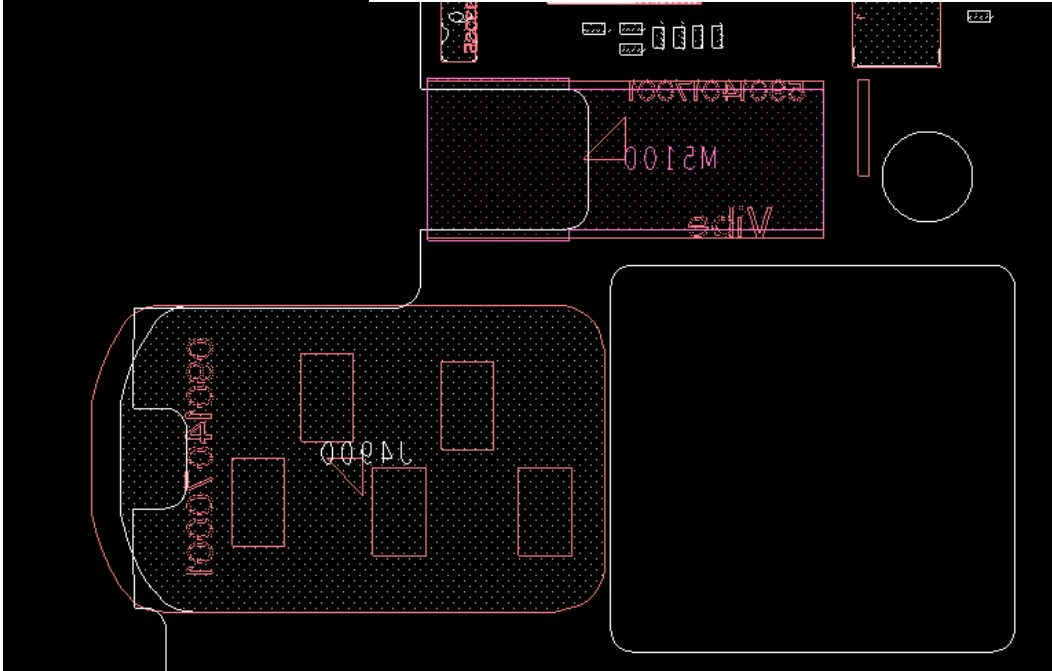
Motor shown above in pink.

- Enable vibration and observe motor. If motor starts to turn and stop. Replace M5100 (pink in diagram).
- With vibration enabled, try turning the motor shaft slowly by hand, if it starts turning and then stops, or if starts turning and continues turning. Replace M5100 (pink in diagram).
- If motor does not try to turn at all, try to apply pressure to the top of the vibrator to see if it starts turning (bad solder joint).
- If motor still does not turn, visually inspect and x-ray the parts below, shown in blue:
