# **XT1225/XT1254 BASEBAND TROUBLESHOOTING GUIDE**

**Sept 18, 2014**

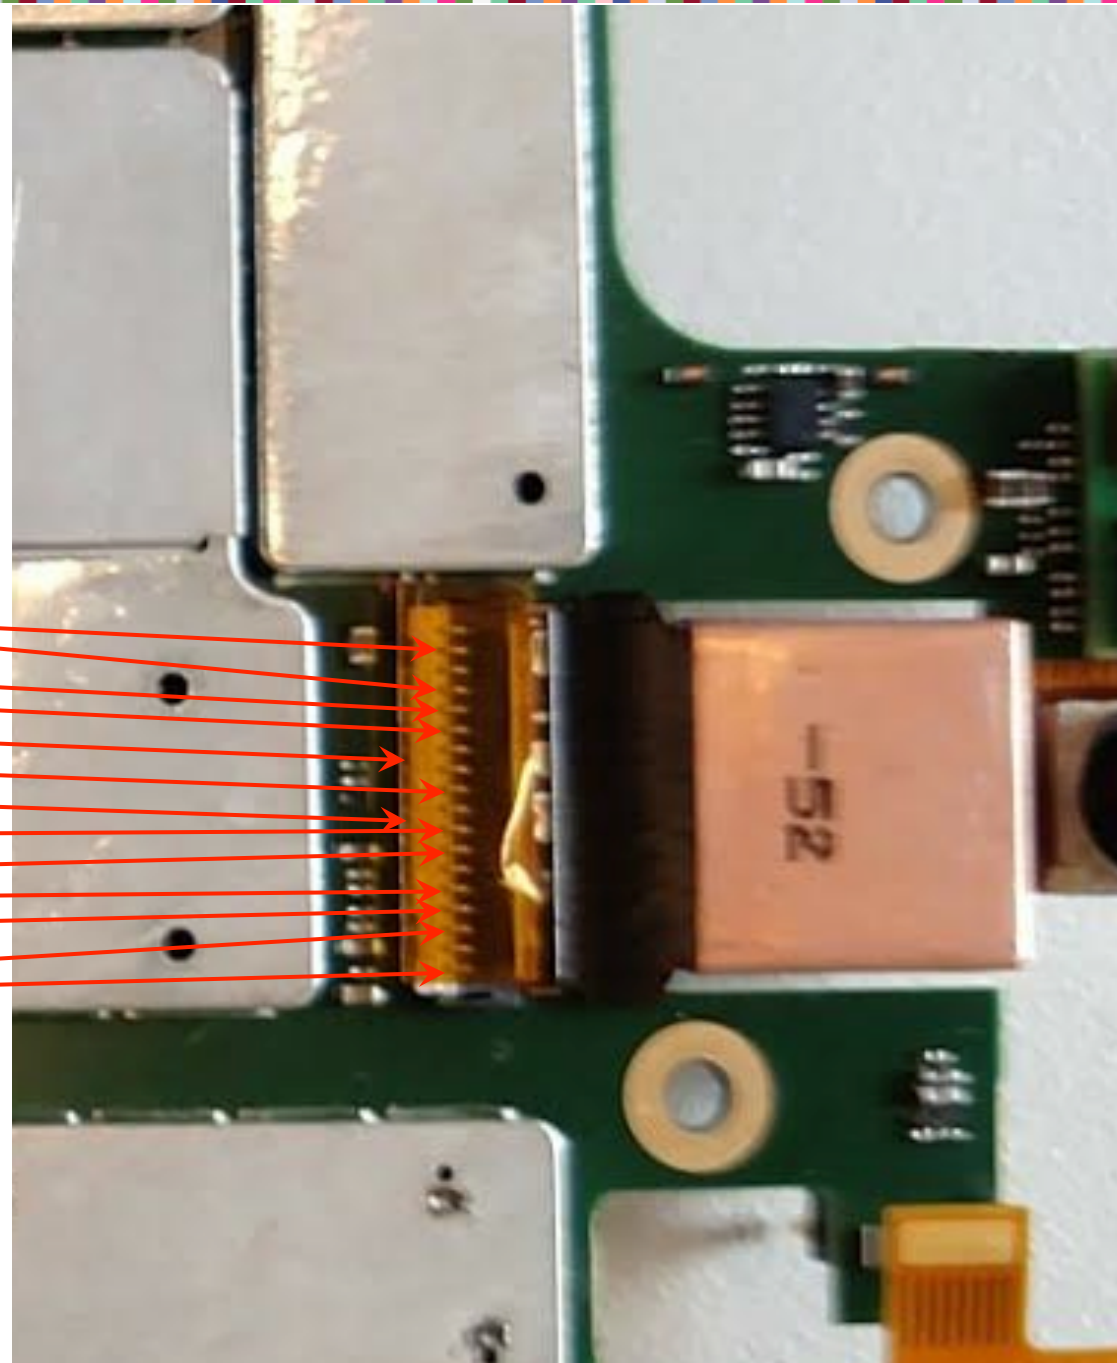
- 1) Even pins are available for gentle probing on ZIF connector.
- 2) If the camera is not turning on, the only time you will see these signals is during boot, right before the vibrator turns on. The best way to catch the signal is to set an oscilloscope to single trigger.

- o Test available signals
  - Pin4: AVDD (2.8v)
  - Pin8: DATA3\_N (Check MIPI exist on all MIPI lines)
  - Pin10: MCLK (24MHz @ 1.8v)
  - Pin12: DATA1\_P (Check MIPI exist on all MIPI lines)
  - Pin15: RESET (1.8v) (Odd pin under ZIF door)
  - Pin18: CLK\_N (Check MIPI exist on all MIPI lines)
  - Pin21: I2C\_SCL (1.8v communication present)
  - Pin22: I2C\_SDA (1.8v communication present)
  - Pin24: DATA2\_P (Check MIPI exist on all MIPI lines)
  - Pin28: DVDD (1.0v)
  - Pin30: VIO (1.8v)
  - Pin32: DATA4\_P (Check MIPI exist on all MIPI lines)
  - Pin36: AFVDD (2.7v)

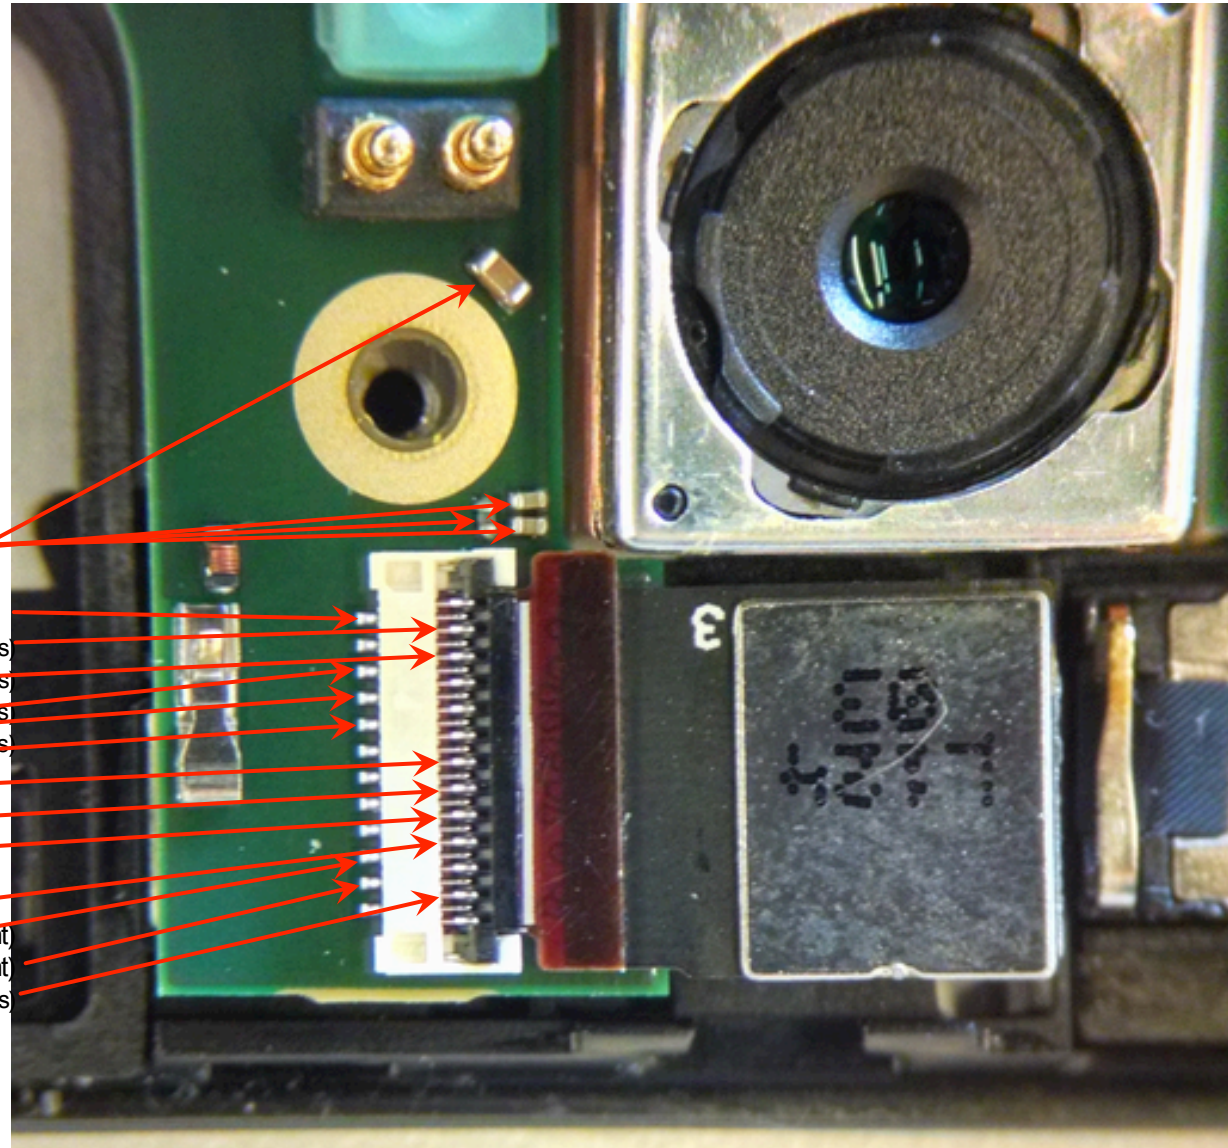
- Pin2: DATA1\_P (Check MIPI exist on all MIPI lines)
- Pin3: DATA1\_N (Check MIPI exist on all MIPI lines)
- Pin5: CLK\_P (Check MIPI exist on all MIPI lines)
- Pin6: CLK\_N (Check MIPI exist on all MIPI lines)
- Pin8: MCLK (24MHz @ 1.8v)
- Pin10: VDDIO (1.8v)
- Pin13: AVDD (2.8v)
- Pin15: DVDD (1.2v)
- Pin17: RESET (1.8v)
- Pin19: I2C\_SCL (1.8v communication present)
- Pin20: I2C\_SDA (1.8v communication present)
- Pin22: DATA2\_P (Check MIPI exist on all MIPI lines)
- Pin23: DATA2\_N (Check MIPI exist on all

MIPI lines)

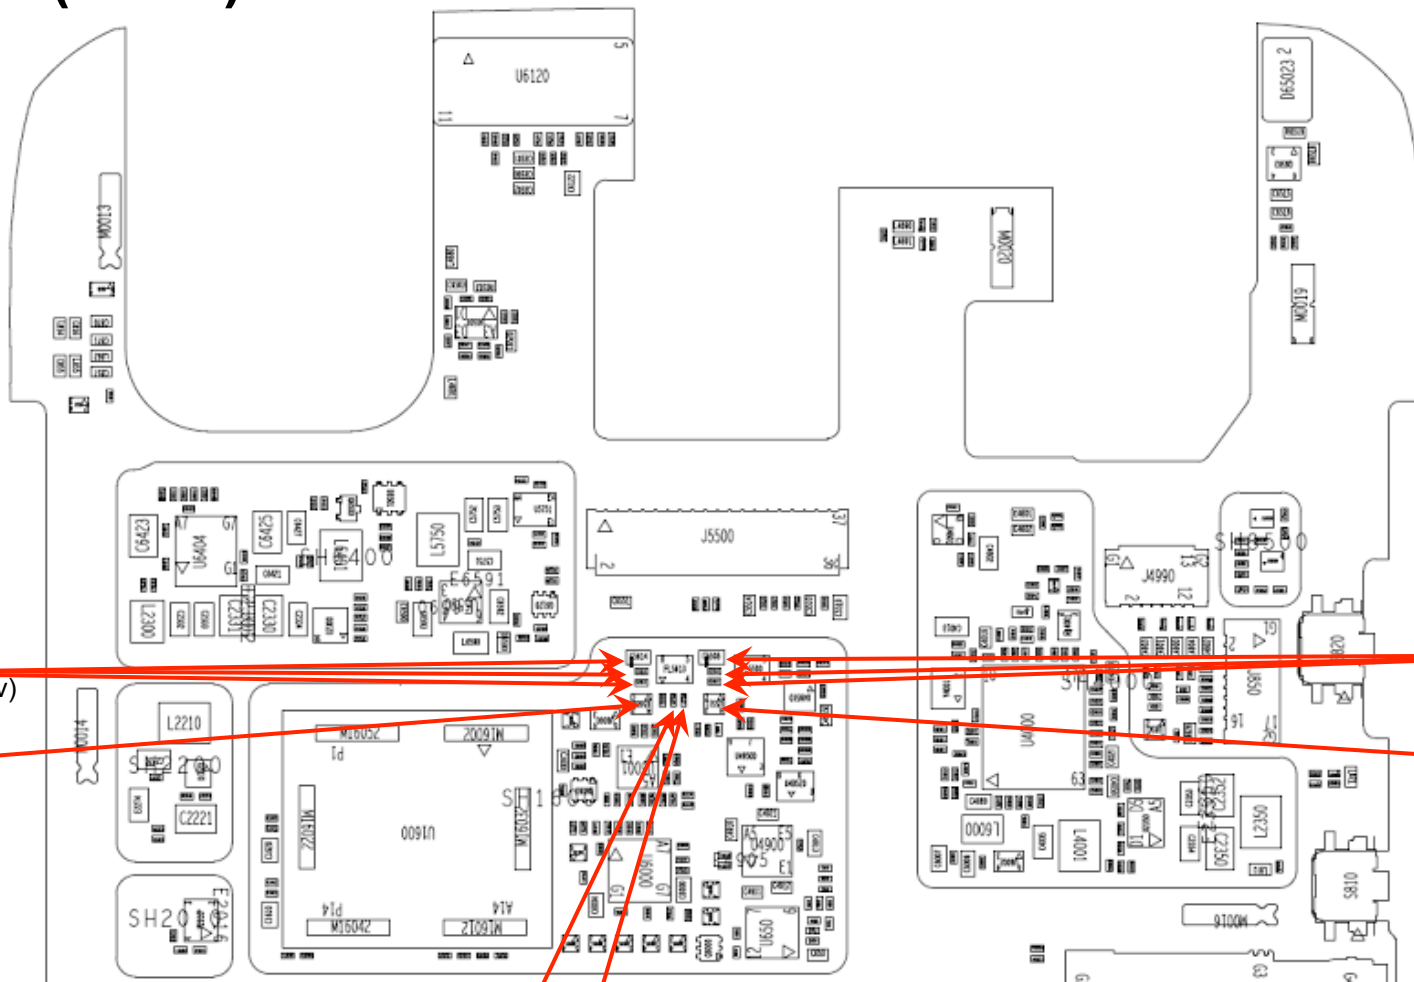
AVDD output capacitors (2.85v)

AVDD regulator

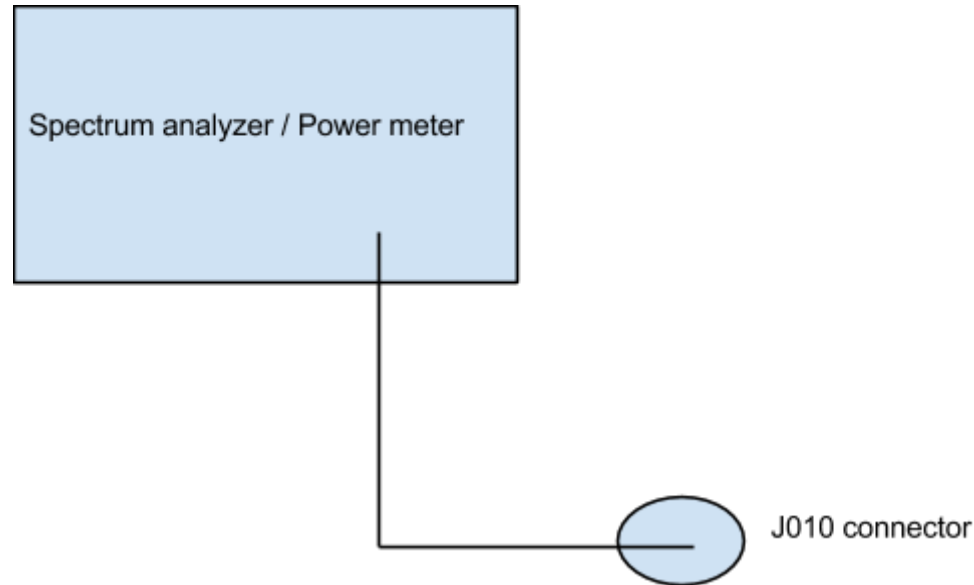
Just connect the spectrum analyzer or power meter directly to J010 connector as following:

The WiFi signal is 20 MHz wide. If you use a spectrum analyzer, you should pick a wide enough span to measure the channel power across 20 MHz. Or if your spectrum analyzer can support 20 MHz resolution bandwidth, you can just use zero span.

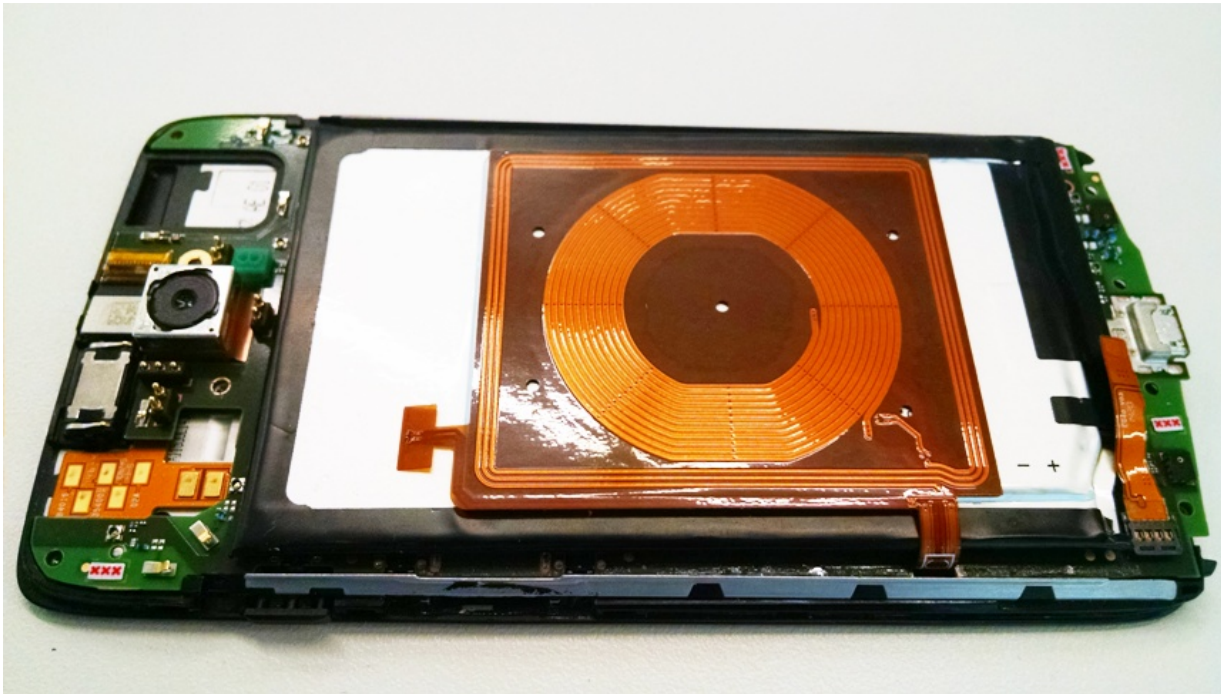
1. Verify NFC antenna exists, is connected, and verify it is properly seated.

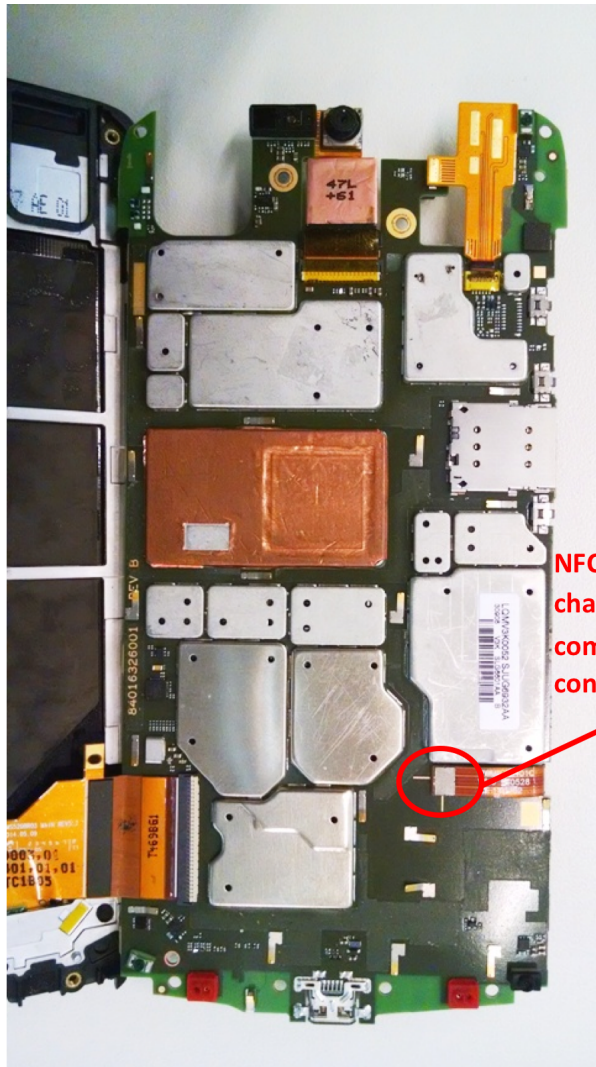
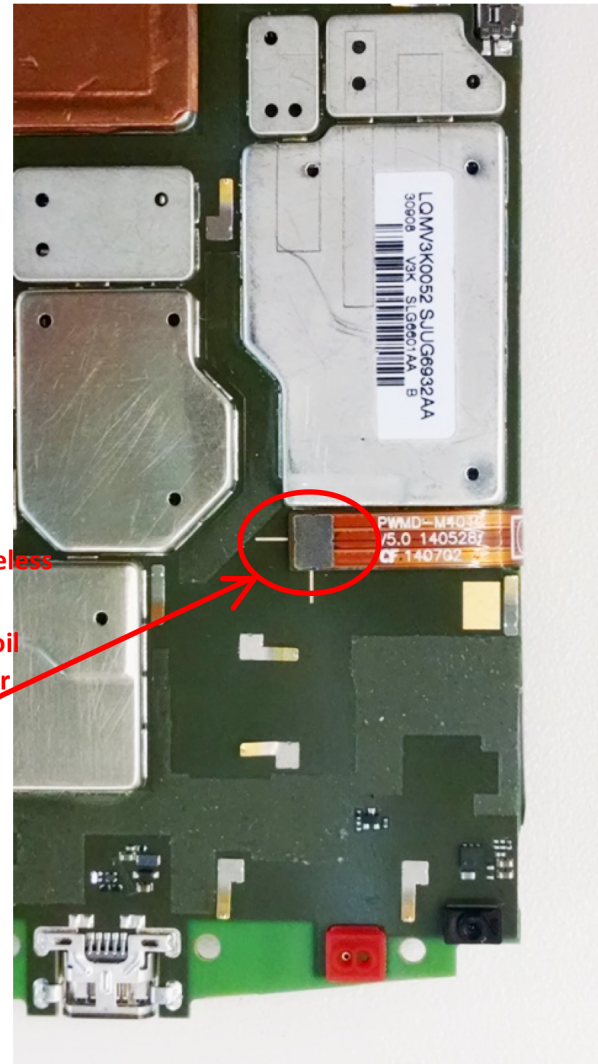
NFC/Wireless  
charging  
combo coil  
connector

2. Verify NFC antenna connector is not damaged on flex or on PCB. There may be soldering defects, such as shorts, broken pads. There may also be broken pins within the connector. Often broken pins can occur through improper insertion of connector.

3. Replace NFC antenna to see if it follows antenna itself.
4. Ensure NFC antenna matching components are not damaged.
