Moto X Play/DROID MAXX 2 BASEBAND TROUBLESHOOTING GUIDE V1.0

Moto X Play/DROID MAXX 2
BASEBAND TROUBLESHOOTING GUIDES

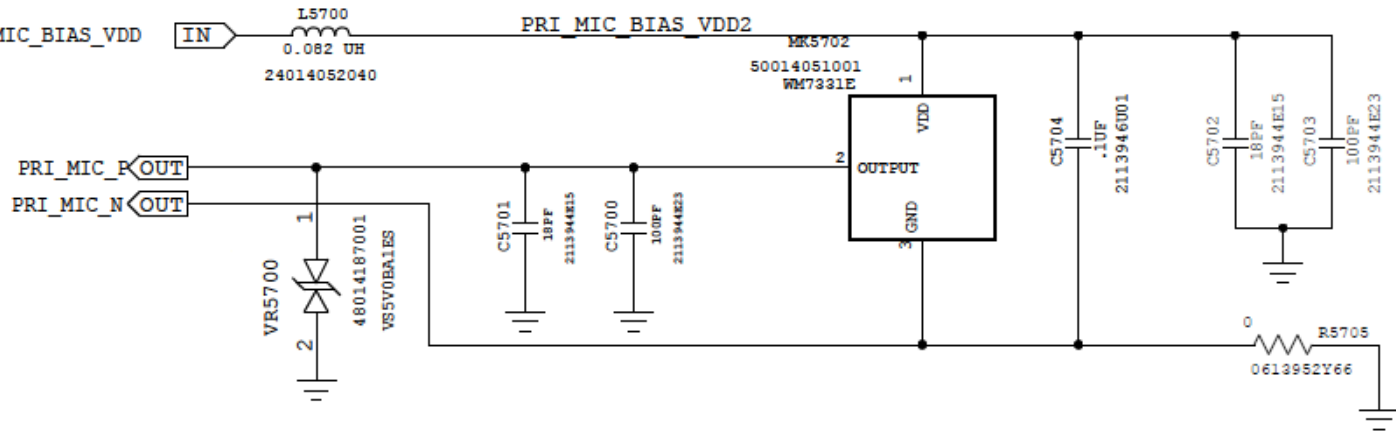
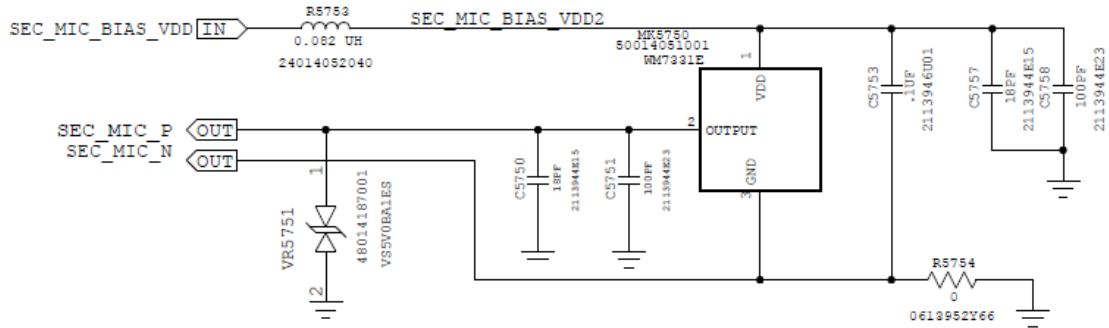
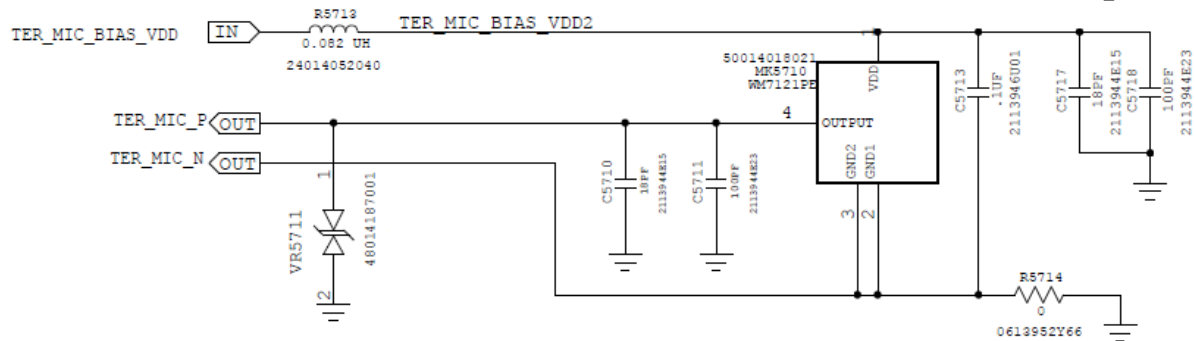
If a mic is not functioning...

- Check to make sure the microphone and mic ports are not blocked.
- Check to make sure the mic gasket and mic grommets are seated properly.
- Check the microphone for diaphragm debris indicating a shattered diaphragm. Look under a microscope to view inside the microphone port for damage or debris.

- Check to make sure none of the capacitors on the mic lines are shorted or damaged.
- Check the mic bias C5702 (Mic1), C5757 (Mic2), C5717 (Mic3). The mic bias should be 2.8V when the microphone is enabled.

- If the failure is no microphone audio, check mic loopback through CQA at the board level with a display connected. (Mic loopback may be easier to check with a headset plugged in)

- If there is no audio during mic loopback, inject a 35mVrms, 1kHz sine wave onto the mic signal side of C5700 (Mic1), C5751 (Mic2), C5711 (Mic3) and listen for the tone during loopback. If you can hear the tone now, you know either the mic is bad, or there's a process defect with the mic-to-PCB connection.

- X-ray the mic to check for process defects.
- If swapping the microphone fixes the issue, the bad microphone should be sent to the supplier for FA.

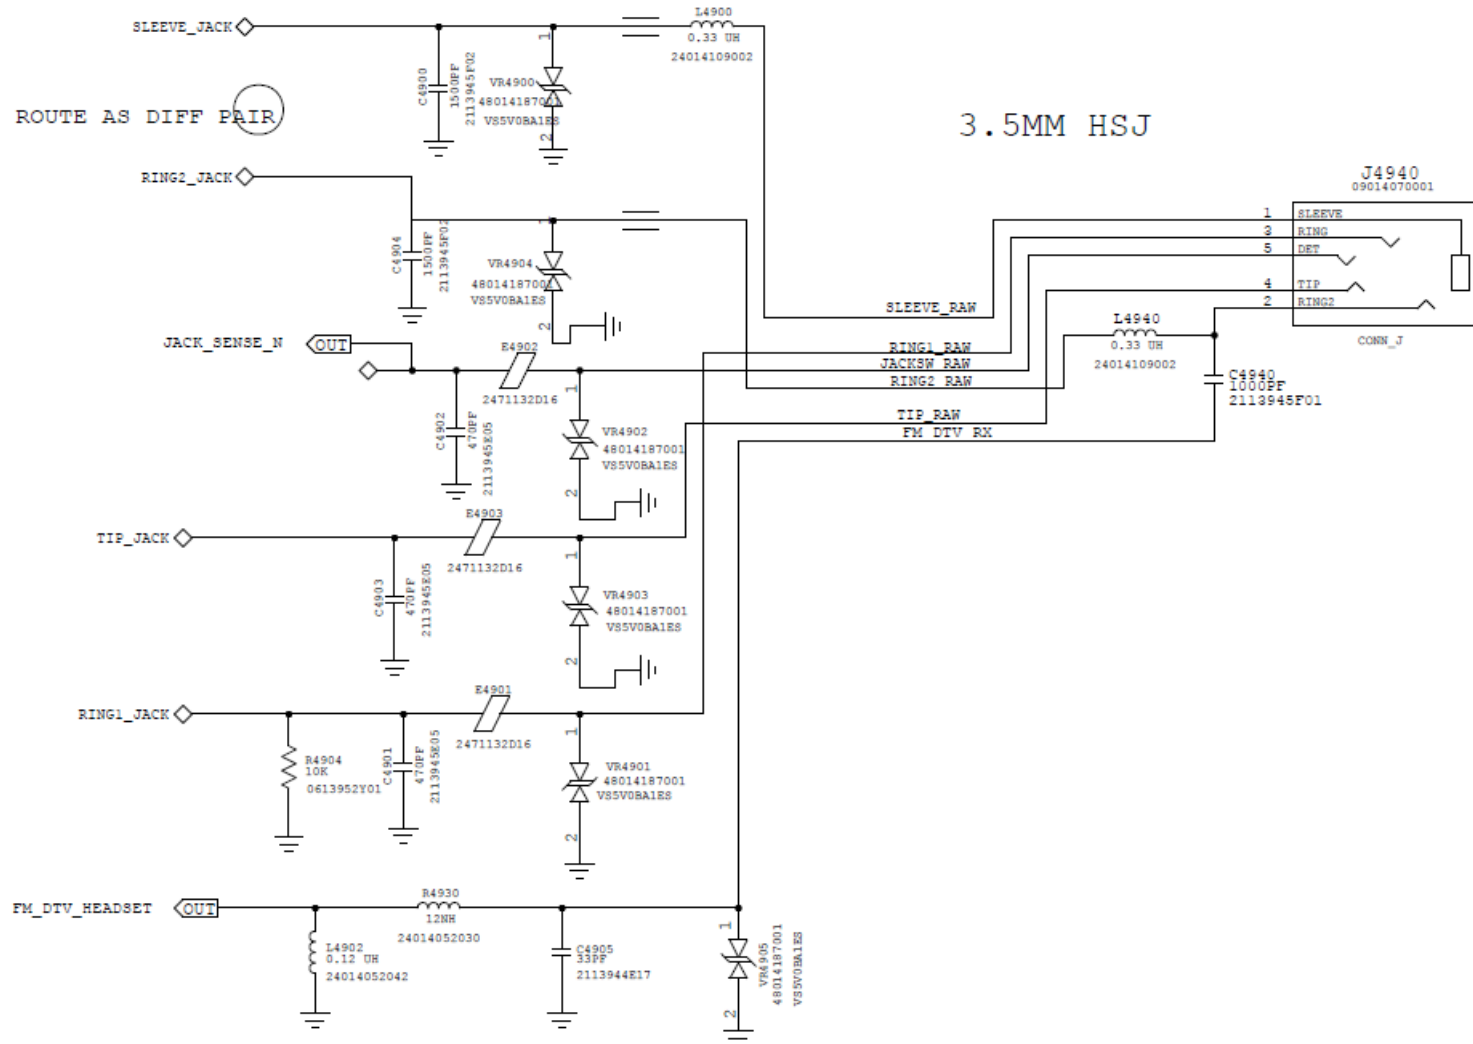
3.5mm Headset Path (cont'd)

- Check the pins on the headset jack for any bent pins or missing pins (Top Carrier)
- **On the PCB:**
 - Series components L4900, E4901, E4902, E4903, and L4940 must be physically placed and measured using a DMM. Replace if any are found to be open circuit.
 - ESD Diodes VR4900, VR4901, VR4902, VR4903, VR4904 must be open circuit. Measure these with a DMM to ground. If any short circuit is found, replace the ESD diode.
 - Shunt caps C4900, C4901, C4902, C4903, and C4904 must not be shorted across.
 - U4900 must have voltage on the VDD line, and can be probed on C4907. This should measure 1.8V nominally.

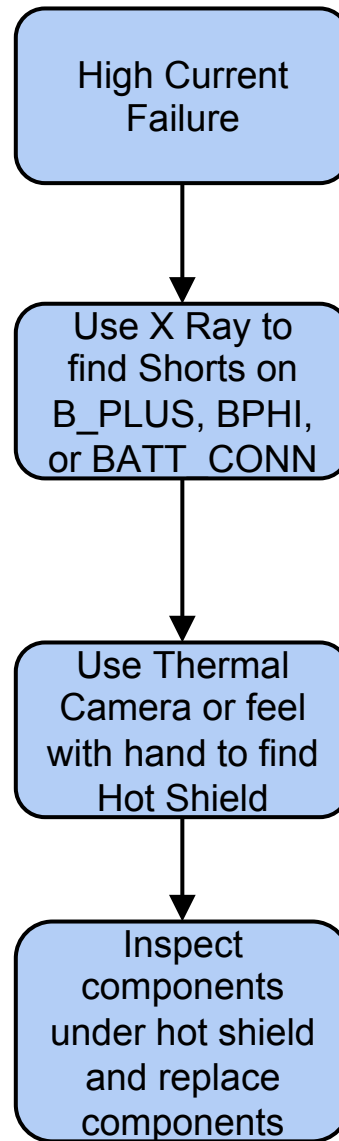
High Kill or Off Current

- First check for solder ball shorts on major ICs or discrete resistors or capacitors that are skewed and shorting to each other
- Follow the list at right
- Replace parts in order
- Recheck test after removing each shield and after removing each component

Circuit	Typ [uA]	Max [uA]	Ref
PM8916	5	18	1
SMB	12	20	2
Kung Kow	1	1	3
Vibe Driver	1.75	4	4
Loud Speaker	1	1	5
HSJ	20	20	6
Rear Cam ALDO	1	1	7
uSD LDO	1	1	8
Rear Cam LDO Bia	1	1	9
Rear Cam AFLDO	1	1	10
LED Cam Flash	1	1	11
Front Cam ALDO	1	1	12
Display PMU	1	3	13
Prox LED	1	10	14
QFE	1	5	15
NFC	3.9	3.9	16
Fuel Gauge	25	42	17
Tuner	1	2.8	18
TOTAL	79.65	136.7

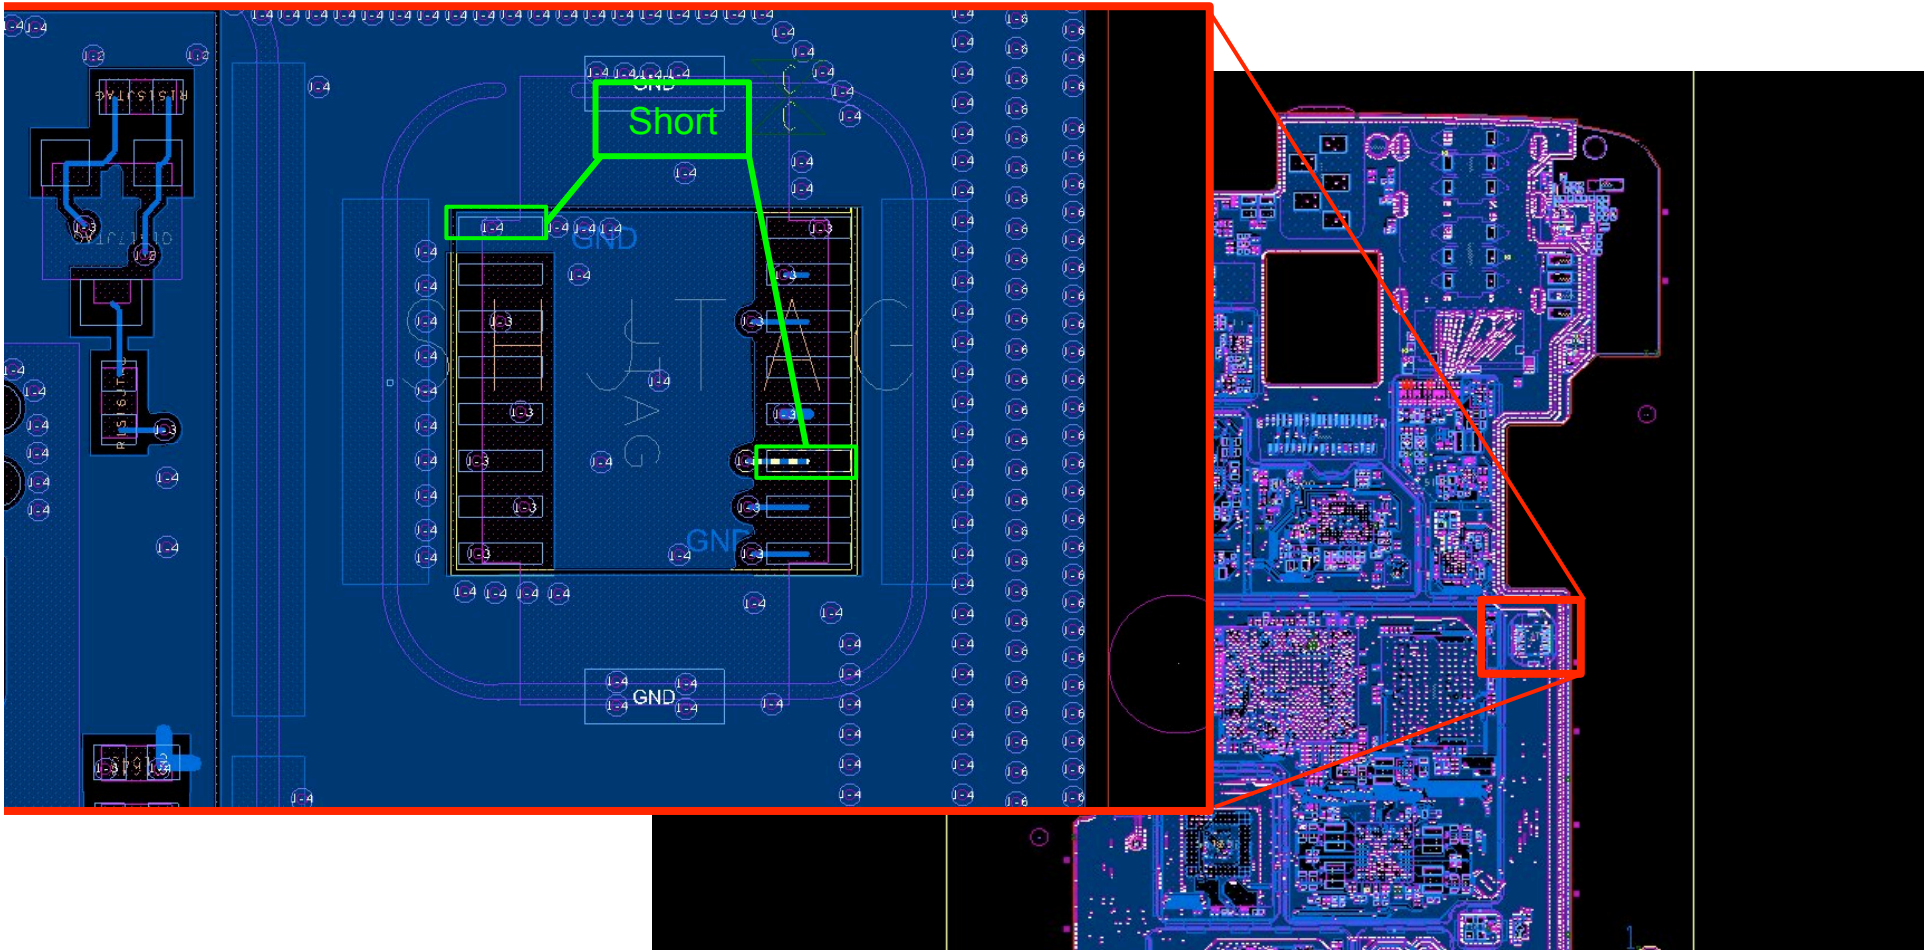
Force Blankflash Mode

- Sometimes if a board has software already flashed, or there was some problem with software, a board can be forced into this mode by shorting two highlighted pins on the debug connector:
- Then when board is in this mode, blank flashing can be attempted to reflash the device and/or find more information on the failure.

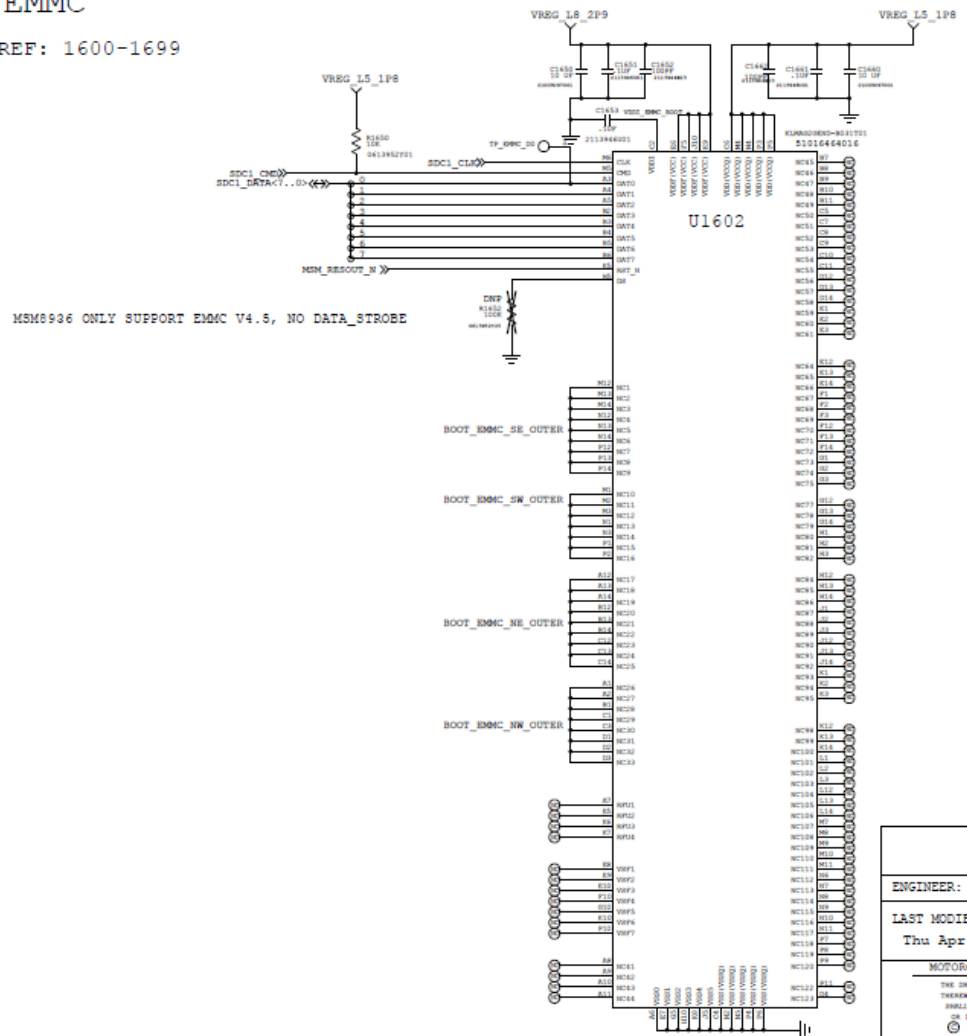
If the phone is stuck at the logo screen or does not power up completely or keeps enumerating in blank flash mode then EMMC component could be suspected:

1. Check the 1.8V, 2.95V supplies
2. Probe the EMMC_CLK line to measure 400Khz first and then maximum of 177MHz.
3. Wire our command and data lines along with clock and put it on the scope. If the command does not output the command information then the EMMC controller inside the chip could be corrupted.
4. Note down lot code and date code.
5. Try user reset (hold power key for 10secs) and restart the procedure.
6. If it still fails X-ray the board and reflow the part.
7. If it still continues to fail, the part might need to go back to supplier.

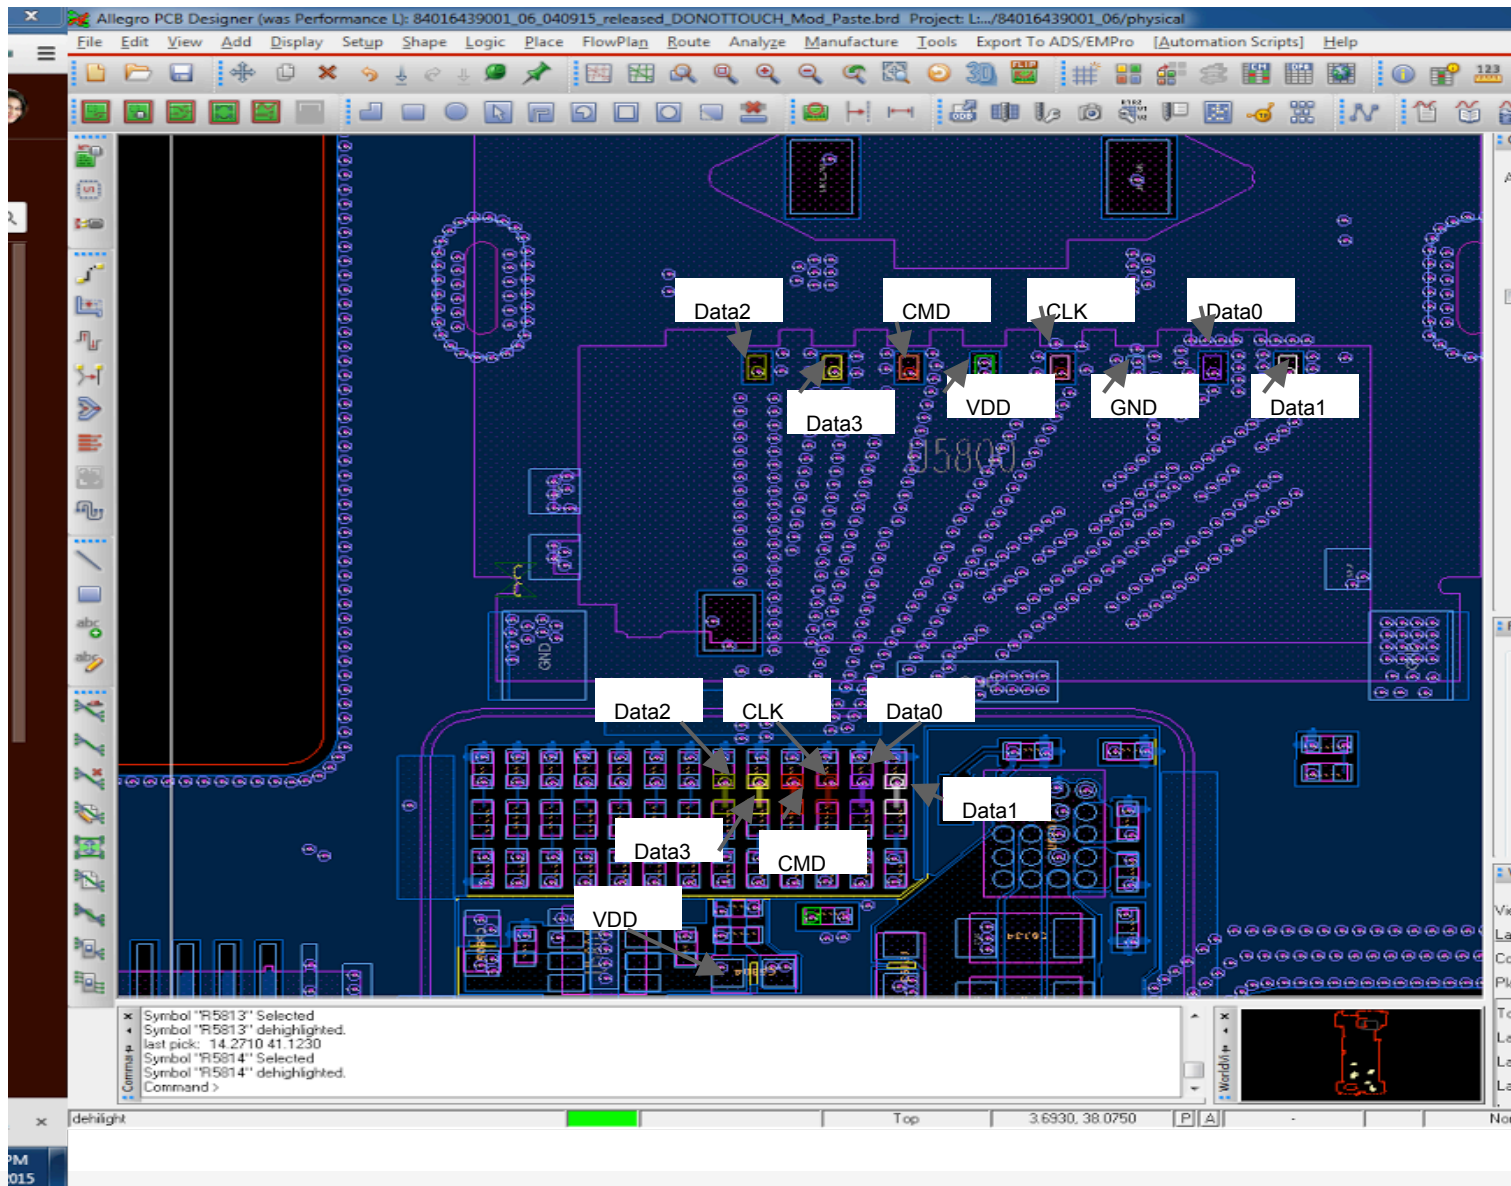
Micro SDCARD PCB Contacts

1. When you put a card in the tray you should see SD_Card_det_n line go high
2. Measure supplies VDD_SDC (3V), VREG_L5_1P8 (1.8V)
3. If you do not see the VDD_SDC supply come up measure the VREG_L11_SDC (1.8V) to ensure the LDO is turning on. B_PLUS can also be measured to see if its present.
4. Depending on the type of card placed in the slot you can measure sdc2_clk as 12.5MHz, 25MHz, 50MHz, 100MHz, 200MHz during a read or write operation
5. Probe SDC2_DATA<3..0>, SDC2_CMD to ensure there is activity on the bus. Start with Data0.
6. If any line is held low then measure the voltage across the ESD diodes placed on all data and detect line to ensure you read 0.7V confirming its not shorted to ground.

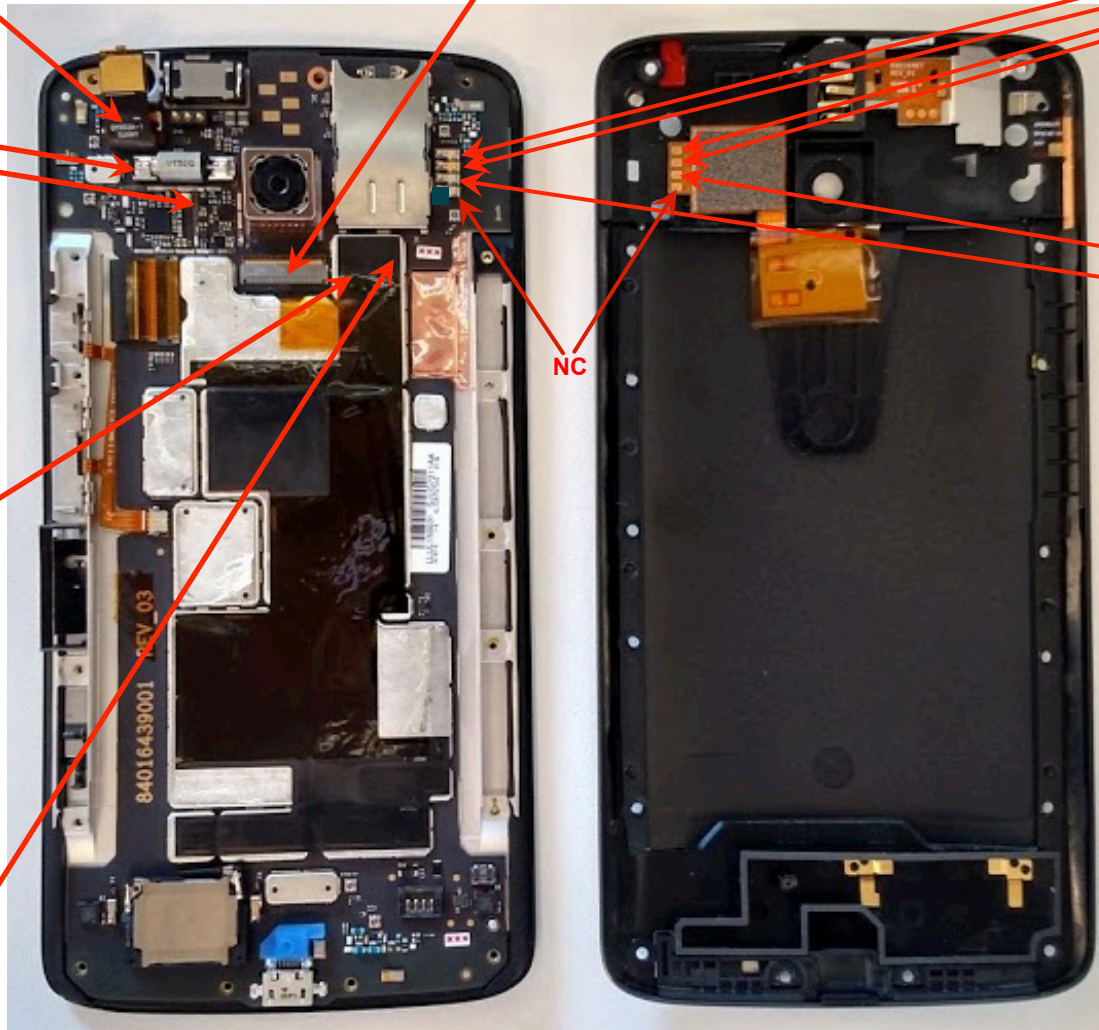
Camera Troubleshooting

If the camera does not turn on, change the camera module. If the camera still does not power on, then it is likely an issue on the main PCB.
