Moto X Force/DROID Turbo 2 BASEBAND TROUBLESHOOTING GUIDE V1.0

TABLE OF CONTENTS

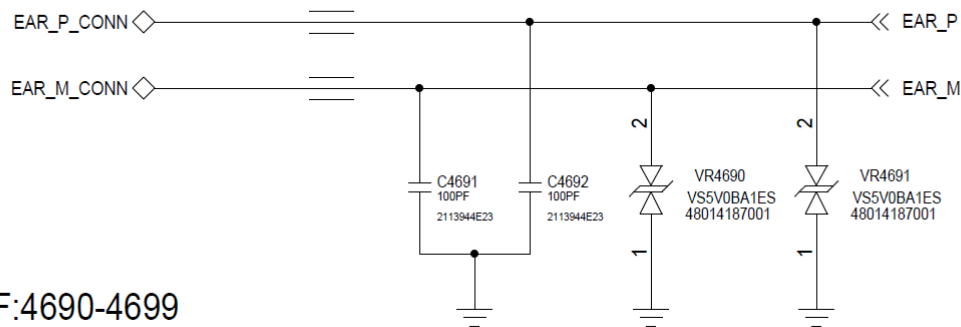
EAR PIECE

- Check that the impedance of the earpiece speaker is near 32 ohms, and that the spring contacts are not bent.
- Check that the earpiece flex is seated properly in the rear housing with no debris on it. You should also be able to see slight imprints in the gold pads where the speaker spring contacts were touching the flex; these imprints should be centered - if they are on the edge of the pad, there may be an alignment issue.
- Check that the J4600 B2B flex connector on the PCB is seated properly with no damage to any pins on the PCB-side or Flex-side.
- Check C4691, C4692, VR4690 and VR4691 for any placement issues.

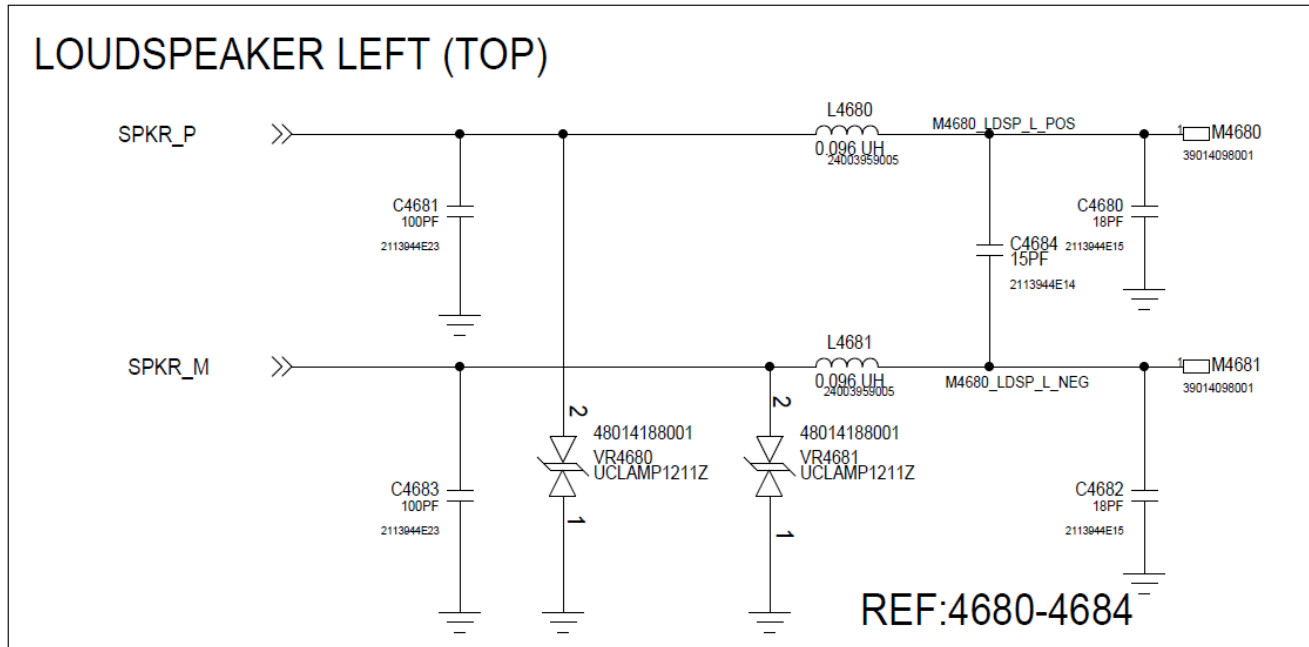
Loudspeaker

- Verify the impedance of the loudspeaker module is ~8 ohms.
- Lack of mechanical contact should also be checked between the PCB spring contacts and the loudspeaker module (check for bent/broken/missing pins on PCB spring contacts).
- Make sure L4680 and L4681 are not skewed or damaged.
- Check C4680, C4681, C4682, C4683, C4684, VR4680, and VR4681 for any placement issues.

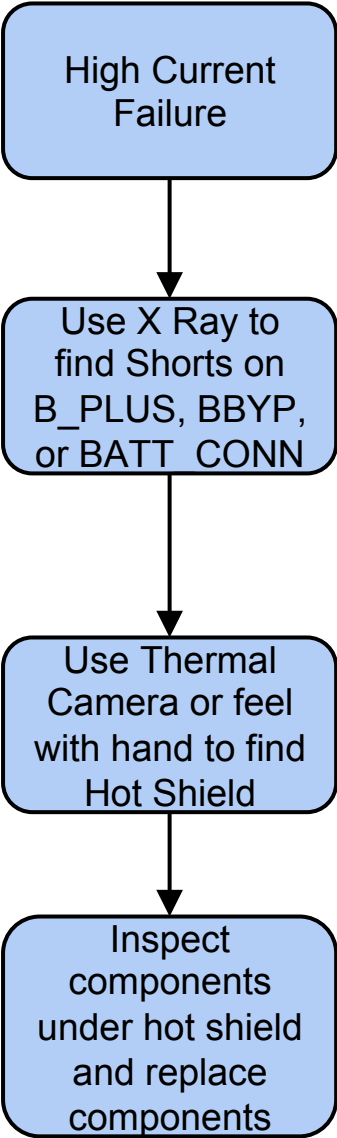
High Current Failure

High Kill or Off Current

- First check for solder ball shorts on major ICs or discrete resistors or capacitors that are skewed and shorting to each other
- Follow the list at right
- Replace parts in order
- Recheck test after removing each shield and after removing each component

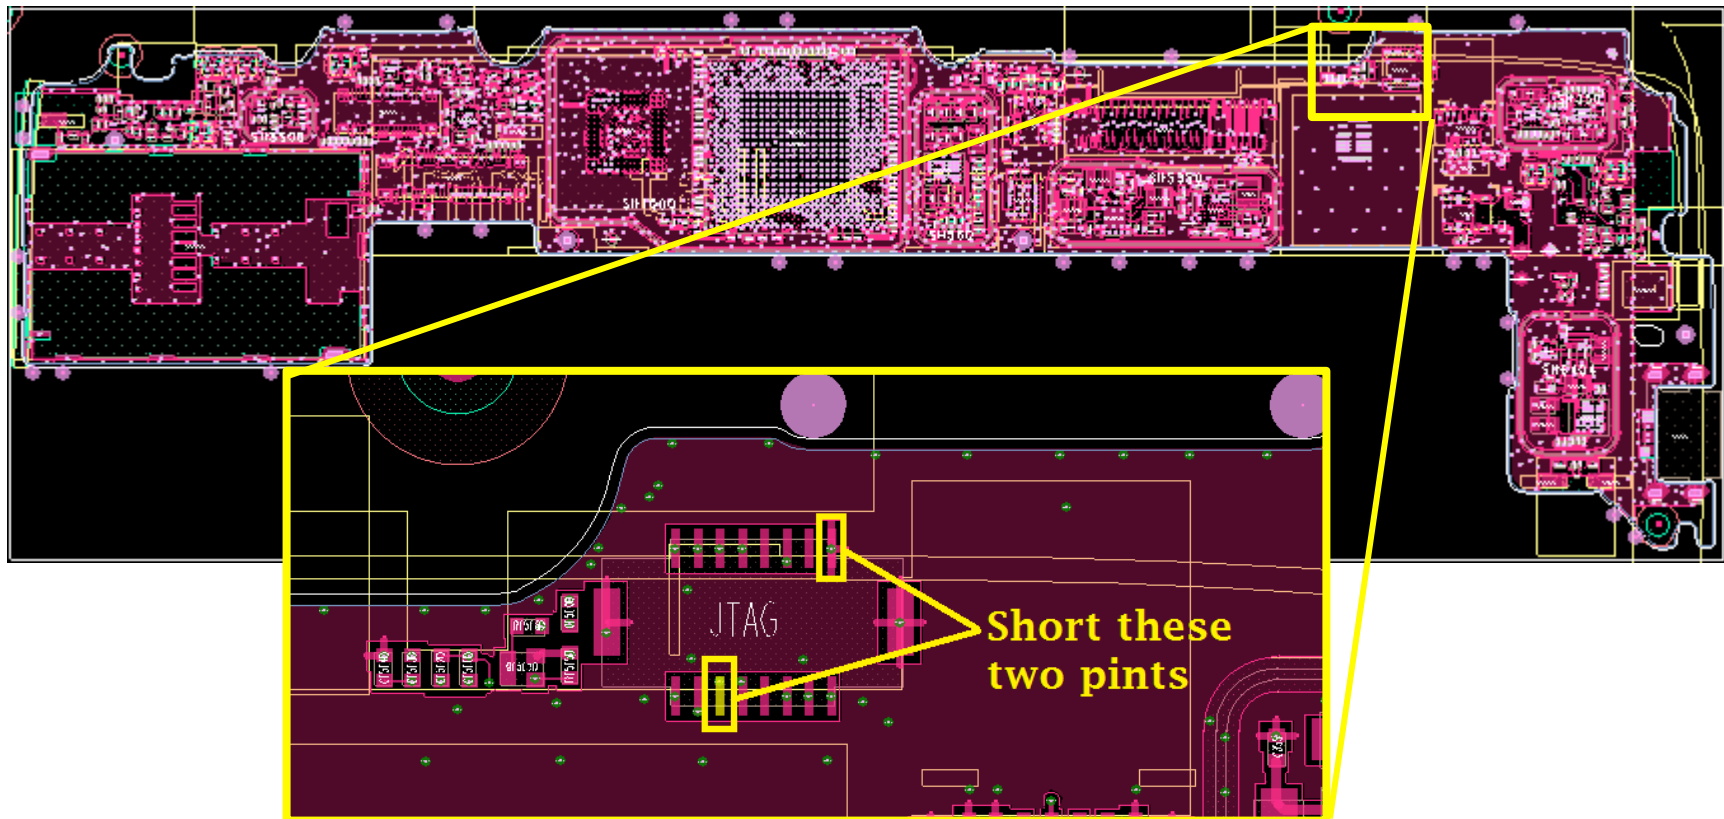
Force Blankflash Mode

- Sometimes if a board has software already flashed, or there was some problem with software, a board can be forced into this mode by shorting two highlighted pins on the debug connector.
- Then when board is in this mode, blank flashing can be attempted to reflash the device and/or find more information on the failure.

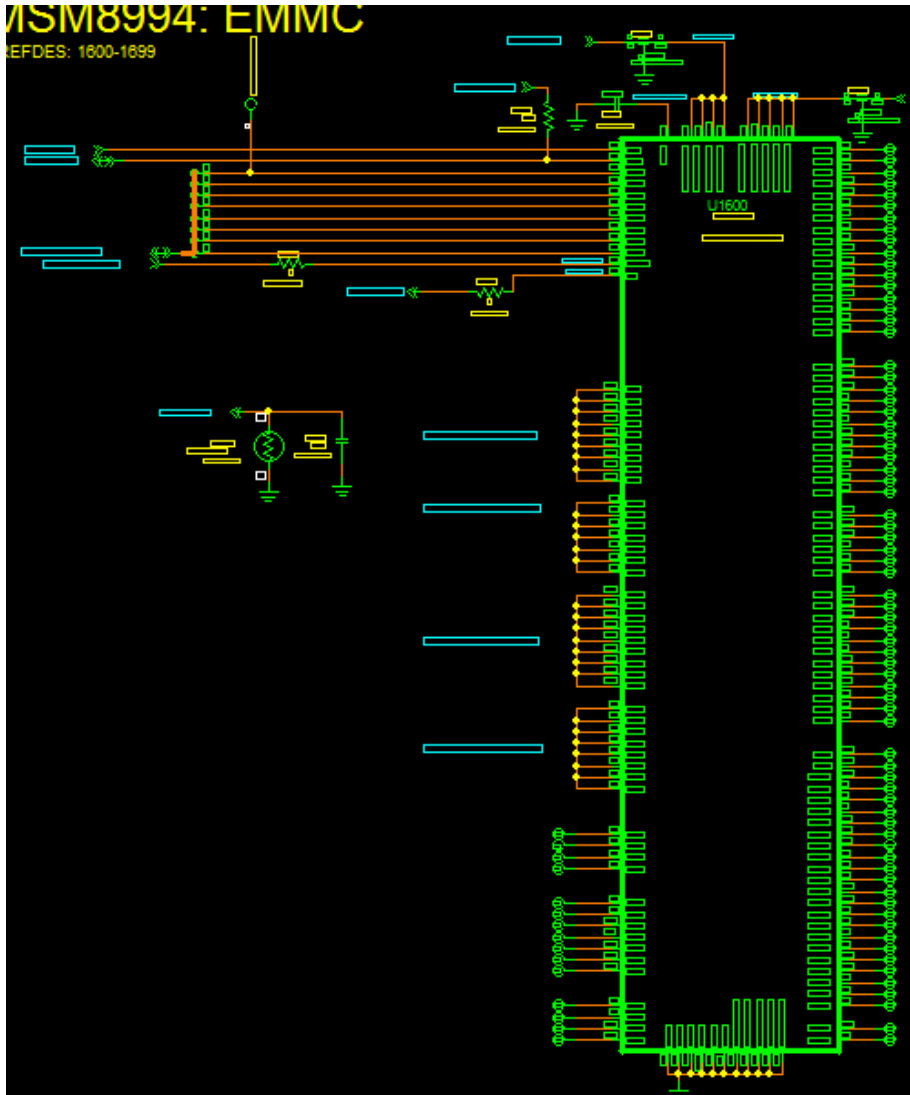
EMMC (Internal NAND)

If the phone is stuck at the logo screen or does not power up completely or keeps enumerating in blank flash mode then EMMC component could be suspected:

1. Check the 1.8V, 2.95V supplies
2.95V accessible at C1610
1.8V accessible at C1620
2. Probe the EMMC_CLK line to measure 400Khz first and then maximum of 177MHz.
EMMC_CLK accessible at C1011 or R1010
3. Wire our command and data lines along with clock and put it on the scope. If the command does not output the command information then the EMMC controller inside the chip could be corrupted.
CMD accessible at R1610
D0 accessible at test point
4. Note down lot code and date code.
5. Try user reset (hold power key for 10secs) and restart the procedure.
6. If it still fails X-ray the board and reflow the part.
7. If it still continues to fail, the part might need to go back to supplier.

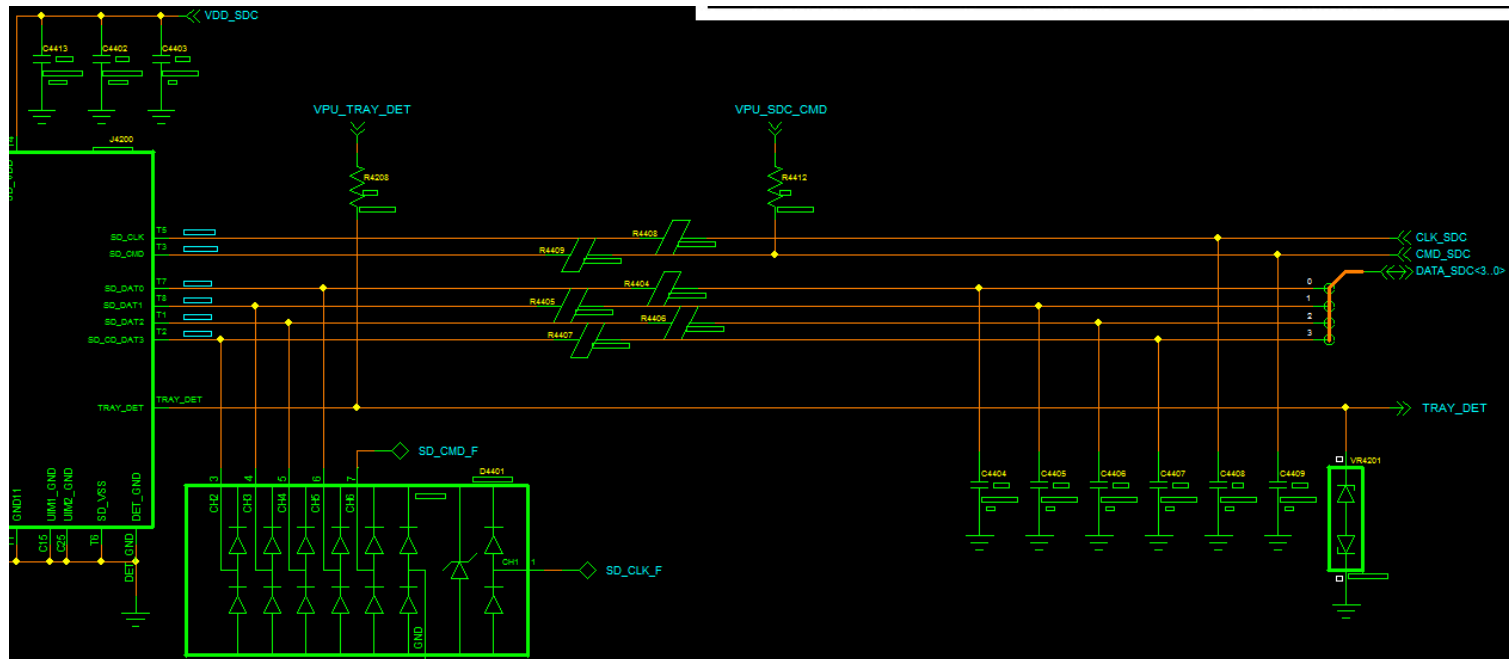
Micro SDCard (Removable Memory)

1. Tray Det (accessible at R4208) should be low when a tray is not present and high when a tray is present. If R4208 is high and no tray is present, the Detect pin on J4200 is most likely unsoldered

4. Depending on the type of card placed in the slot you can measure sdc2_clk as 12.5MHz, 25MHz, 50MHz, 100MHz, 200MHz during a read or write operation.
CLK accessible at R4408

5. Probe SDC2_DATA<3..0>, SDC2_CMD to ensure there is activity on the bus. Start with Data0. R4404-R4407 is data and R4409 is CMD.
6. If any line is held low then measure the voltage across the ESD diodes placed on all data and detect line to ensure you read 0.7V confirming its not shorted to ground.
