Title: Troubleshooting-Guide MotoRAZR maxx V6

Doc. No: TSG\_3G\_V6  
Version: 1.0  
Date: 23.07.2007

## Troubleshooting Guide MotoRAZR maxx V6

### Level 3

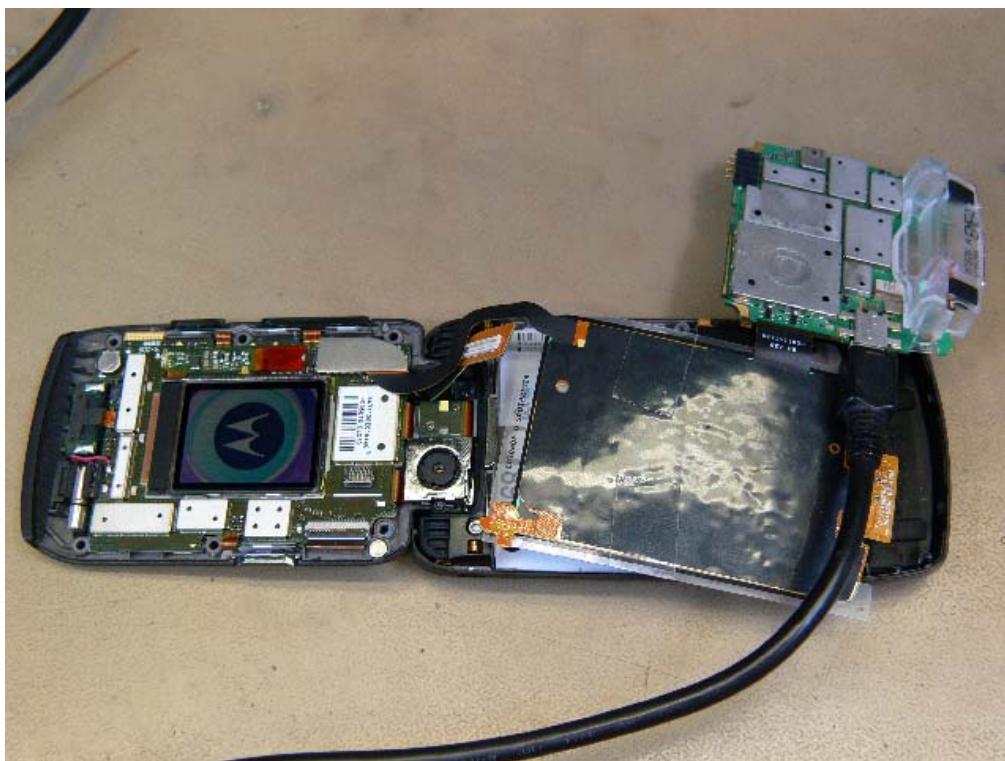
**Figure 5**

*d) Flip PCB defective*

If the fault has not been cleared with one of the previous steps a), b) or c), it is most likely a defective Flip PCB.

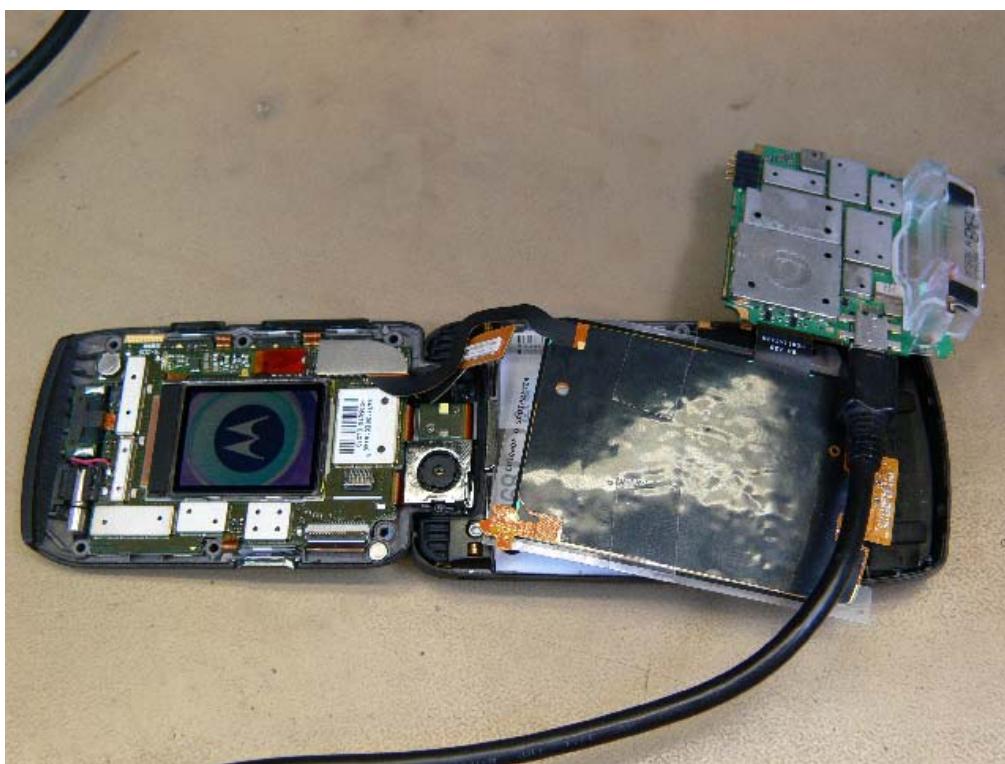
Figure 11

- d) *Main display or CLI display faulty*

Check function of both displays. If just one of them has no function, most likely that display itself is defective

Remove flip cover. Unseat the display module assembly flex connector from its socket and temporarily connect the display module assembly and transceiver board assembly with a known good keyboard flex assy as shown on Figure 9. Check function of both displays. If the fault has been cleared, reassemble flip assy with new keyboard flex assy.

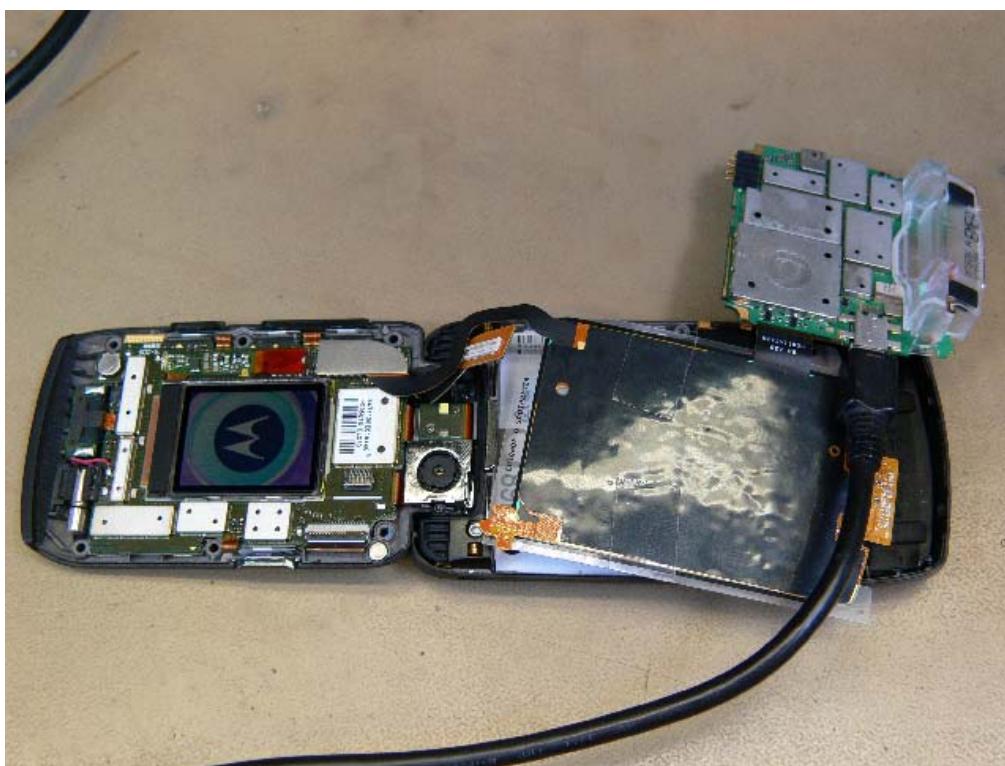
Figure 12

- c) *Flip PCB defective*

If the fault has not been cleared with one of the previous steps a) or b), it is most likely a defective Flip PCB.

Remove flip cover. Unseat the display module assembly flex connector from its socket and temporarily connect the display module assembly and transceiver board assembly with a known good keyboard flex assy as shown on Figure 10. Check function of keyboard. If the fault has been cleared, reassemble flip assy with new keyboard flex assy.

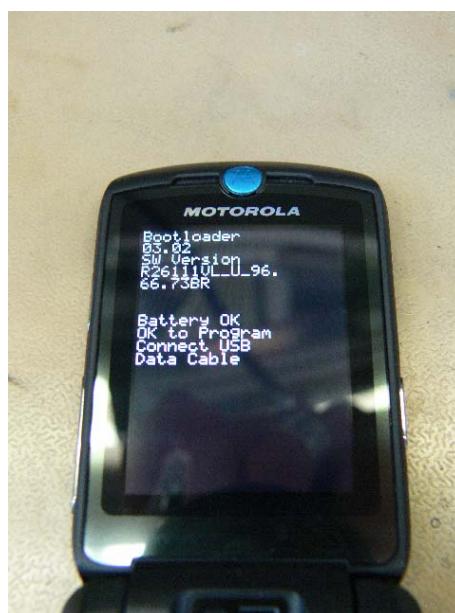
Figure 13

d) *Software corrupt*

If the telephone shows a bootloader menu as shown in Figure 10 or is able to enter the bootloader menu by holding "\*" + "#" keys while turning on, the phone software possibly can be recovered by a 1FF software reflash. Proceed to [recovering flash memory in forced flash mode](#).

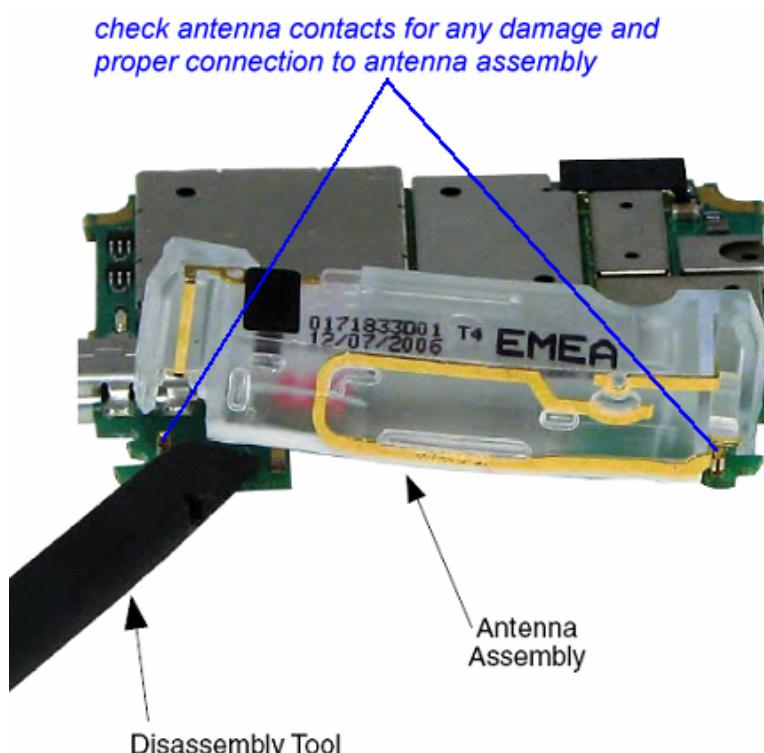
**Figure 14**

- a) *Antenna assembly defective*

Check to make sure that the antenna contacts are properly connected to the antenna contacts on the transceiver board assembly. If connected properly, substitute a known good antenna. If the fault is still present, proceed to b).

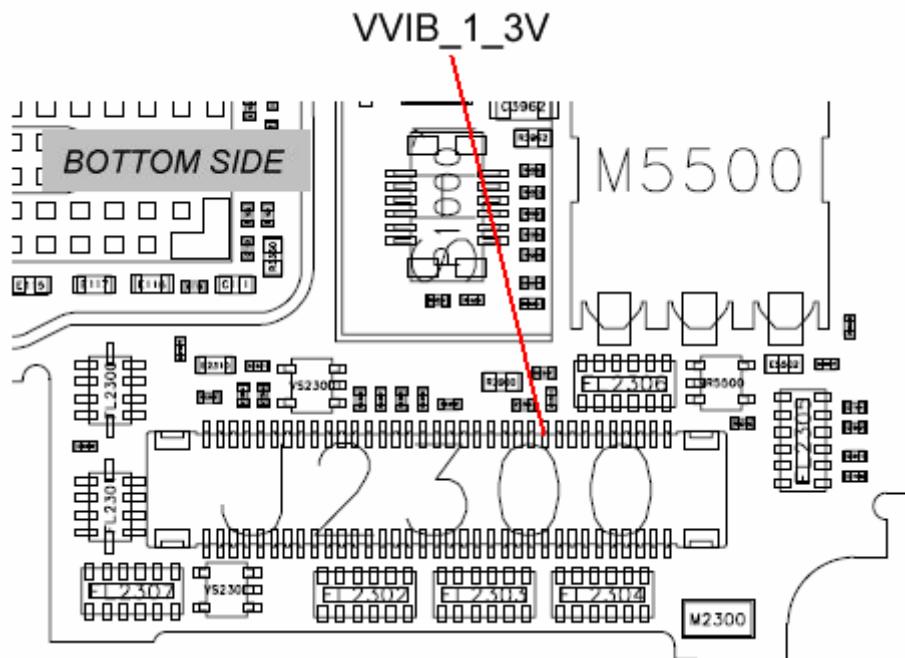
Figure 20

Turn on vibrator via RepairStudio/Radiocomm. Measure [VVIB\\_1\\_3V](#) at [J2300-19](#), it should be 3Vdc.

- If ok check [J2300](#) for defective part/ dry solder joints
- If not ok, change ATLAS IC [U3000](#).

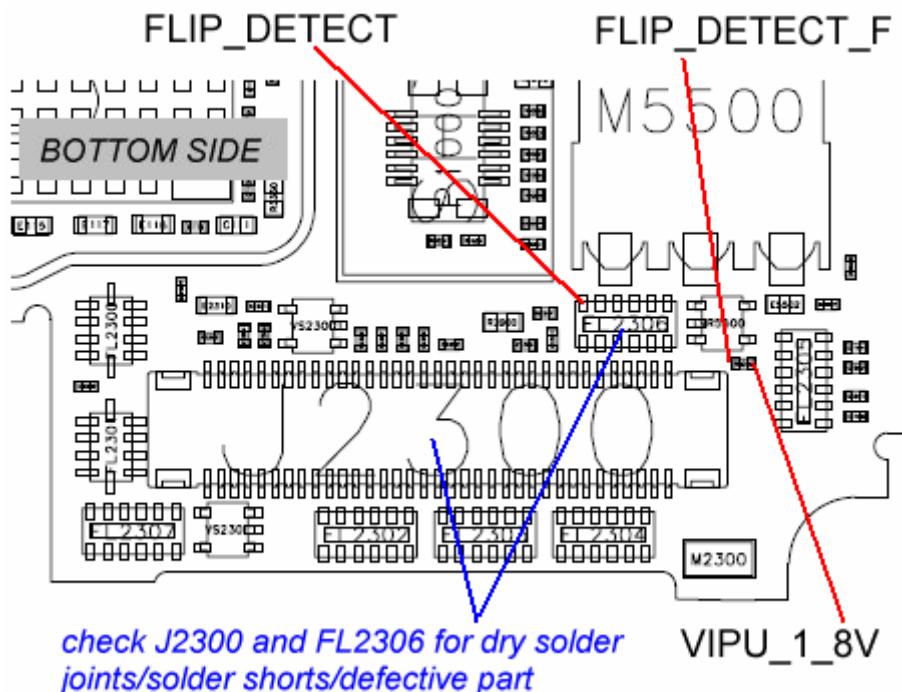
Figure 22

Check [FLIP\\_DETECT\\_F](#) at [R2316-2](#) – should be 1.8Vdc (High signal), if it is low check [VIPU\\_1\\_8V](#) at [R2316-1](#). If 1.8Vdc are present check [J2300/FL2306](#) for dry solder joints/solder shorts/defective part – if ok it is most likely a problem with the ARGON [U1000](#) – forward to an authorized level 4 service center.

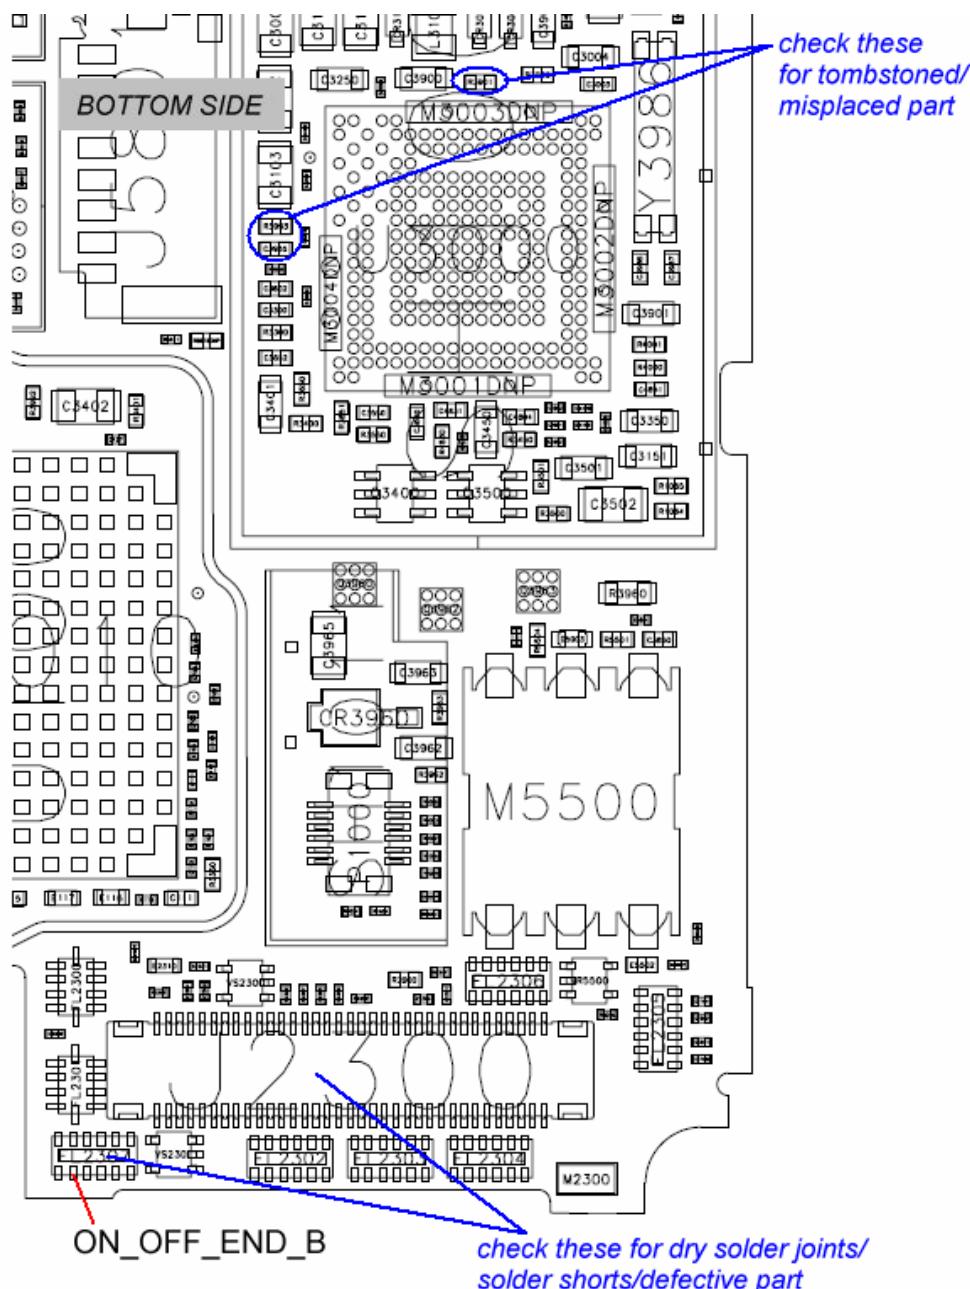
Figure 25

The On/Off button function can easily be checked by attaching a known good flip assembly to the PCB. By inserting an EMU Bus USB cable the phone should turn on. Check ON OFF END\_B at FL2307-8. It should be a HIGH signal of 2.8Vdc and LOW signal if Button is pressed.

- If signal is at HIGH level and not switching down when On/Off button is pressed, check J2300 and FL2307.
- If signal is always at LOW level or down (below 2.8Vdc), check R3993/C3955. If they are ok, it is most likely a problem with the ATLAS IC U3000.

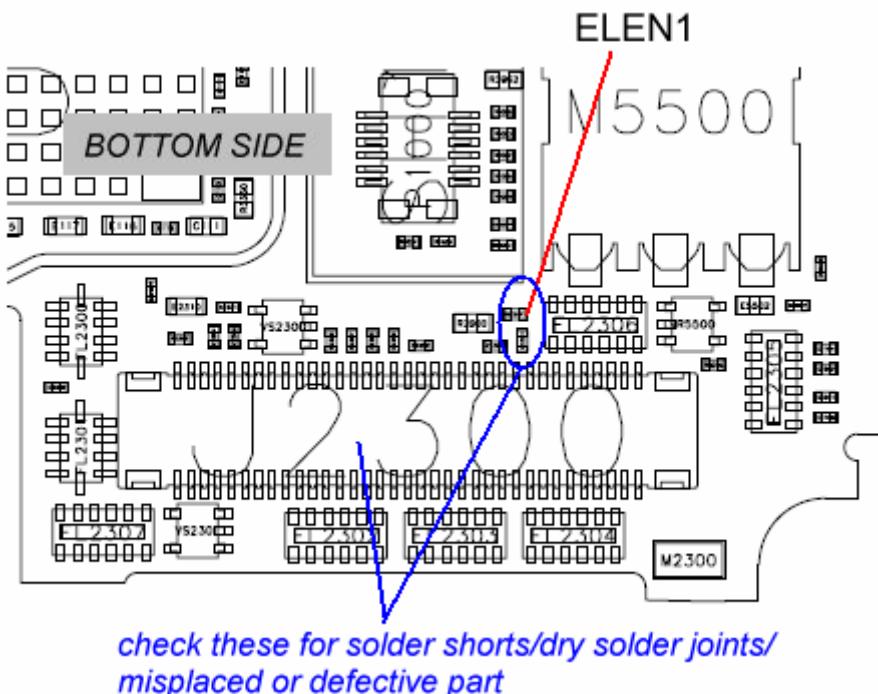
Figure 26

Keypad lighting is done by EL. The EL driver is located on the keyboard PCB. Turn on keypad backlight via RepairStudio/Radiocomm. Check [ELEN1](#),

- if [ELEN1](#) is HIGH, check [J2300](#)
- If [ELEN1](#) is LOW, it is most likely a problem with the ARGON [U1000](#) – forward to an authorized level 4 service center.

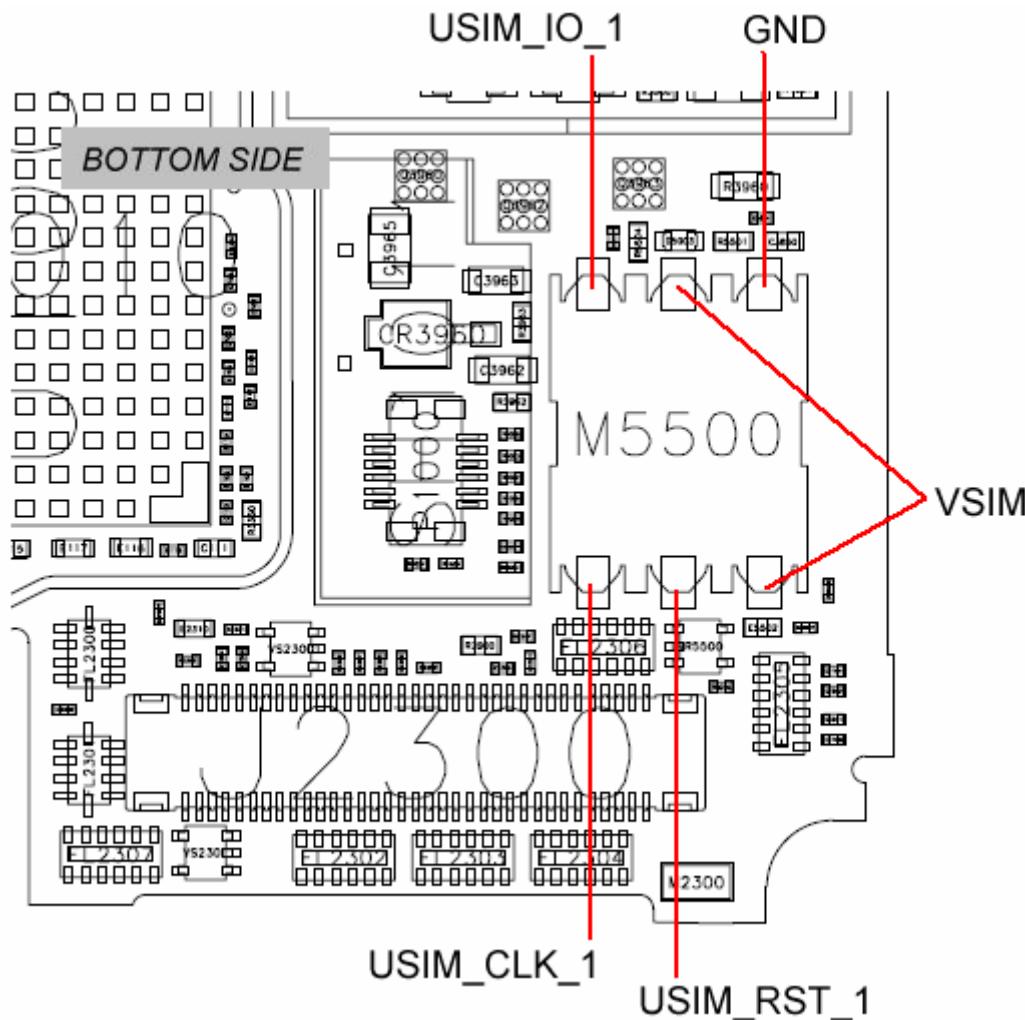
Figure 27

If far less than 30 kOhm to GND, it could be a defective ATLAS IC [U3000](#).

If any of these has far less than 30 kOhm to GND, it could be a defective ARGON IC [U1000](#) – forward to an authorized level 4 service center.

Before replacing the ATLAS IC [U3000](#) or the ARGON [U1000](#), make sure that none of the associated capacitors/diodes have low resistance to GND.

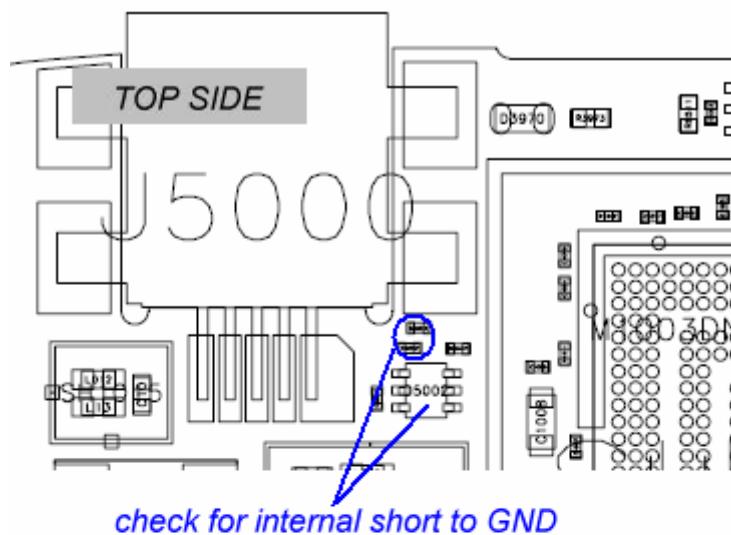
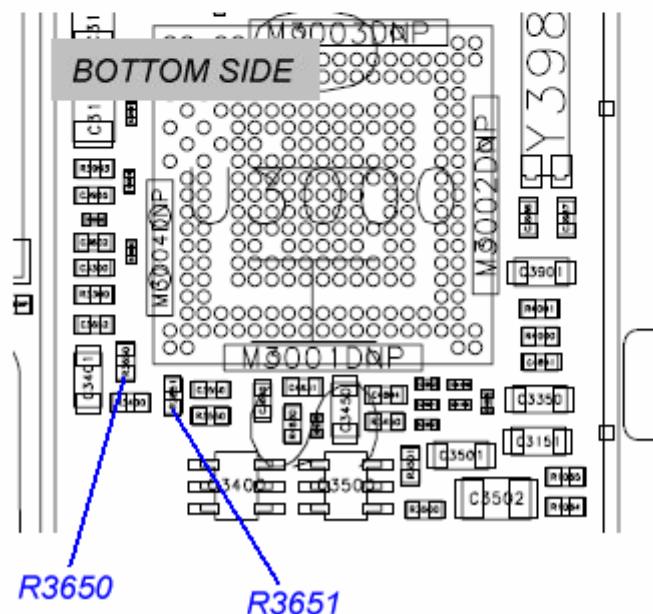
Figure 29

- If not, visually check EMU-Connector [J5000](#) for mechanical defects or contamination on contacts, bad soldered pins or solder shorts
- Check [D5002/C5001/C5002](#) for internal short to GND, [R3650/R3651](#) (22 Ohm)
- If ok, change ATLAS IC [U3000](#)

If the problem remains, it could be a problem with the ARGON IC [U1000](#) – forward to an authorized level 4 service center.

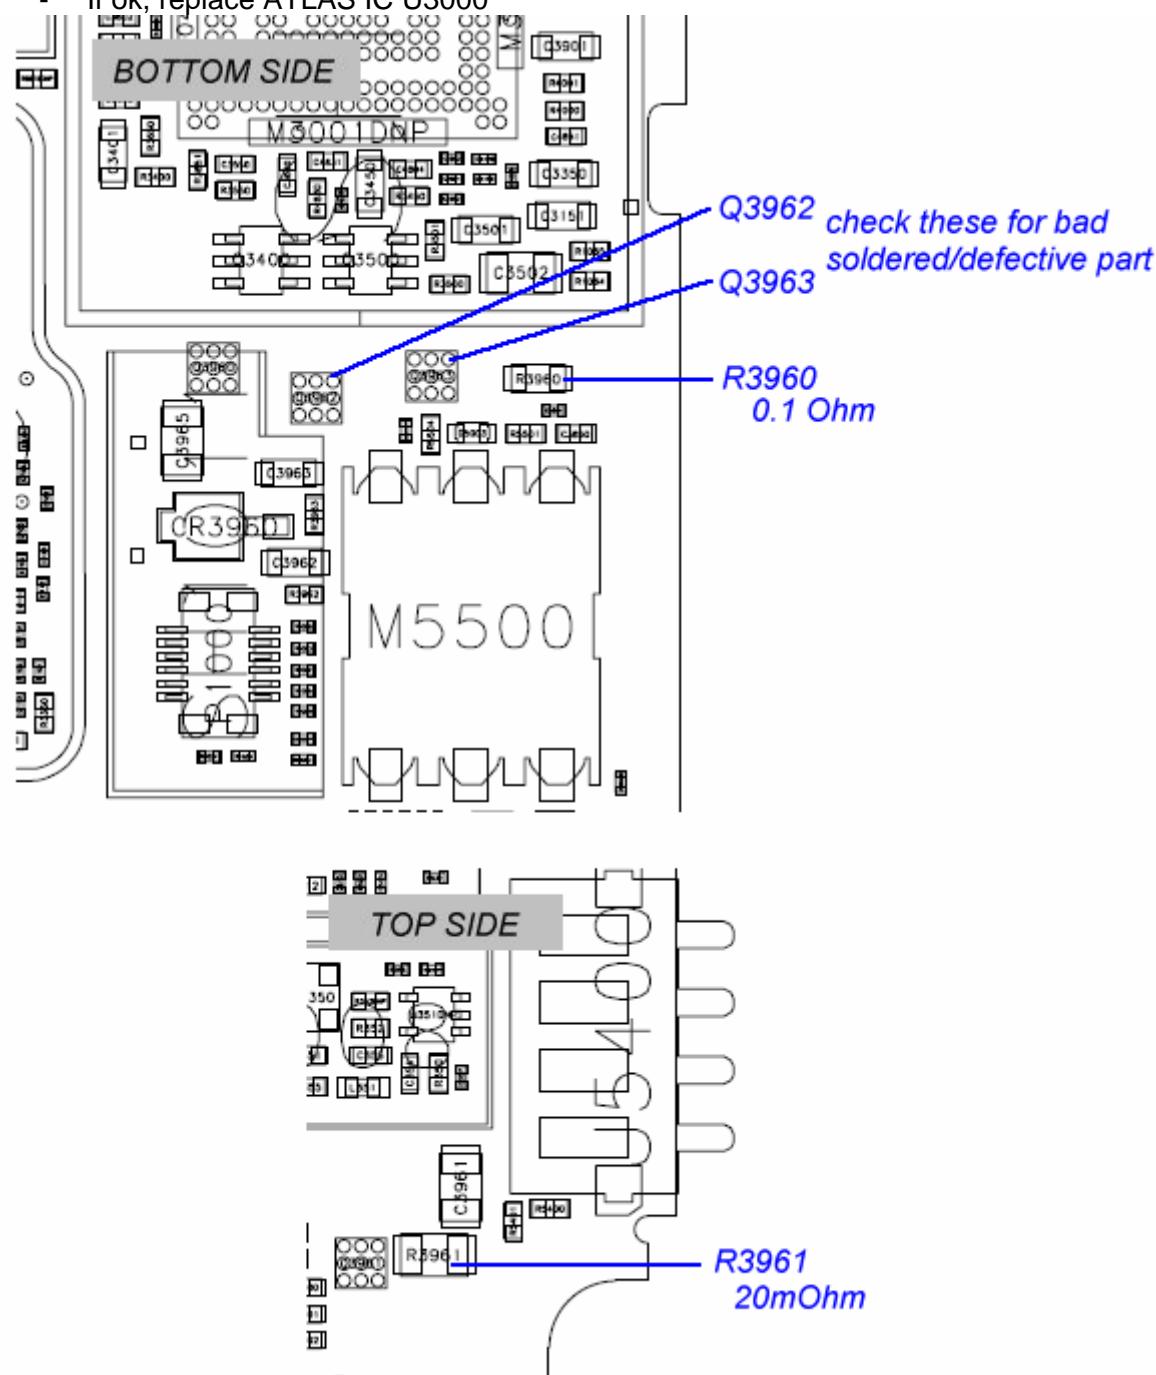
Figure 31

If there is no off current, check the whole path for the charging current. Make a battery/charger phasing to see, if only the charger current or additionally the battery phasing is affected. For a charger current problem only:

- Check the whole charger path for misplaced parts/solder shorts/defective parts
- If ok, replace ATLAS IC U3000

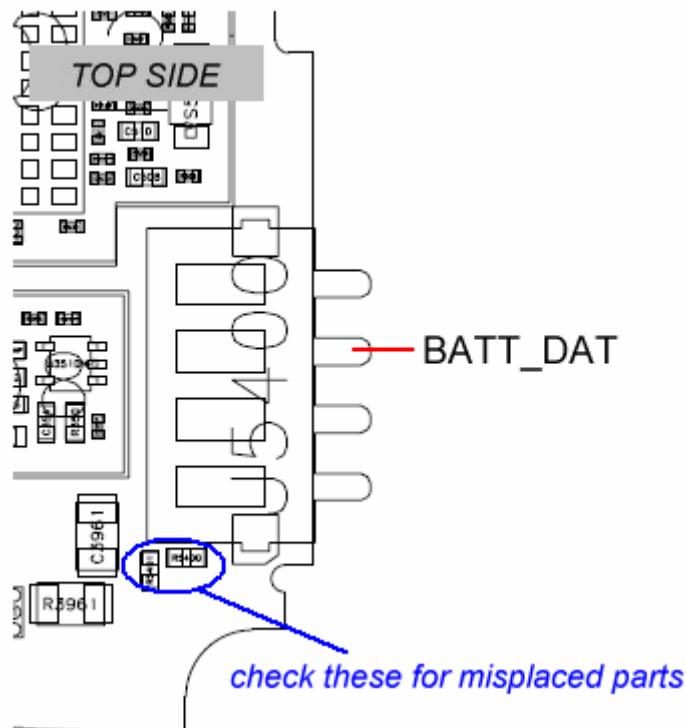
Figure 32

Verify [BATT\\_DAT](#) at [J5400-2](#) while PCB is connected via EMU USB cable. It should be 2.775V. If it is low, check [BATT\\_DAT](#) at [R5400-2](#), if it is 2.775V here, change/resolder [J5400](#).

In any other case it is most likely a problem with the ARGON [U1000](#) – forward to an authorized level 4 service center.

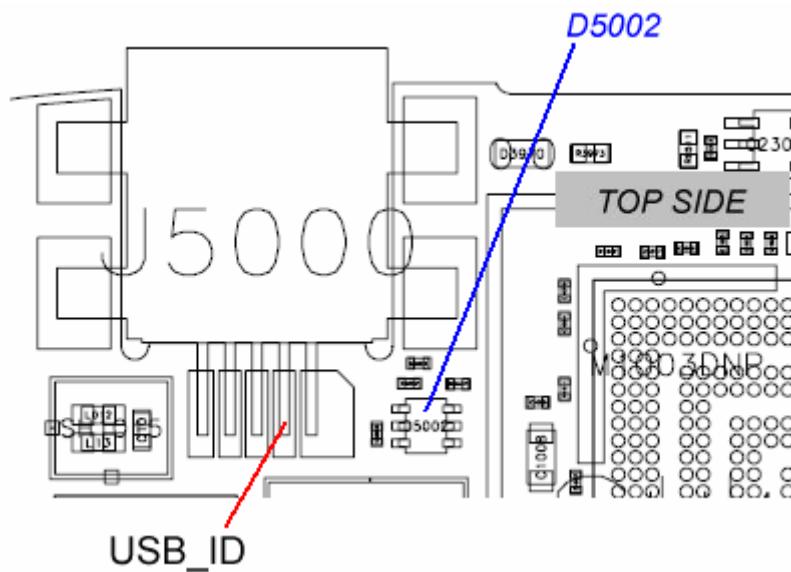
Figure 34

- check [USB\\_ID \(J5000-4\)](#) to GND with an ohmmeter
- If less than 1MOhm [D5002](#) should be removed.
- If still less than 1MOhm it should be because of a defective ATLAS IC, replace [U3000](#).

A new diode array [D5002](#) has to be placed after successful repair.

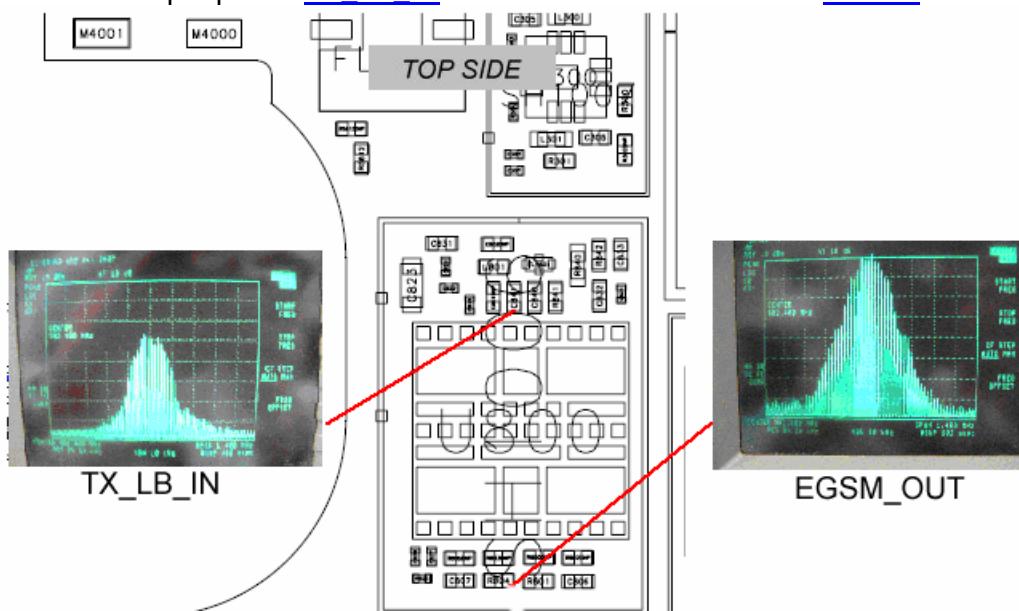
Figure 36

If output power [EGSM\\_OUT](#) from PA is low

- Check to see if PA [U800](#) is soldered down properly
- Check the input power [TX\\_LB\\_IN](#) to the PA from TransAAM at [C841-1](#)

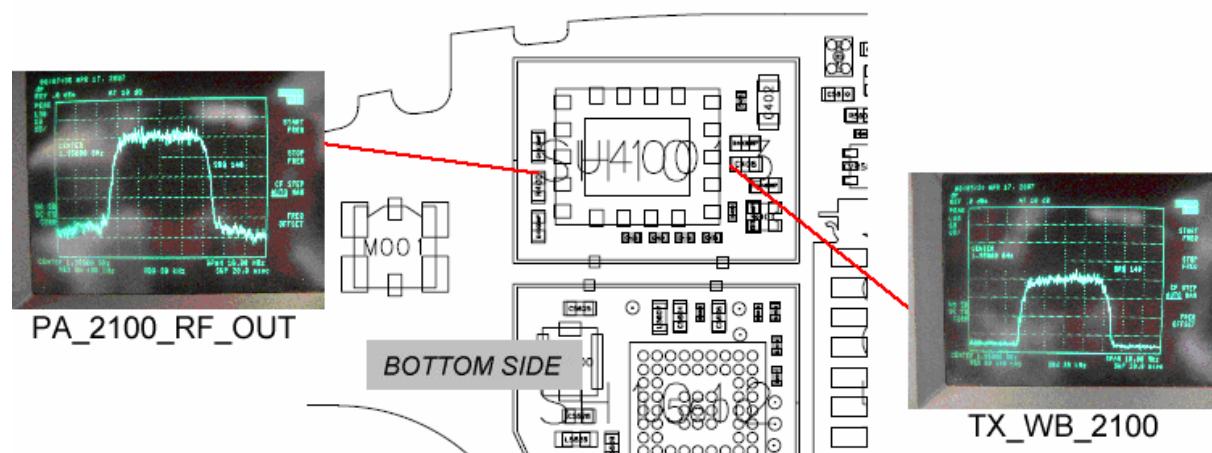
**Figure 37**

If output power [PA\\_2100\\_RF\\_OUT](#) from WCDMA PA is low

- If input power to PA is low it is most likely a problem with the SYMPHONY U100.
- If input power to PA is ok it is most likely a problem with the PA [U400](#) itself.

- Check to see if PA [U400](#) is soldered down properly
- Check the input power [TX\\_WB\\_2100](#) to the PA from SYMPHONY at [C408-1](#)

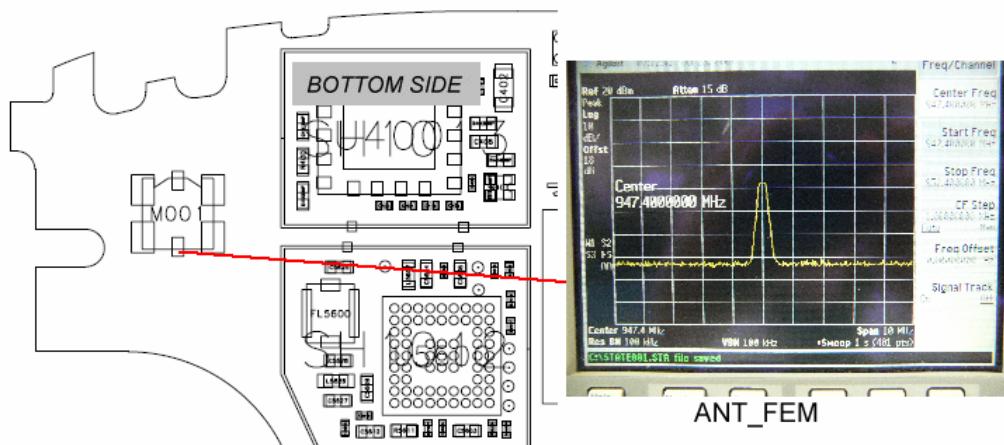
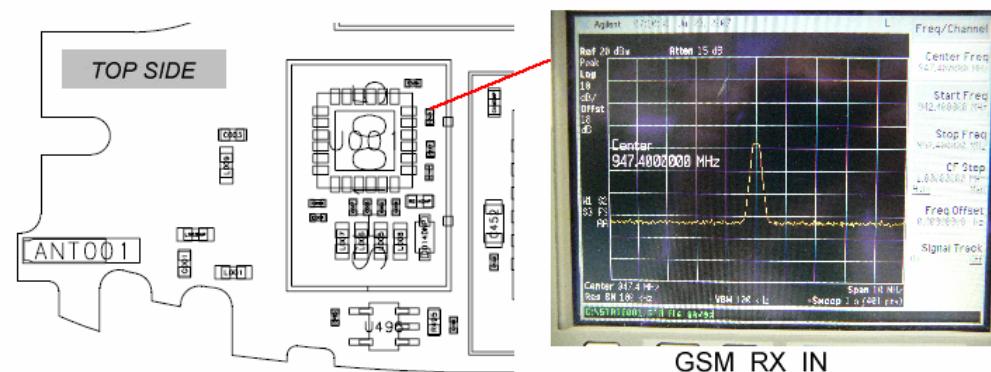
**Figure 38**

Inject a RF from Test Set. The power level should be set to max power. Check [ANT\\_FEM](#) at antenna switch [M001-1](#). Check for presence of [GSM\\_RX\\_IN](#) at [C524-2](#).

- If not ok replace FEM [U001](#)
- If ok there is most likely a problem with the SAW Filter [FL500](#), the TransAAM [U500](#) or the ARGON [U1000](#) – forward to an authorized level 4 service center.

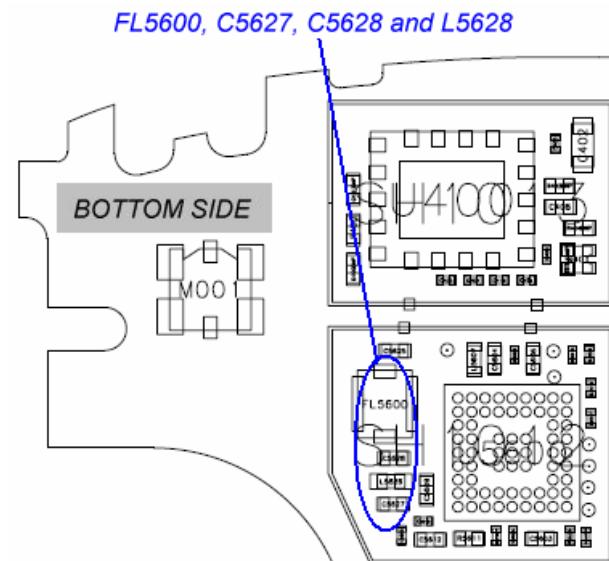
Figure 40

The diplexer performance is dependent on both the WCDMA RX and Bluetooth sides of the circuit. Bluetooth components ([FL5600](#), [C5627](#), [C5628](#) and [L5628](#)) must all be properly placed for the WCDMA RX to function properly. Visually inspect these components when presented with a WCDMA RX front-end failure.

Visually inspect WCDMA diplexer components ([L012](#), [L13](#) and [C10](#))

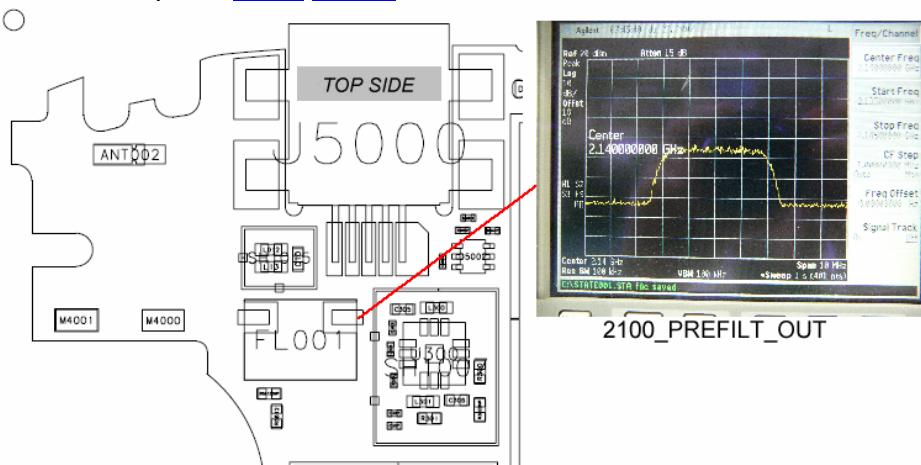
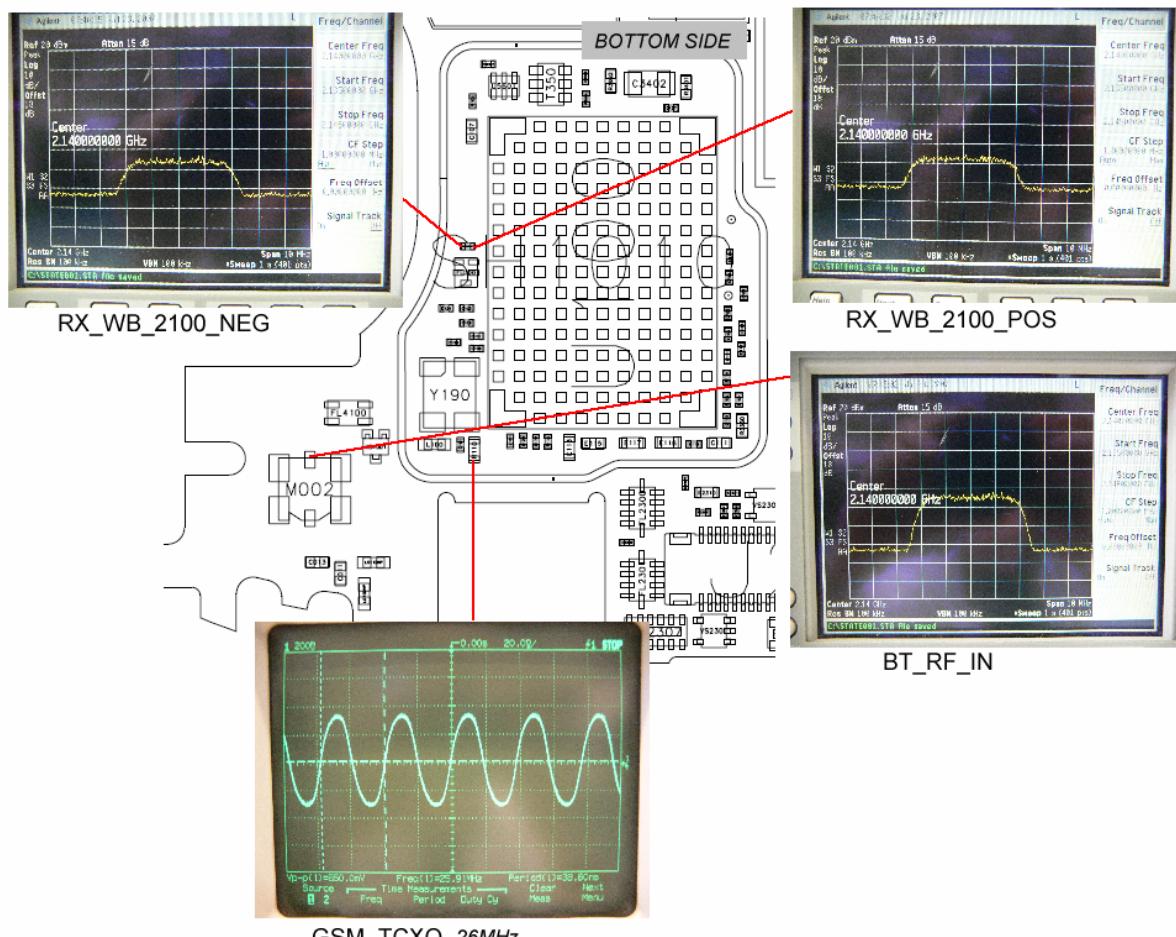
Figure 42

- If bad, replace [M002](#)
- Check for presence of [2100\\_PREFILT\\_OUT](#) at [FL001-1](#), if bad replace [FL001](#)
- Check [RX\\_WB\\_2100\\_NEG/RX\\_WB\\_2100\\_POS](#) at [R305](#), if ok in size and form (if unsure compare with a known good PCB) suspect the SYMPHONY [U100](#)
- If [RX\\_WB\\_2100\\_NEG/RX\\_WB\\_2100\\_POS](#) are not ok, check [VRF\\_RX\\_2\\_775V](#) at [R304](#), if ok check/replace [U300/FL300](#)
