**FIELD SERVICE BULLETIN**

FSB Number: LVCCFSB2005-41  
Authors: Darwin Garcia  
Date: February 24, 2005  
Total No. of Pages: 3  
Subject: **MPX220 No Keypad Function**  
Model Affected: **MPX220**  
Level of Repair: 3

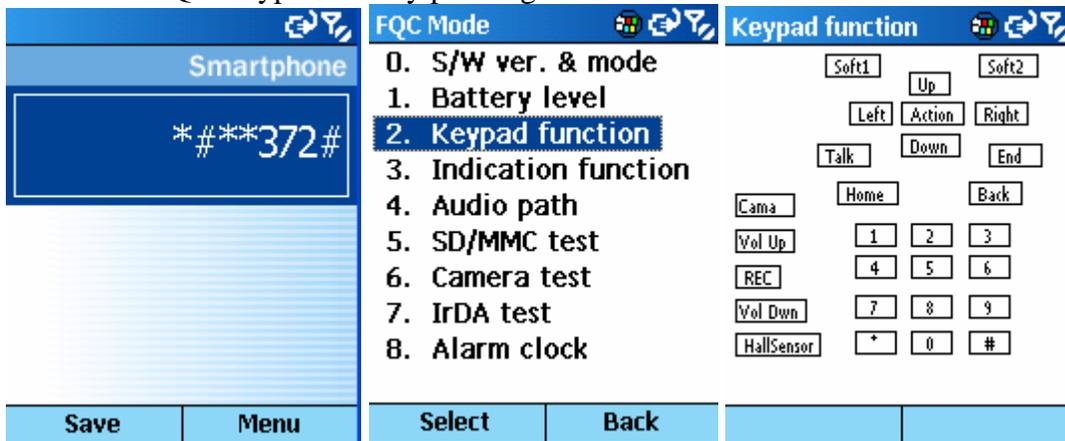
2. Perform FQC Keypad Test by pressing `*#*#372#send`

Pressing the key(s) will clear the screen when each key is pressed (except REC) if not this indicates a failure. Failed key(s) should be tested under normal phone operation and if the tone is not heard and the phone does not react it's most likely a hardware problem. Remove the keypad from the phone and repeat the test by pressing directly on mylar domes to ensure it is a keypad hardware issue.

Perform standard mylar replacement procedure, which is to include cleaning the keyboard contacts and retest the failure.
