FIELD SERVICE BULLETIN

FSB Number: LVCCFSB2005-307
Authors: Darwin Garcia
Date: October 20, 2005
Total No. of Pages: 5
Subject: **V3 CLI Lens Replacement**
Model Affected: **V3**
Level of Repair: 2

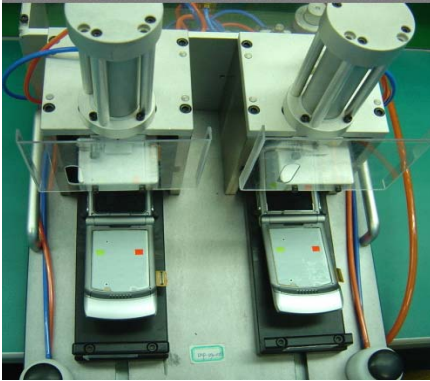
This is not an issue at the factories because they are using a pressing tool for CLI lens assembly which is not available for service centers and all CLI lenses are placed onto new display chassis which have not been reworked.
