FIELD SERVICE BULLETIN

FSB Number: LVCCFSB2006-83
Author: Tony Bryan/Darwin Garcia
Date: March 10, 2006
Total No. of Pages: 9
Subject: GSM RAZR V3 & RAZR 05 – Toko Hall-Effect Switch
Phone Models: GSM RAZR V3, RAZR 05
Level of Repair: 2

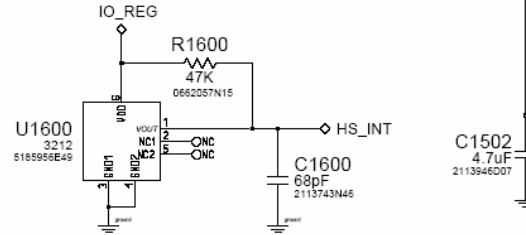
Flips can be sorted by measuring switch resistance. Measure the Hall-Effect switch resistance to separate the Allegro part from TOKO parts, different supplier part has different resistance.

Method: Using the Multi meter measure the Hall-Effect switch resistance through HS_INT pin and Ground pin in the flip 50pin connector. See Image Below.

Allegro Part - Resistance Measurement less than or equal to 43.5 kOhm (Allegro Nominal Value = 39.8 kOhm)

Toko Part – Resistance Measure greater than or equal to 44 kOhm (Toko Nominal Value = 51.4 kOhm)

High Quality
 Multi-Meter
 (Example: HP34401A)

The positive probe connect Ground pin and
 the negative probe connect Hs-INT pin.
 The resistance measurement range to set to
 AUTO.
