Title: Troubleshooting-Guide V3xx

Doc. No: TSG_3G_V3xx

Troubleshooting Guide MotoRAZR V3xx Level 3

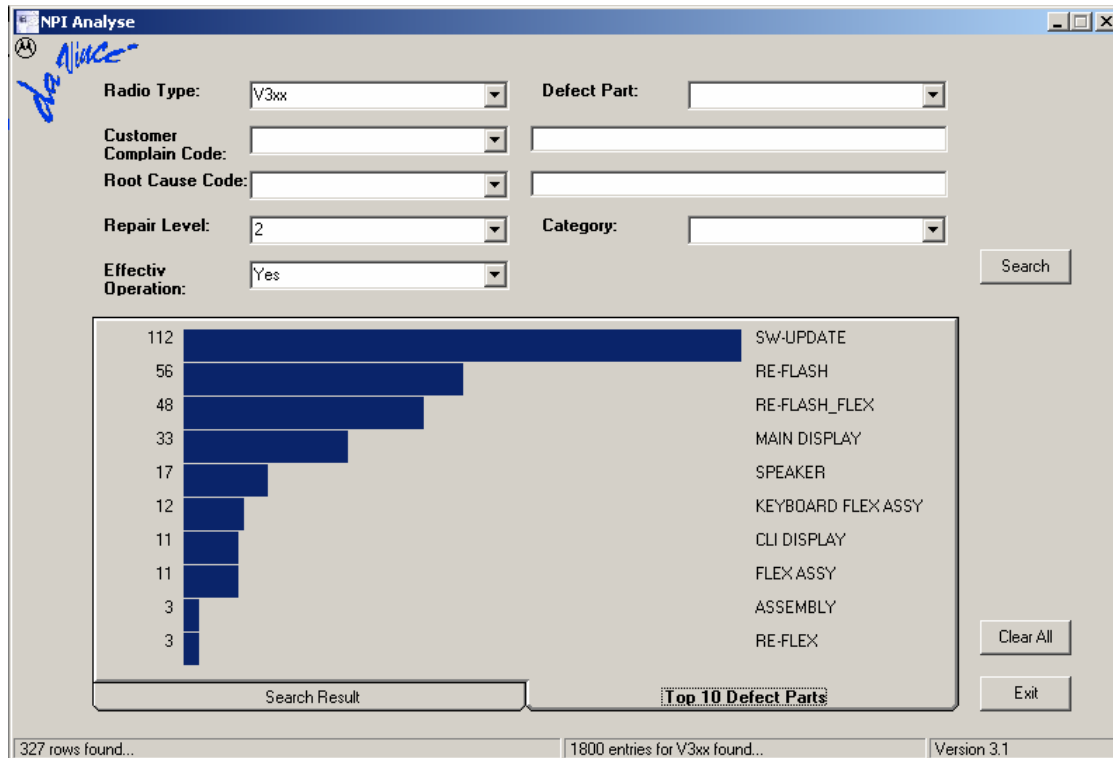
Figure 1
Level 2 parts

Top Ten defective parts

Following is an analysis summary of the V3xx repaired during NPI process by the Repair Entitlement Group CSS Flensburg
