GSM V80_ Joystick Rubber Torn Issue

Our Reference: SI46_10_2004

Product/System: V80

FIELD SERVICE INFORMATION

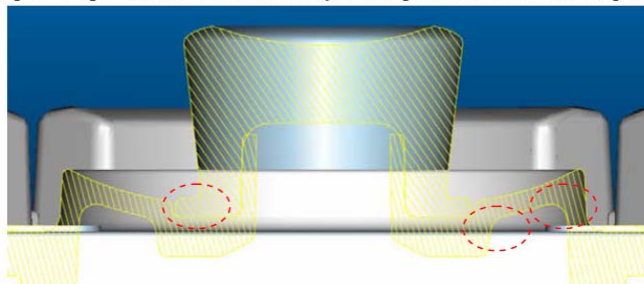
Design Center has issued new Rev B joystick come from new 16 extra cavity tooling. The part was qualified on Sep. 1st 2004. Below picture is the comparison between old joystick Rev A and new joystick Rev B.

- Add Radius at all sharp corner
- Remove glue channel
- Characterize the pull test performance for each cavity. Set requirement for minimum pull force for future build

If the joystick is determined to be faulty, replace the joystick with Rev B written on the joystick rubber surface you may see the capital letter "B". All mass production cross over to Rev B. Rev A should not be used anymore.
