STANDARD FIELD SERVICE BULLETIN

FSB Number	CHRAEFSB2018-3
Author	Tony Bryan
Date	01/12/2018
Subject	Moto X4 - Front Camera Focus Performance
Model Affected	XT1900-1-7 (All Models)
Level Of Repairs	Level 2

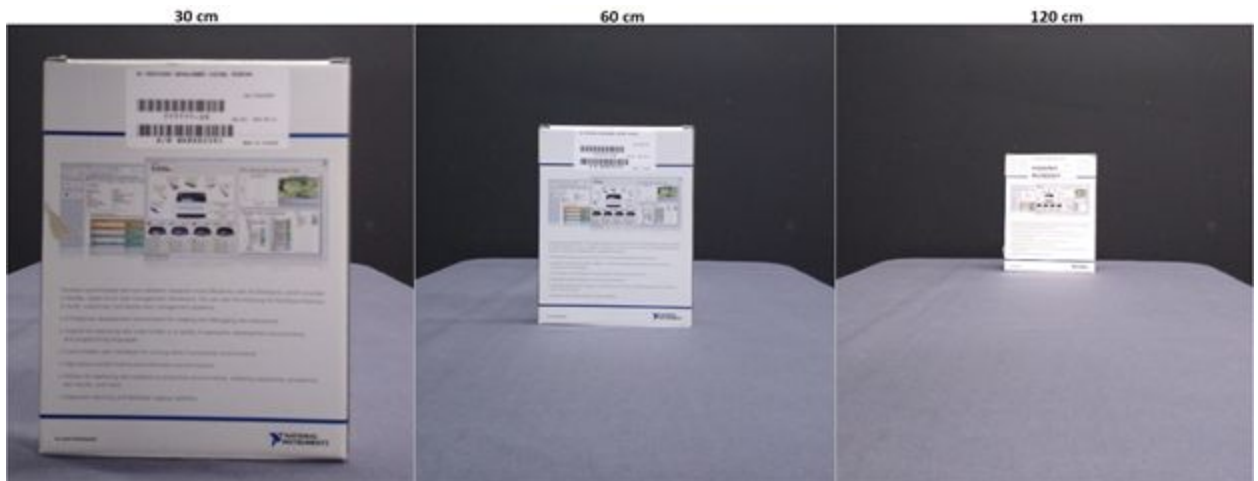
An example of the acquired images is shown below.

Consider each image and distance and use the table shown below to identify an undesired behavior.

3. If the resulting photos show a behavior similar to example images labeled as **UNDESIRE** above, consider this device to be problematic and should be repaired.

1. Execute the **Focus Test Procedure** specified in the **Short Term** solution section above to confirm if the device has a functional issue or not.
 - a. If the captured photos show a behavior similar to example images labeled as **UNDESIRE** above, then consider this device to be problematic and should be repaired as directed below.

- i. Following Service Manual, carefully disassemble the device and remove PCBA from Rear Housing Assembly (P/N: 5S58C09xxx & SS58C19xxx).
 - ii. Inspect the Rev Marking on the Rear Housing Assembly (P/N: 5S58C09xxx & SS58C19xxx). If marking is Rev A, then replace Rear Housing Assembly (P/N: 5S58C09xxx & SS58C19xxx) with Rev B or later. Reference **Figure 1.0** above.

- iii. Replace Front Camera Assembly (P/N: SC28C21776 & 9401405900x).
 - iv. Following Service Manual, carefully reassemble the device and perform the **Focus Test Procedure** specified in the **Short Term** solution section above to ensure issue is resolved.
