ST55

Level 2.5

Repair Documentation

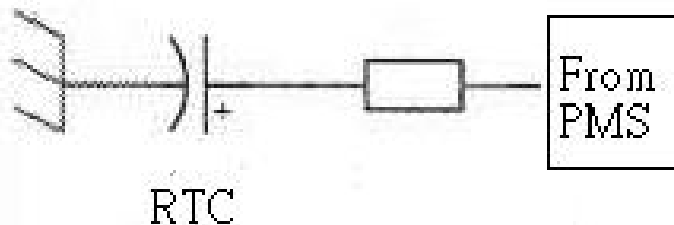
The RTC is a capacitor that supplies the power to the system to make the real time clock go on counting about 45minutes after the main battery of phone is taken off. Besides, the RTC battery will always be charged from the PMS when the main battery is inside the phone. See drawing below.

1. Remove the defected RTC by Hot Air Blower (350°C ~ 400 °C) (350~400 °C).
2. Put on new RTC and add solder at the "+" side first.
3. Then add solder at the "-" side.
- 4.

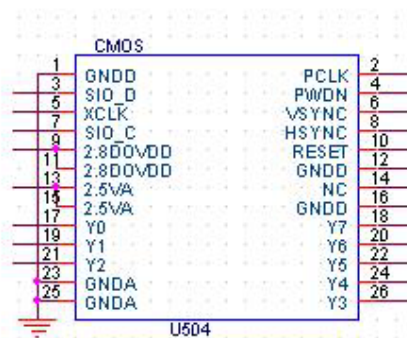
The camera connector is a 26-pins contact type socket. It had 2 kinds of working voltage (2.8 and 2.5V), 13MHz-working frequency. Using the YUV data format.

- 1.Re-solder this connector if cold or insufficient soldering.
- 2.Use hot blower to remove defective connector and add solder on pads.
Avoid excessive heat! Watch surrounding component!
- 3.Heat and put on a new connector to enhance adhesion.
- 4.Re-solder new connector afterwards.

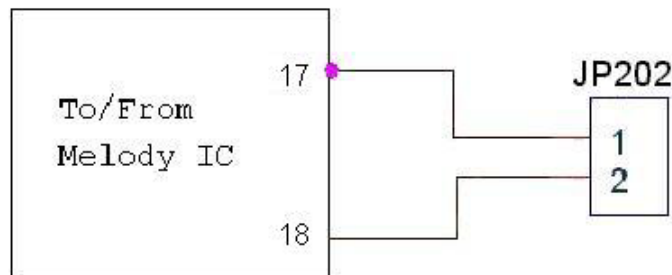
The speaker spring connector is used to contact a 8ohm speaker. It provides two contact trace for the melody signal from the Melody IC. See drawing below.

1. Use hot blower to remove the defective connector.
Avoid excessive heat! Watch surrounding components!
2. Add solder on pads.
3. Heat and put on a new connector to enhance adhesion.

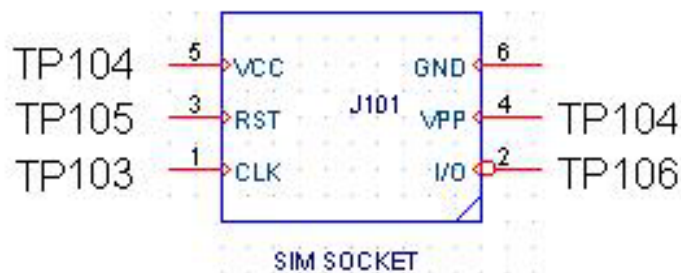
The SIM connector is a mechanical part designed to make a connection with SIM Card (GSM 11.11). The power will be supplied into VCC and VPP. The signal of RESET, CLOCK and DATA from DBP transmit to RST, CLK, and I/O.

- 1.Re-solder this connector if cold or insufficient soldering.
- 2.Use hot blower to remove the defective connector if oxidized or deformed and absorb remaining tin on pads.
3. Put on new connector and add solder on pins in diagonal sequence.

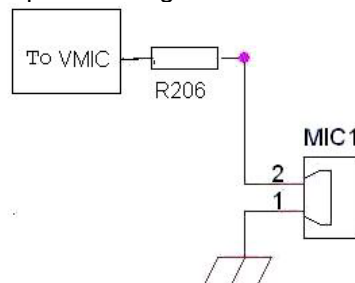
The MIC connector is a two pins holder. See drawing below. There will be about 1.2V bias on PIN-2 as the system is power on. The voice trace here is single end structure. Voice signal will be received by the microphone and goes to the VBC via PIN-2.

- 1.Use hot blower to remove the defective connector.
Avoid excessive heat! Watch surrounding components!
- 2.Add solder on pads.
- 3.Heat and put on a new connector to enhance adhesion.

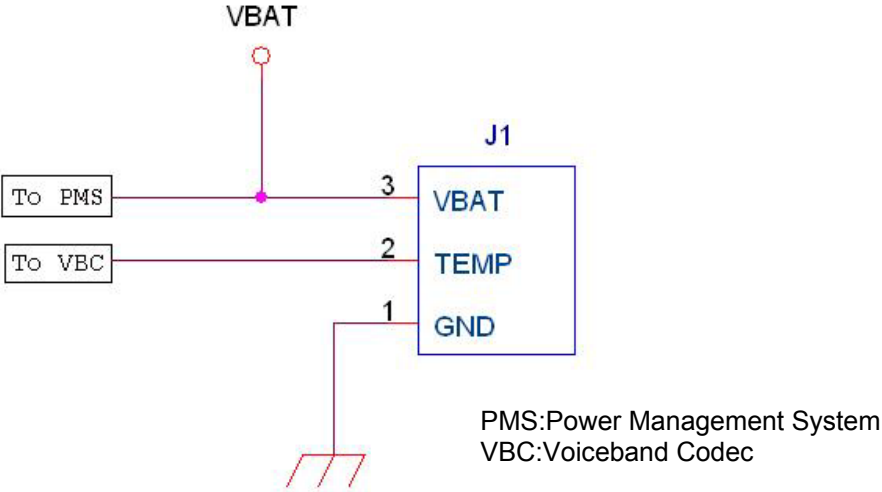
J1 is a battery connector with 3 battery contacts as power supply portion. Normally while power on, the 3.6~4.2V voltage is provided to the handset via VBAT. Temperature is detected via TEMP.

1. Use hot blower to remove the defective connector.
Avoid excessive heat! Watch surrounding components!
2. Add solder.
3. Heat and put on a new connector to enhance adhesion.
4. Re-solder if needed.

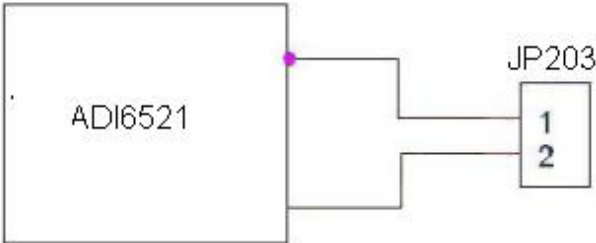
The speaker connector is used to contact a 32ohm earpiece.
It provides two traces for the dlink signal from the ADI6521 IC. See drawing below.

1. Re-solder this connector if cold or insufficient soldering.
2. Heat and remove the defective earpiece by Soldering Iron (350°C ± 20 °C) from the topside.
3. Put on a new earpiece.
4. Heat and press the earpiece to the right position gently.
Avoid excessive heat! Watch surrounding component!
5. Re-solder if needed.

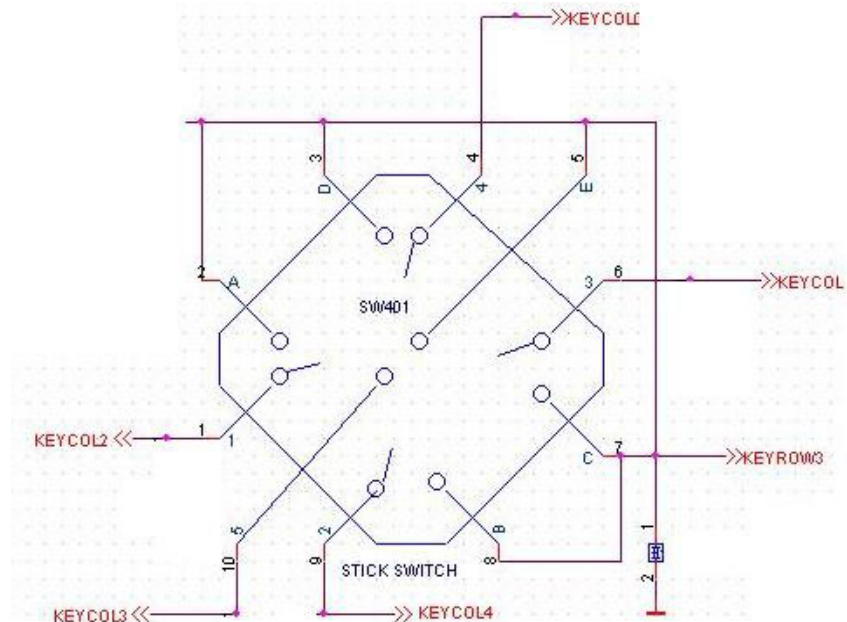
This is a five-way joystick which ROW3, COL0~COL4, used to transmitted the ROW signal, COLUMN signal.

- 1.Re-solder this connector if cold or insufficient soldering.
- 2.Use hot blower to remove the defective connector if oxidized or deformed and absorb remaining tin on pads.
3. Put on new connector and add solder on pins in diagonal sequence.

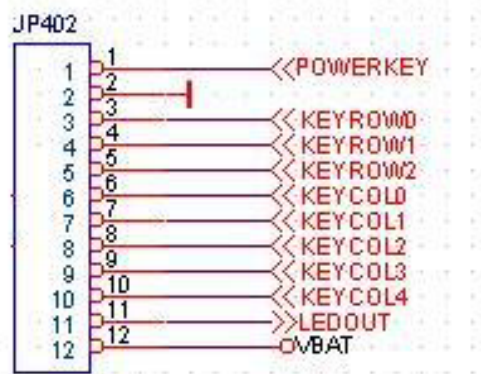
There are 8 pieces LED used in the keypad FPC. The power is supplied to the LED via VBAT (PIN-12). The signal coming from DBP to LED (PIN-11) will control the ON/OFF of LED.
