# Level 2.5 Repair Documentation for XELIBRI

## X2 & X4

V 1.0	Page 1 of 14	ICM MP CCQ GRM
X2 / X4	Company Confidential Copyright 2003© Siemens AG	04/03

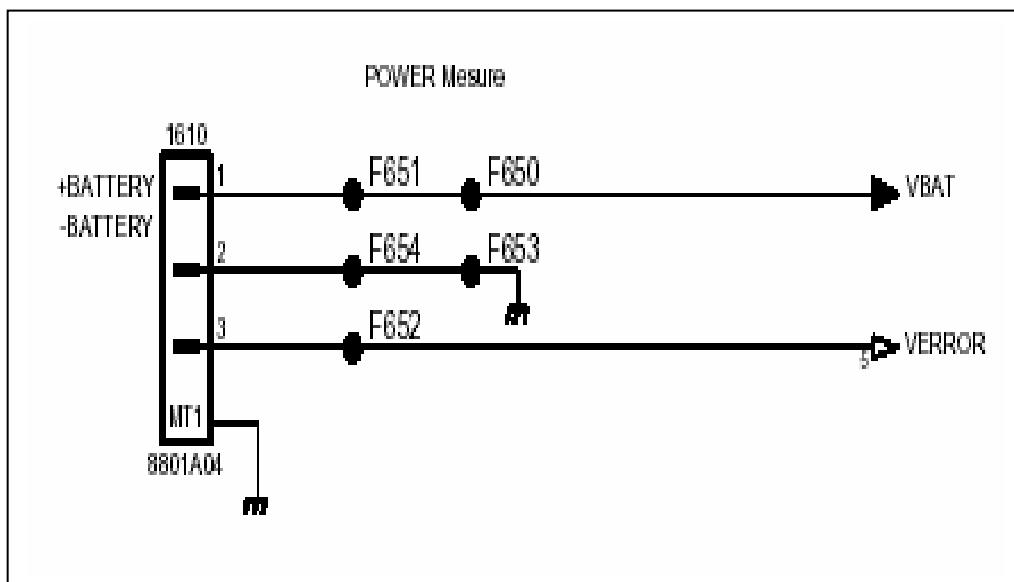
#### 2.2.3 Component Information

Can't power on under normal operation  
Can't charge this handset when power off

The connector (1610) is the battery connector with 3 contacts.  
During power on, 3.5V to 4.2V is supplied to the handset via VBat.  
VERROR is provided to the Battery, goes into the Power Management Unit control charge.

Visually check pins for oxidation or deformity.

1. Use a hot air nozzle to remove the defective connector.

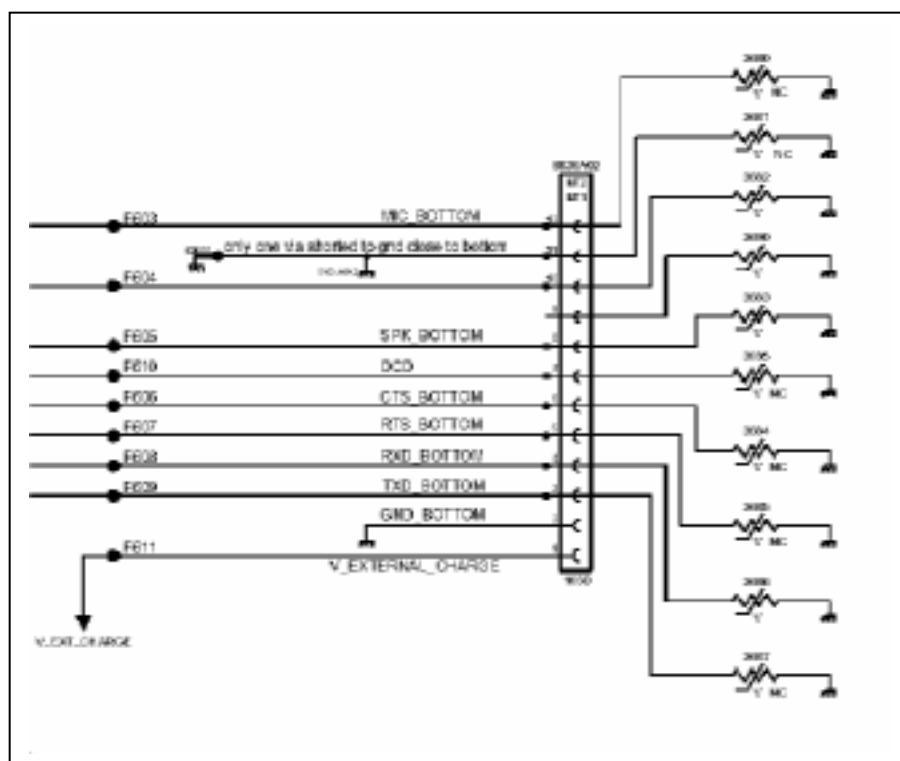
#### 3.2.3 Component Information

The connector (1660) is I/O connector (12 contacts) used the adapter charger.  
The adapter charger uses the PIN1 for V\_EXTERNAL\_Charge and PIN2 GND BOTTOM

Visual inspection of the fittings and I/O pads solder joints (short circuit, leak, poor brightness).

1. Use a hot air nozzle to remove the defective connector.
