Title: Troubleshooting-Guide **K1**

LEVEL 3
DEBUG GUIDE
K1

INDEX	
Requirements	Pag 3
Special Procedure For High Current Failure	pag 4
No power up	pag 5 & 6
No Tx	Pag 7 & 8
No Rx	Pag 9

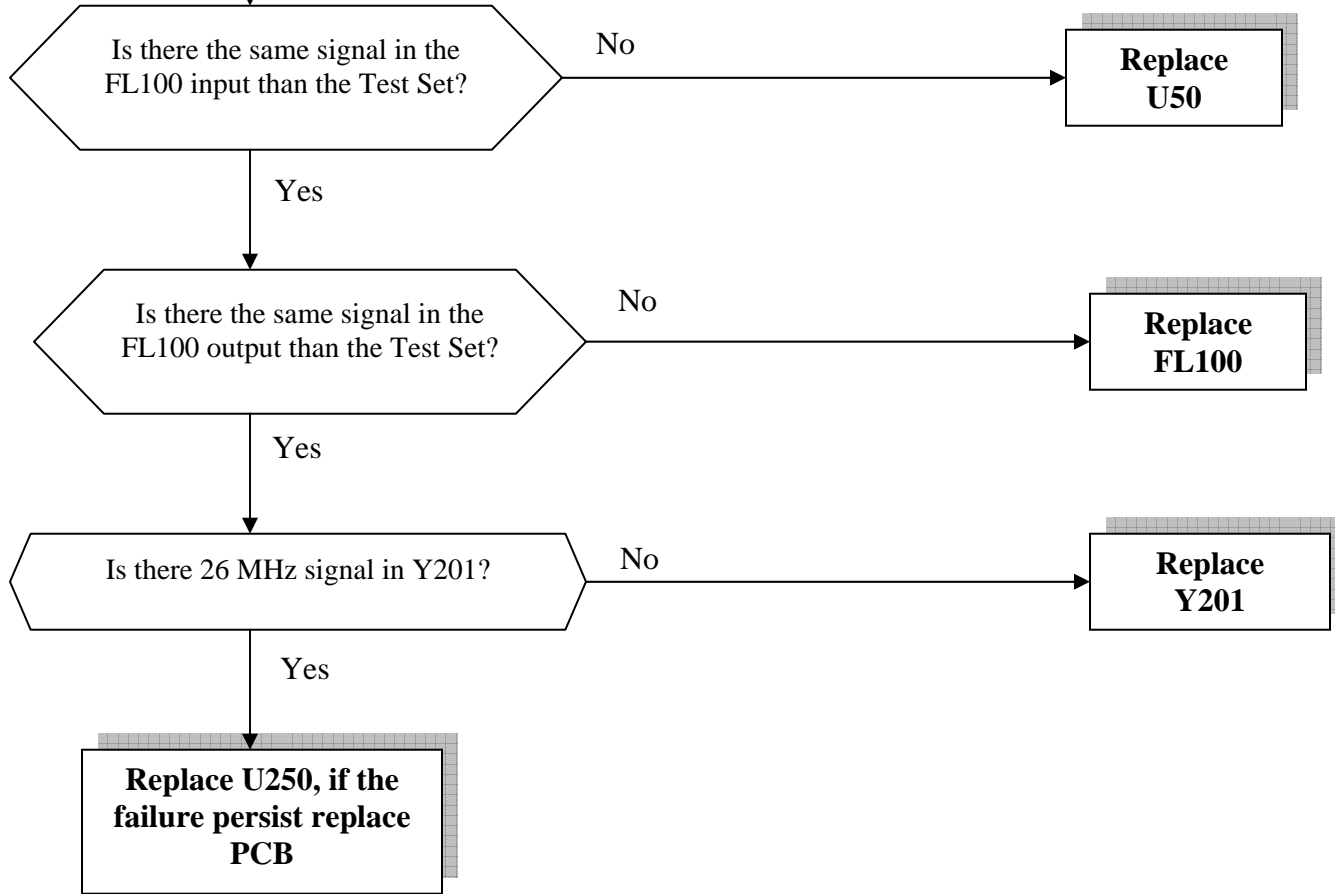
No Rx

Connect the PCB to Radiocomm program with data cable (SKN6371A) to USB and power supply with an external power supply 4.2 v.
Inject a RF from Test Set
