Title: Troubleshooting-Guide **U6**

Debug Guide PEBL U6

This document was created to assist analyzers troubleshooting problems on Motorola Phones.
All information was collected during the repair in the Repair Entitlement Group Flensburg.

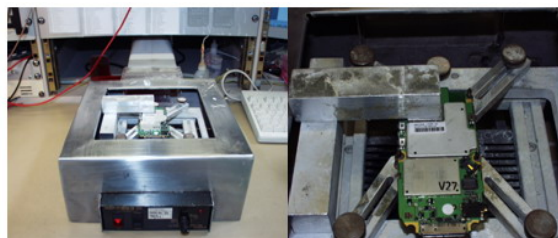
- remove battery and microphone
- **always cover the Bluetooth chip [U301](#) with a metal block or teflon shield**
- the mylar tape is not too sensitive. It can stand some soldering processes, but if it is warmed up handle it carefully. It can´t stand to be scratched in that condition
- use flux for lead free soldering
- use the preheater (HAKKO 853) ,available at AMS

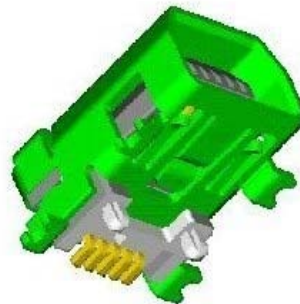
front view

5 4 3 2 1

| ⚡ Pin 1 VBus | - USB Power / Switched B+ (In/Out) |

The **EMU power is 5.1V**. The phone will switch on with lower power, but that would mean an unstable condition for example for the flash process.

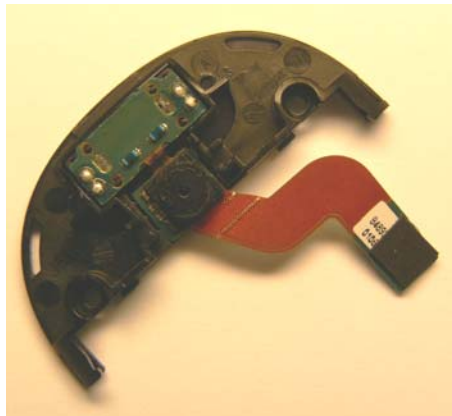
Remove Flip Cover and visually inspect soldered contacts at speaker. If not ok, resolder Speaker. Otherwise replace Speaker with a new one. It is one picepart with the camera module.

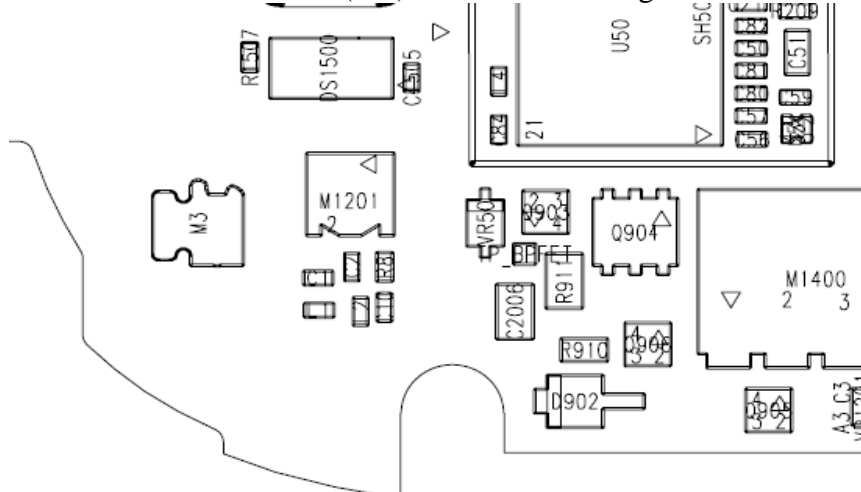
- Check antenna contact (M3) on PCB for damage

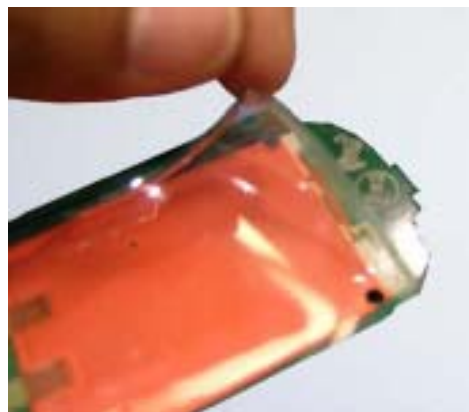
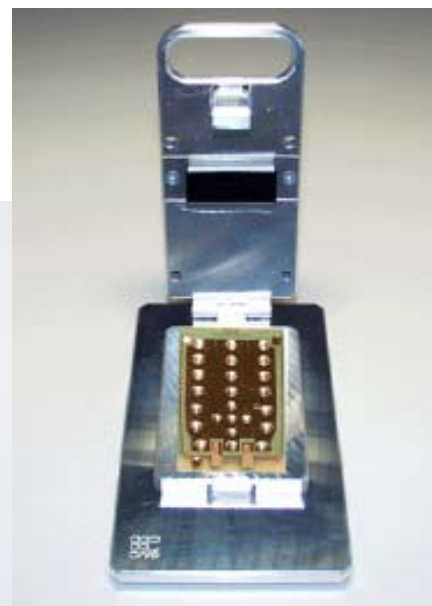
- Check Mylar for misplacement or damage
- Don't use the same mylar again
- Use the mylar placement tool

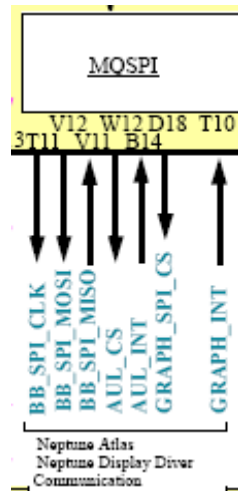
The Neptune [U800](#) controls also the ATI (graphic processor) Reset .

The voltages can be ok without a flip connected, but can break down, if a flip is plugged in, although the flip is ok! Additionally check the clock signal

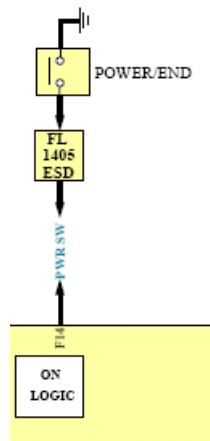
If the on/off button is not working your unit will not start with a battery, but with the repairable supplying voltage to the [EMU connector](#). Or compare with a known good Keypad.

Check [PWR_SW at C937](#). Voltage should measure 2.775Vdc when the on/off normally open switch is not pressed. Voltage should measure 0 Volts when the switch is pressed/closed.

If signal is missing, check [FL1405](#).

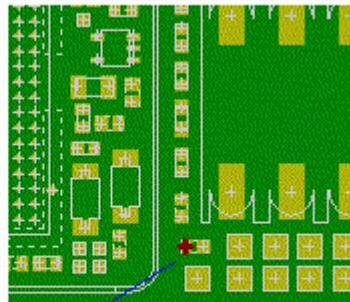
R380 watchdog

In case the phone draws current but switches off after a few seconds, you can force the phone not to switch off, by setting the **Watchdog R830 DNP**. Place a short resistor as [R830](#), or just put solder across the pads of [R830](#), the “/WDOG” signal will be pulled to high level and the ATLAS IC [U900](#) will not switch off its power regulators. Now, you have time to measure or find thermal failures using a coolant spray as described in the [Battery life short/Charging problems/No turn on due to excessive current drain](#) section of this document.

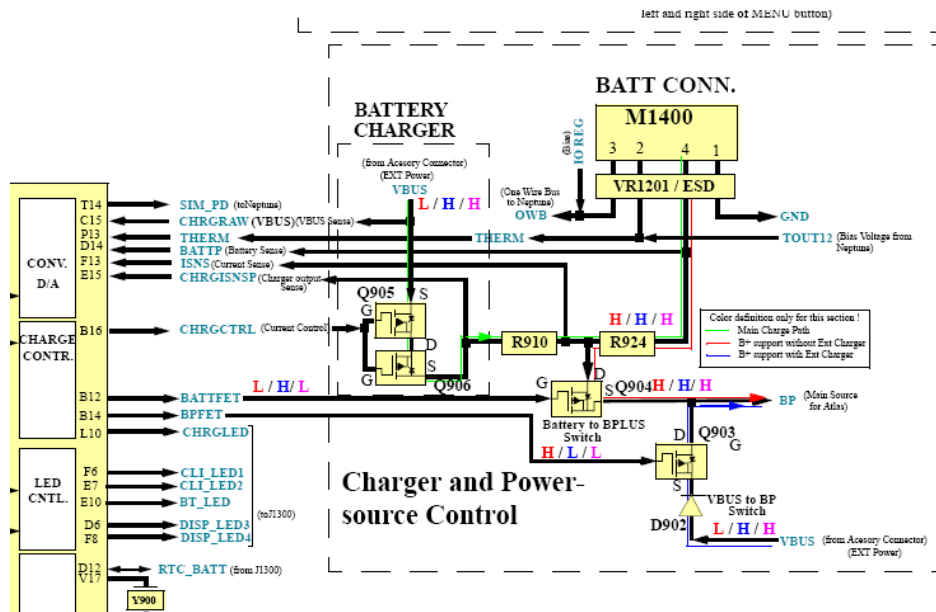
- Check the whole charger path for misplaced parts, solder shorts or defective parts
