W370/W375 Troubleshooting Guild

Compal Communications, Inc.

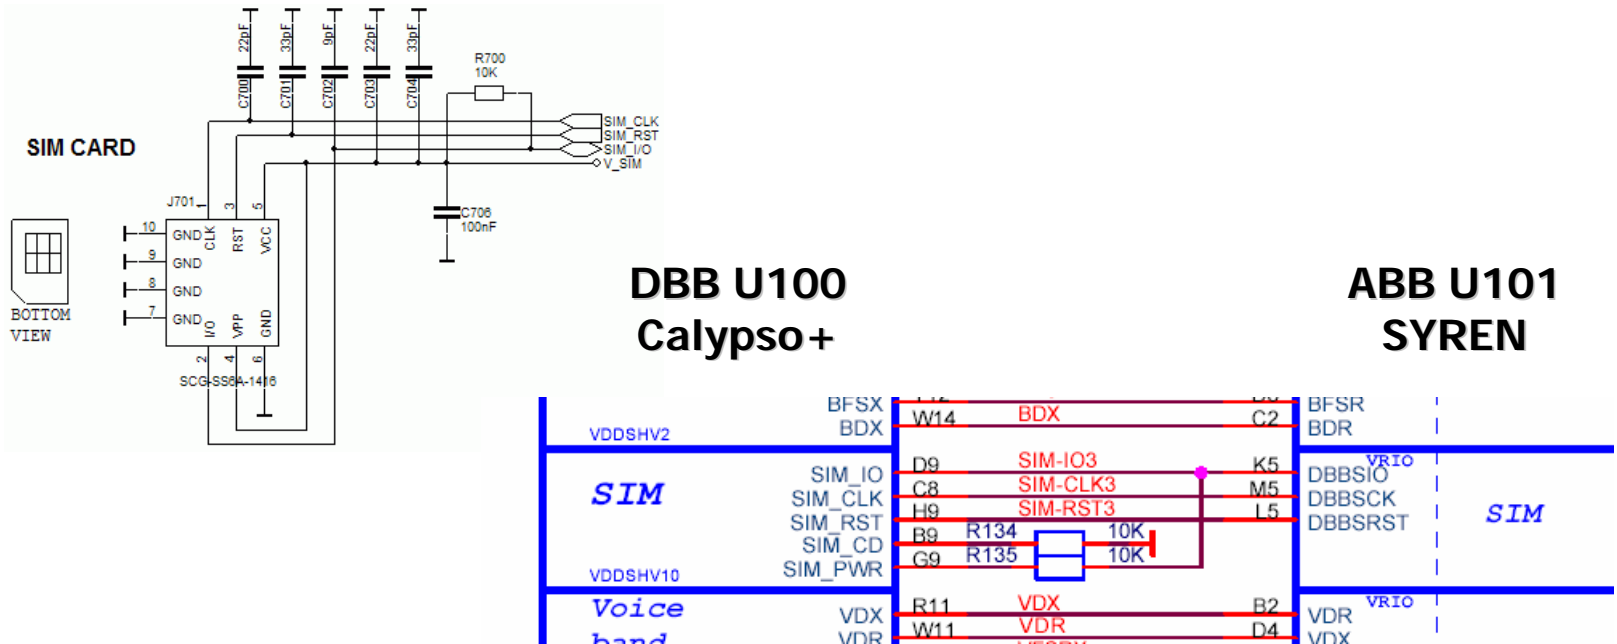
SIM Card Not Found

1. Download SW image to the damaged unit again.
2. Exam whether the contact between SIM card and connector is poor or not.
3. Check the SIM interface between ABB & DBB.
4. If all the signals of ABB are normal but all the signals of DBB are abnormal, please check CalpysoLite_G2 (U7).
5. If all the signals of ABB are abnormal, please check ABB.

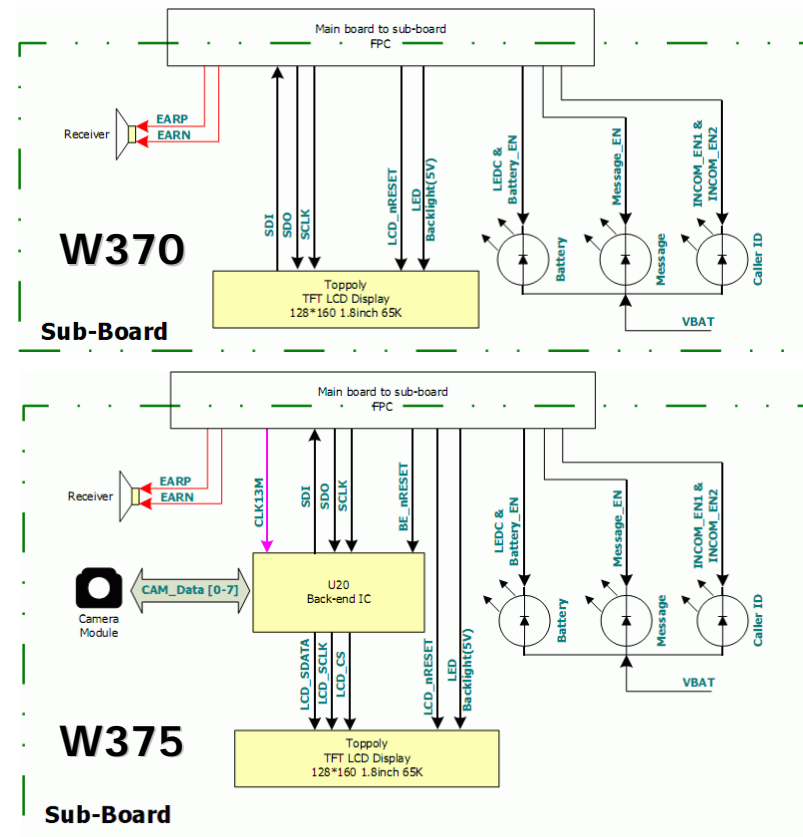
Display Abnormal (2)

- The difference between W370 and W375 is the signal routing through back-end IC U20.

1. Please download SW image to the damaged unit.
2. Please check the contact of FPC between main board and sub-board.
3. Exchange the damaged unit with good main board or good sub-board to narrow and find out whether the problem is located on main board or sub-board.
4. For 370, please check all the signal traces of DBB (U100) and LCD connection (J11). The signal traces are LCD_nRESET, LCD_nCS, SCLK, SDO and SDI.
5. For 375, please check the signal traces of DBB (U100), Backend IC (U20) and LCD connection (J11).

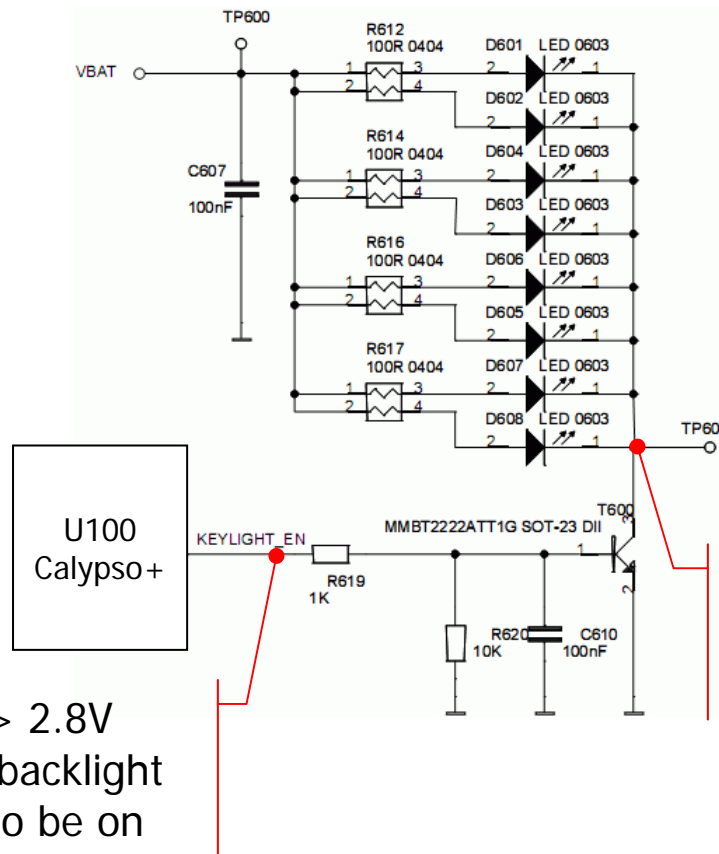
No Keypad Backlight

1. Check the status of all the LEDs.
2. Check the related circuits.

Should be $> 2.8V$
when keypad backlight
is supposed to be on

Should be $< 2V$
when keypad backlight is
supposed to be on

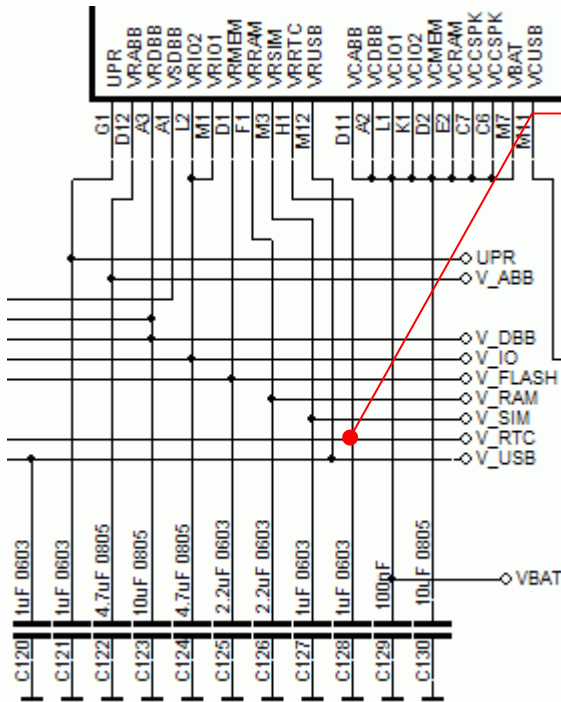
RTC failed

1. Download SW to the damaged unit
2. Check the V_RTC from SYREN (U101)
3. Check the related circuits of DBB and 32KHz oscillator

Should be around 1.5V

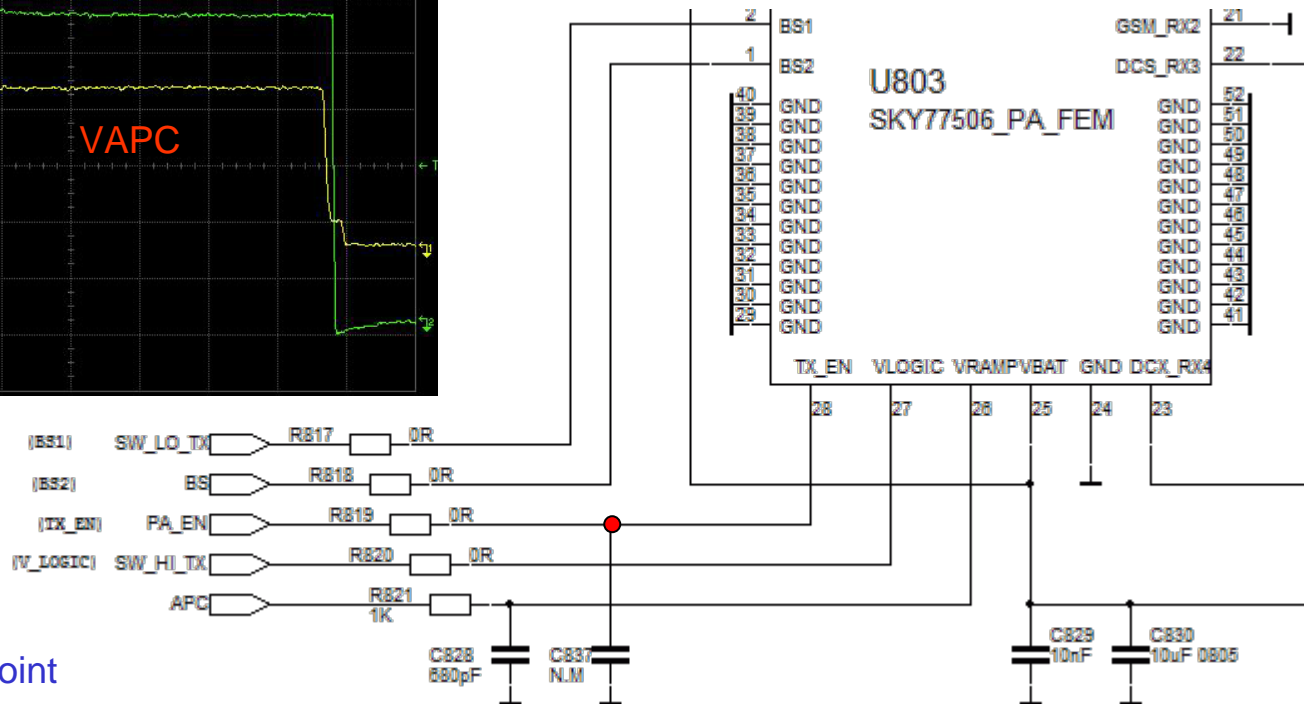
Cannot Call Out (3)

C. Check T/R switch control pin (Vc1/Vc2)

- Set HP8960 or HP8922, Operating mode: Test mode, Test function: BCH+TCH
 - GSM/GSM850 band: CH62/CH189:902.4/836.4 MHz, cell power:-60dBm, MS_TX_level : 5
 - DCS/PCS band: CH699/CH661:1747.6/1880MHz, cell power:-60dBm, MS_TX_level : 0
- Use oscilloscope probe to touch C709 (PA_EN) to get waveform

● :Probe Point

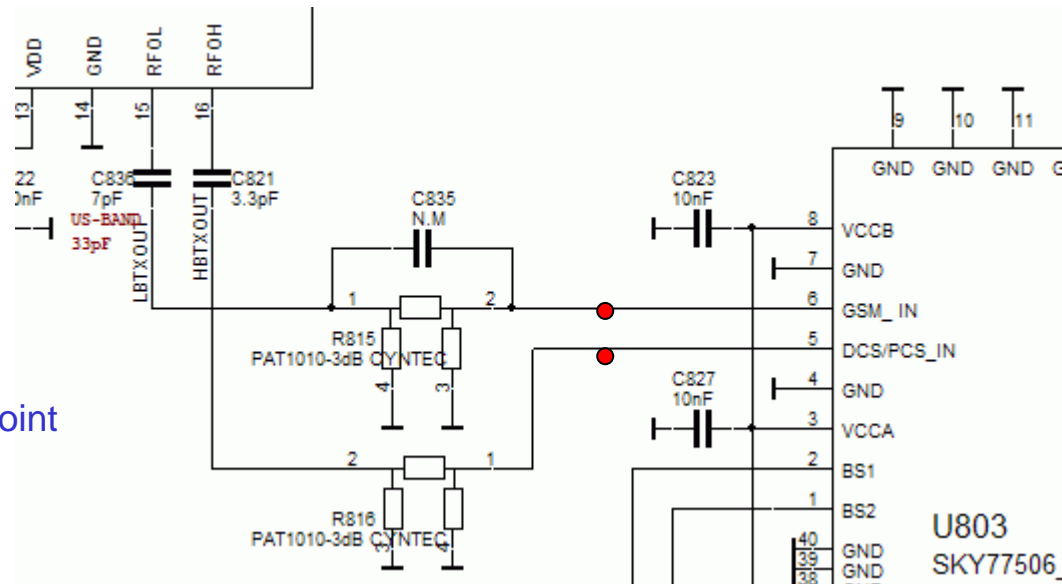
Cannot Call Out (4)

D. Check TXVCO out (PA input)

- Set HP8960 or HP8922, Operating mode: Test mode, Test function: BCH+TCH
 - GSM/GSM850 band: CH62/CH189:902.4/836.4 MHz, cell power:-60dBm, MS_TX_level : 5
 - DCS/PCS band: CH699/CH661:1747.6/1880MHz, cell power:-60dBm, MS_TX_level : 0
- Use spectrum probe to touch **red point ~ 3dBm** (RBW=VBW=200KHz, attenuation=20dB)
- Use spectrum probe to touch **red point ~ 3dBm** (RBW=VBW=200KHz, attenuation=20dB)

:Probe Point

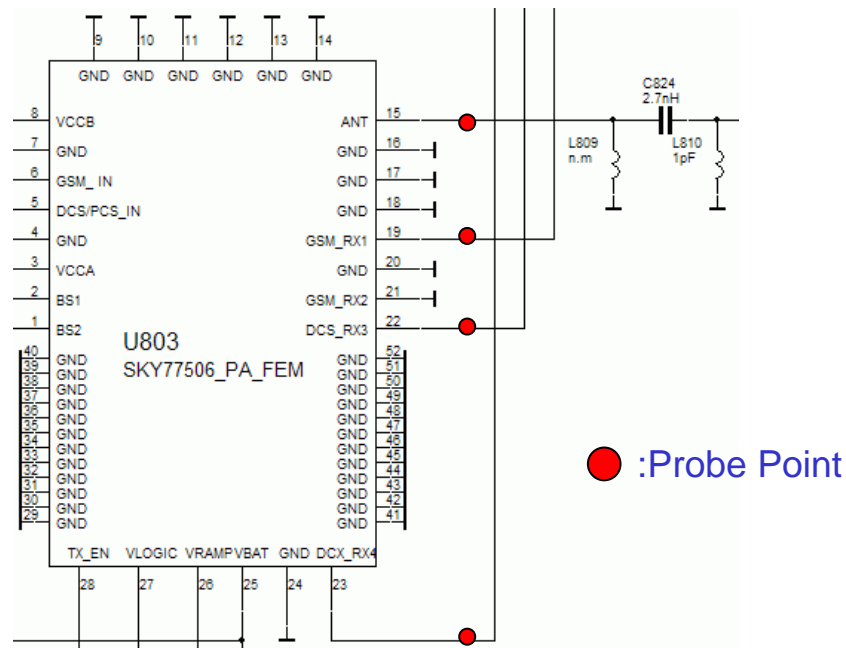
Cannot Call Out (5)

4. Check the receiver path

A. Check path Ant. to T/R switch

- Set HP8960 or HP8922, Operating mode: Test mode, Test function: BCH+TCH
 - GSM/GSM850 band: CH62/CH189:947.4/881.4MHz, cell power:-60dBm
 - DCS/PCS band: CH699/CH661:1842.6/1960MHz, cell power:-60dBm
- Use spectrum probe to touch U803 pin15 **red point~-61dBm** (GSM/GSM850/DCS/PCS input)
- Use spectrum probe to touch U803 pin19 **red point~-62dBm** (GSM/GSM850 output)
- Use spectrum probe to touch U803 pin22/23 **red point~-62dBm** (DCS/PCS output)

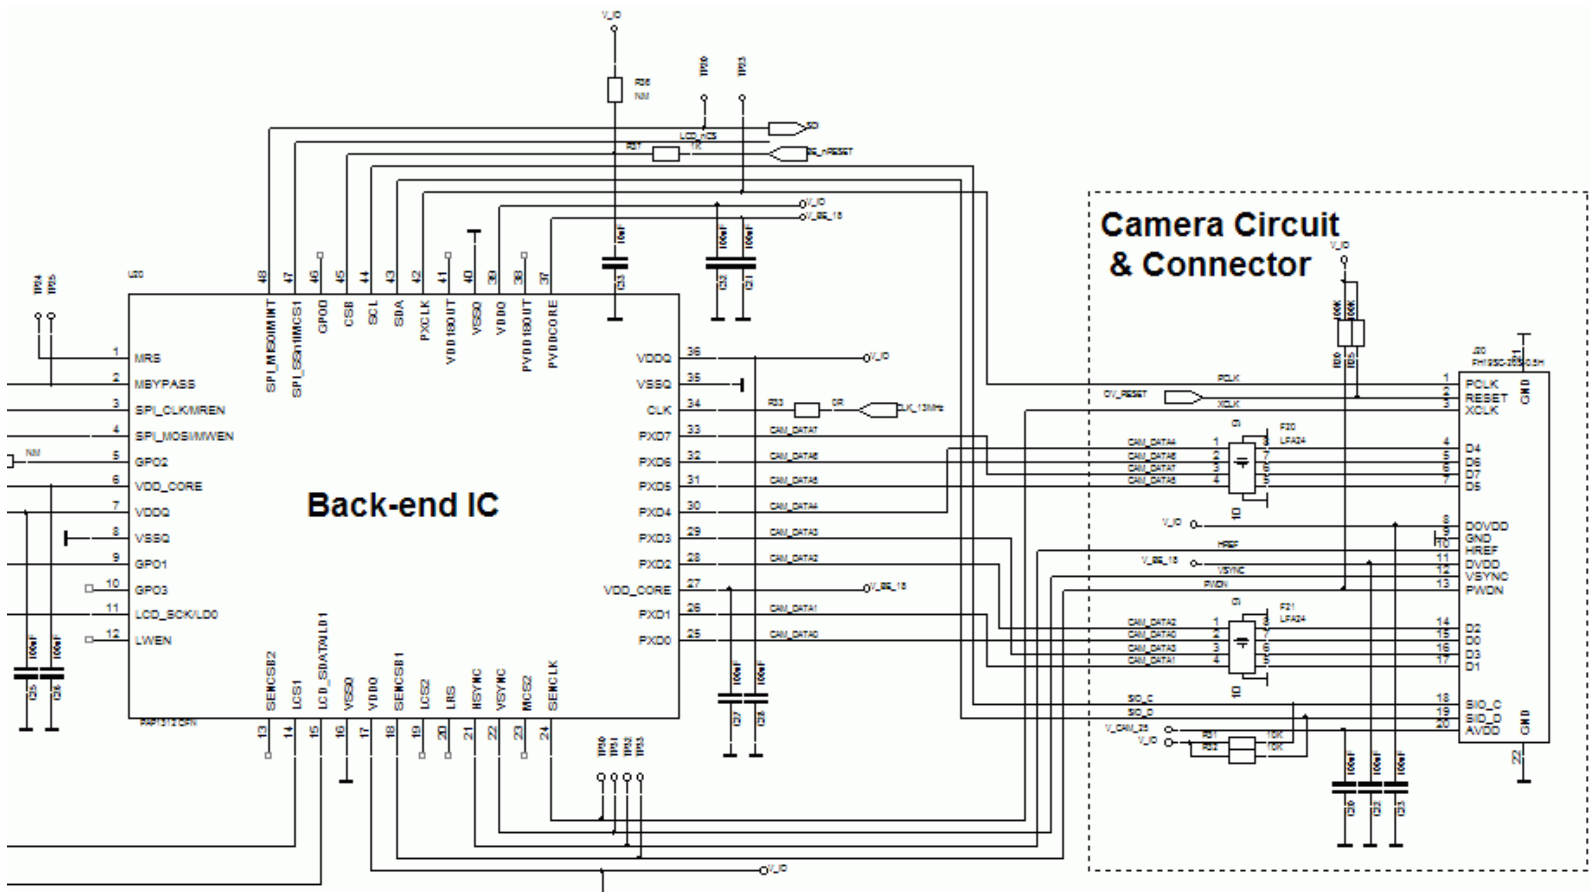
Cannot Take A Picture (2)

Camera schematic (only for W375.)

1. Please download SW image to the damaged unit.
2. Please check whether the preview video can be seen.
3. Exchange the camera module with a good or new one and check if the function is okay or not.
4. Please check all the signal traces between DBB (U100) and Backend IC (U20).
5. Please check all the signal traces between Backend IC (U800) and Camera connector (J20).

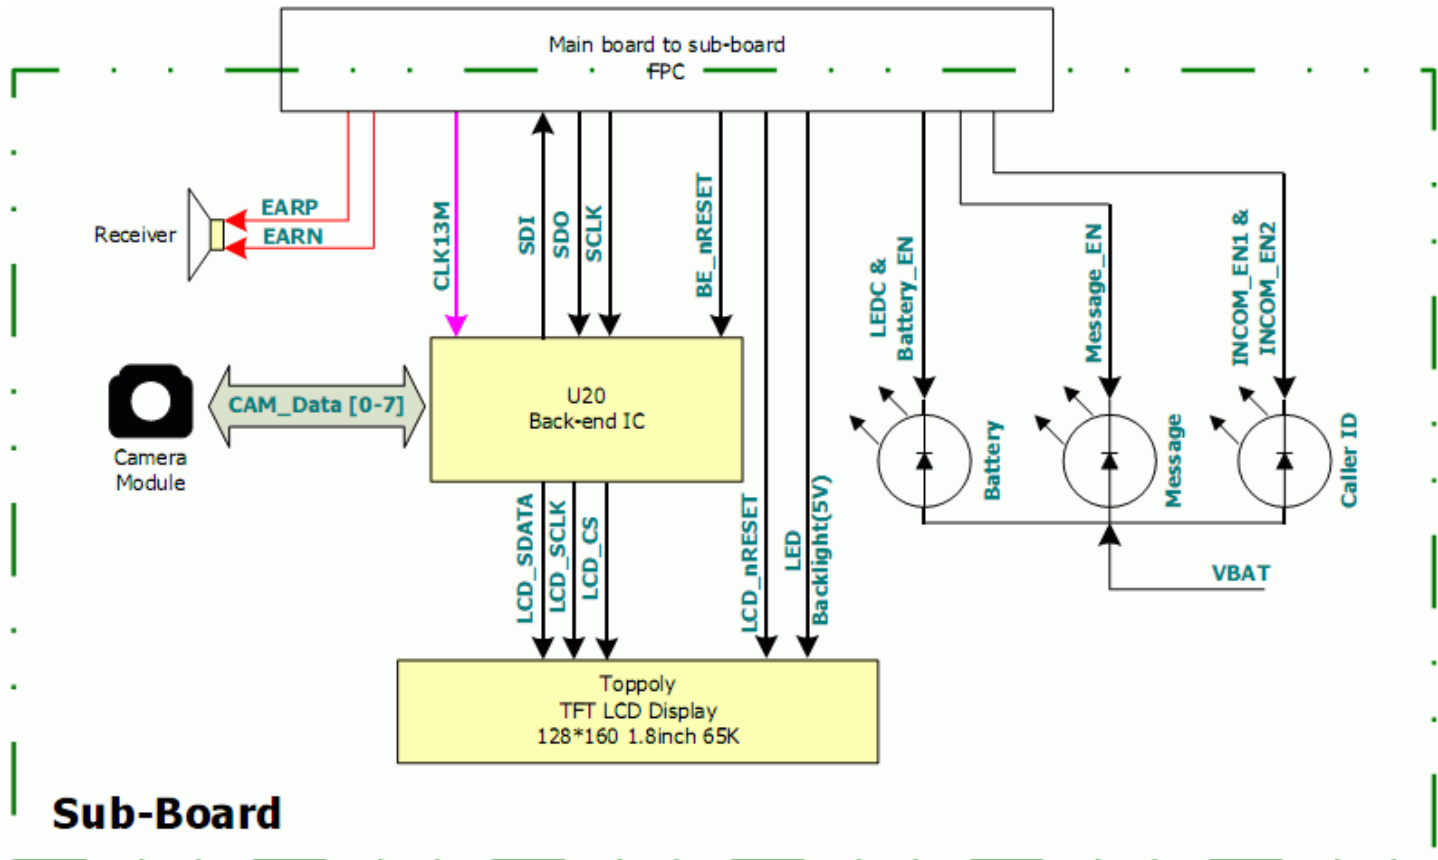
Cannot Take A Picture (3)

Camera function block diagram (only for W375).
