No Turn on Debug Guide

This guide is meant to be a step by step troubleshooting procedure for narrowing down the root cause of no turn on failures.

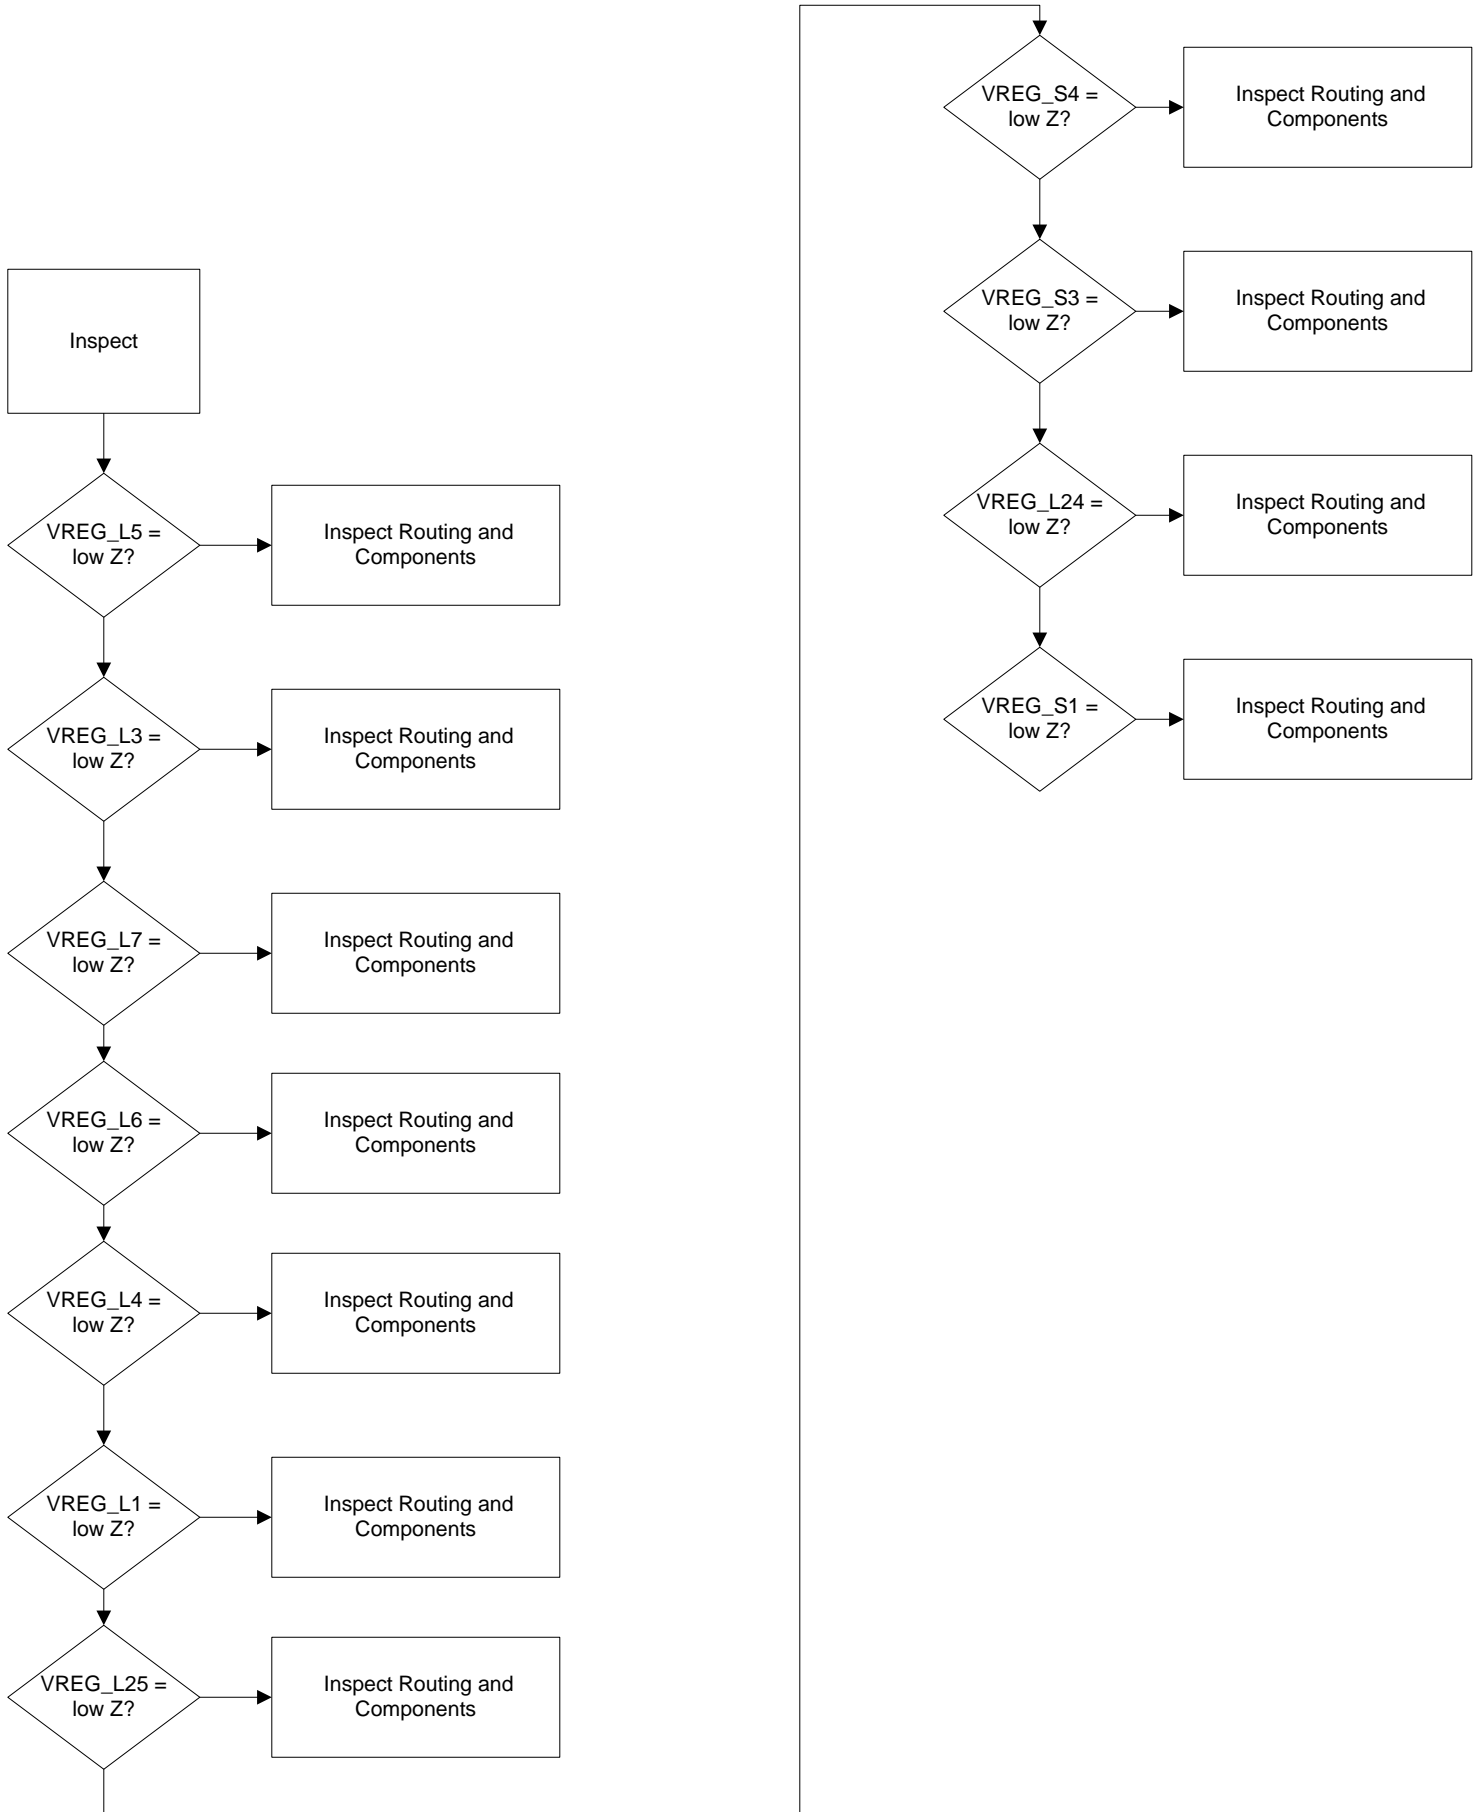
Power up Sequence Flow

The following lists nets to probe for resistance. Measure resistance from net to ground plane and compare to normal board. Note extremely low resistance. Also measure diode drop and compare to normal board.
