Diversity Antenna 2

Diversity Antenna

BT/WiFi

GPS

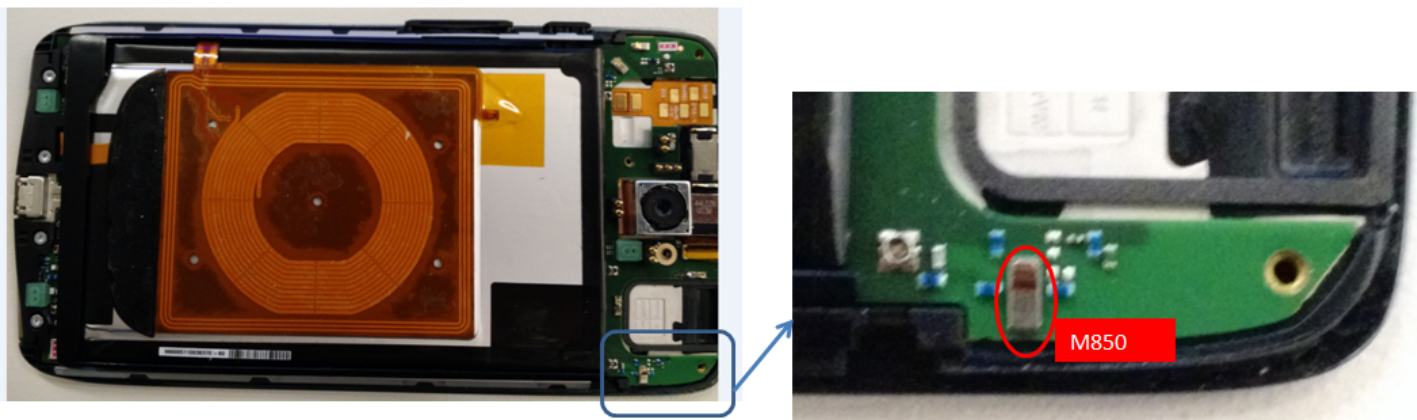
Step 2: If Step 1 does not resolve issue, check if universal contact (RefDes = M850) on the PCB is damaged. Is it touching the antenna pad? If the universal clip is twisted or not making contact, this needs to be replaced:

Figure 1: Universal contact for secondary antenna

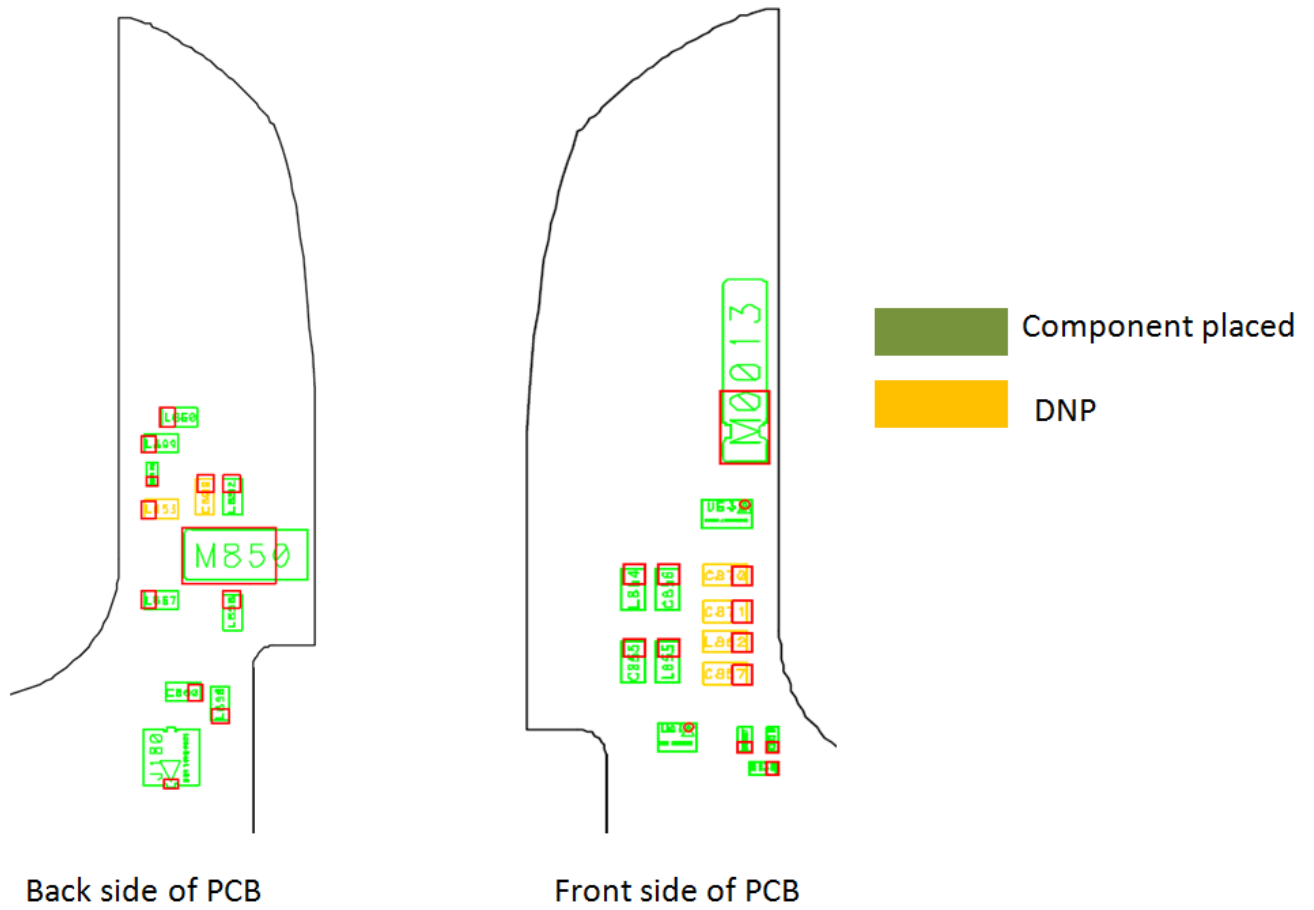
Step 3: If Step 2 does not resolve the problem check if components RefDes = L850, L899, L852, L854, C856, L855, C855, L857, L858, L898 and C860 are placed correctly on PCB as shown below in figures 2 and 3.

Figure 2: Antenna matching components, universal clip, & RF connector for secondary antenna

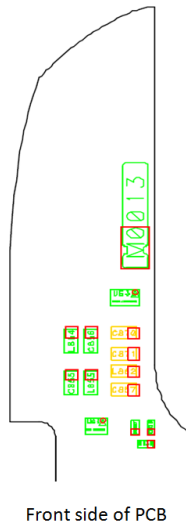
Step 4: If Step 3 does not resolve the problem, check if the ground clips M013 are placed on the board and making contact as shown in Figure 4.

Figure 4: Bottom Ground Clip On the PCB

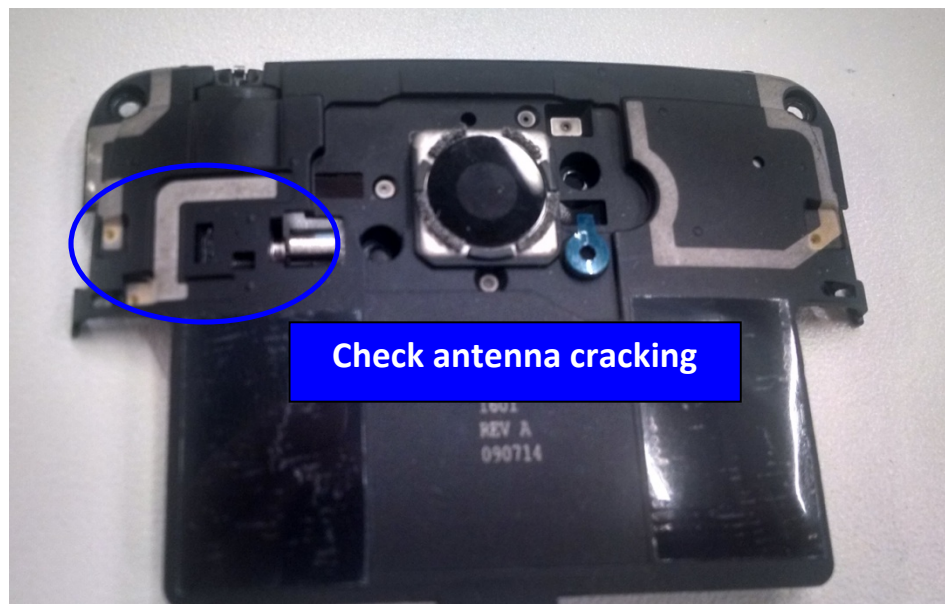
Step 1: Retest**Step 2:** Check for cracks in the WiFi antenna pattern

Cracks will only be visible under a microscope. A known “good” top carrier should be placed and the phone should be re-tested.

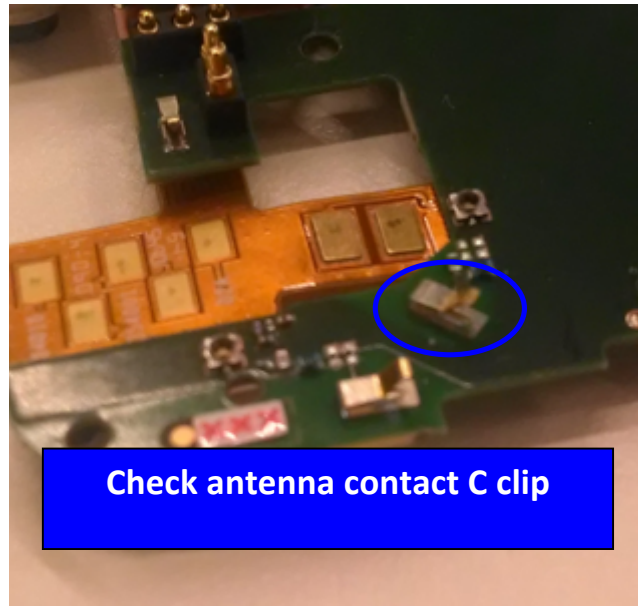
Step 3: Check if antenna C clip contact on PCB is missing, damaged or not making good contact with antenna. The contact should look like this picture below:

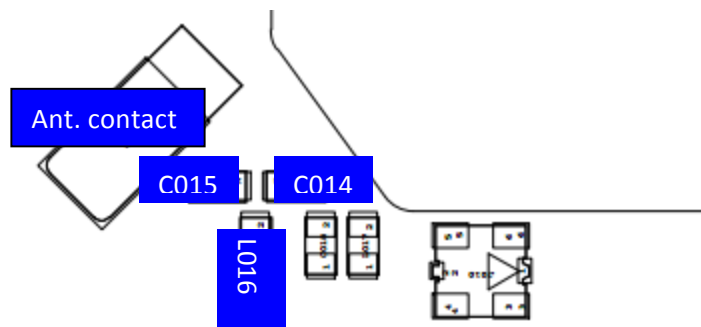
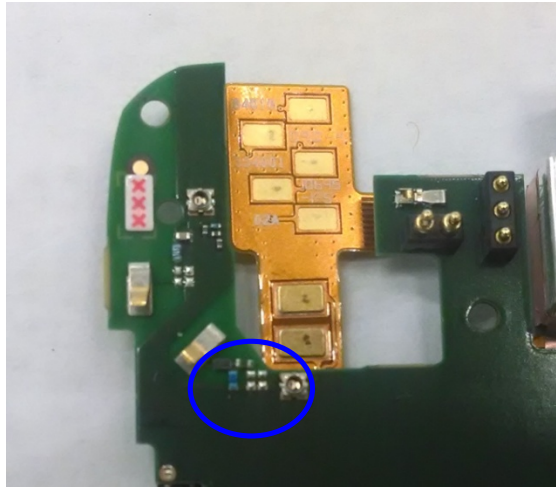
Step 4: Check if antenna is matching components RefDes C014 (0 ohm), C015 and L016 are intact.

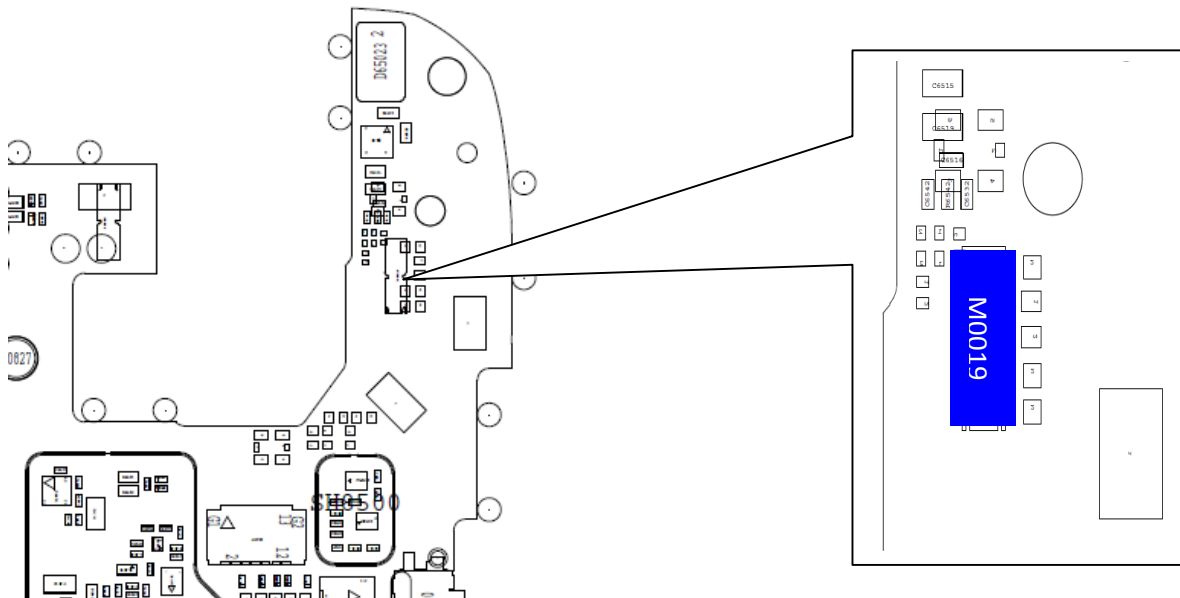
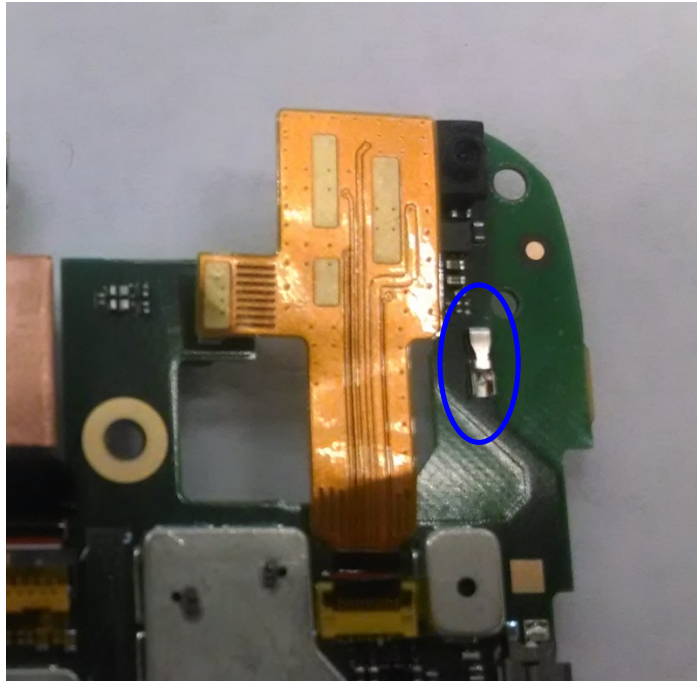
Step 5: Check if PCB to chassis grounding M0019 intact and making good contact.

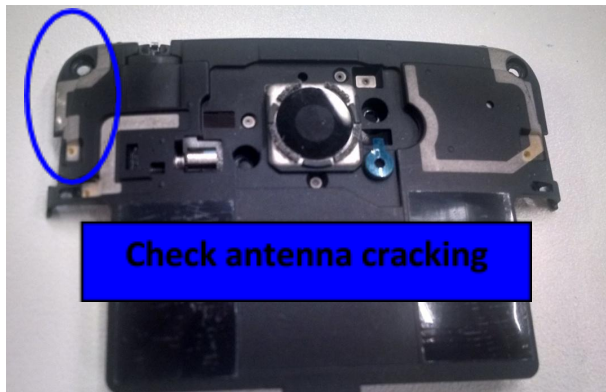
Step 2: check for cracks in the GPS antenna pattern

Cracks will only be visible under a microscope. A known “good” top carrier should be placed and the phone should be re-tested.

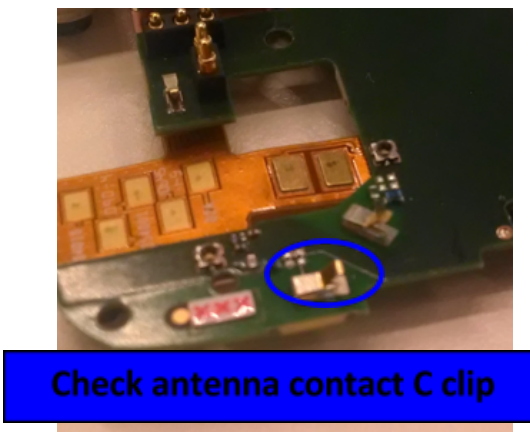
Step 3: Check if antenna C clip contact on PCB is missing, damaged or not making good contact with antenna. The contact should look like this picture below:

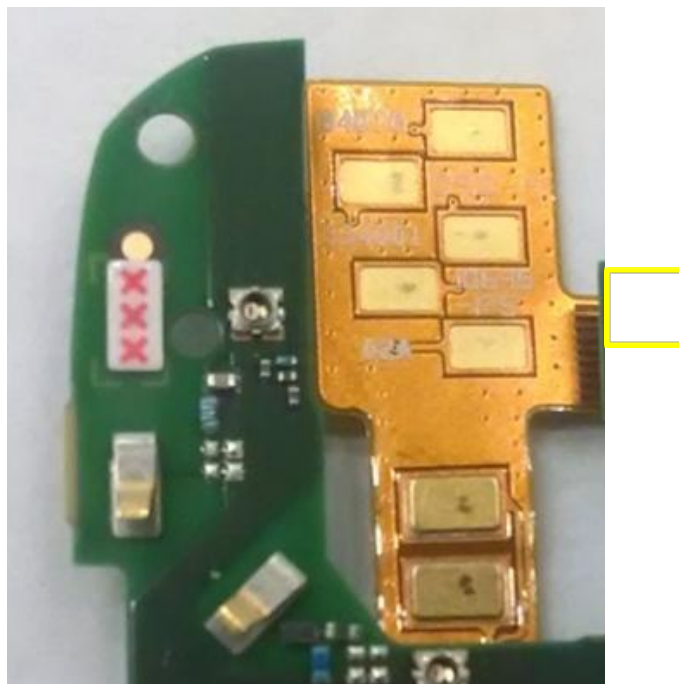
Step 6: If the C/N is more than 15dB lower than spec, check if the RF connector is aligned with solder pads and if the center pin soldered well. The resistance between 2 center pins of RF connector should be 0 ohm.

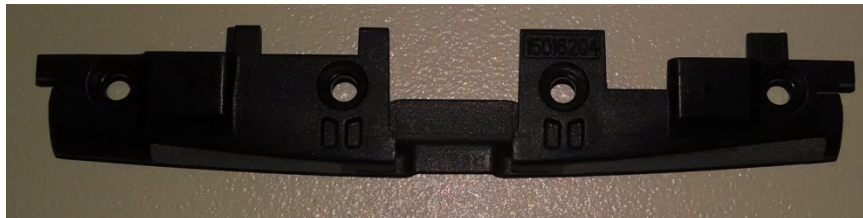
Step 2: If retest does not pass, check if the unit has the bottom antenna carrier assembled correctly. The Quantum bottom antenna carrier should look like Figure 1. Make sure all the screws to hold the bottom carrier are placed.

Figure 1: Quantum Bottom Antenna Carrier

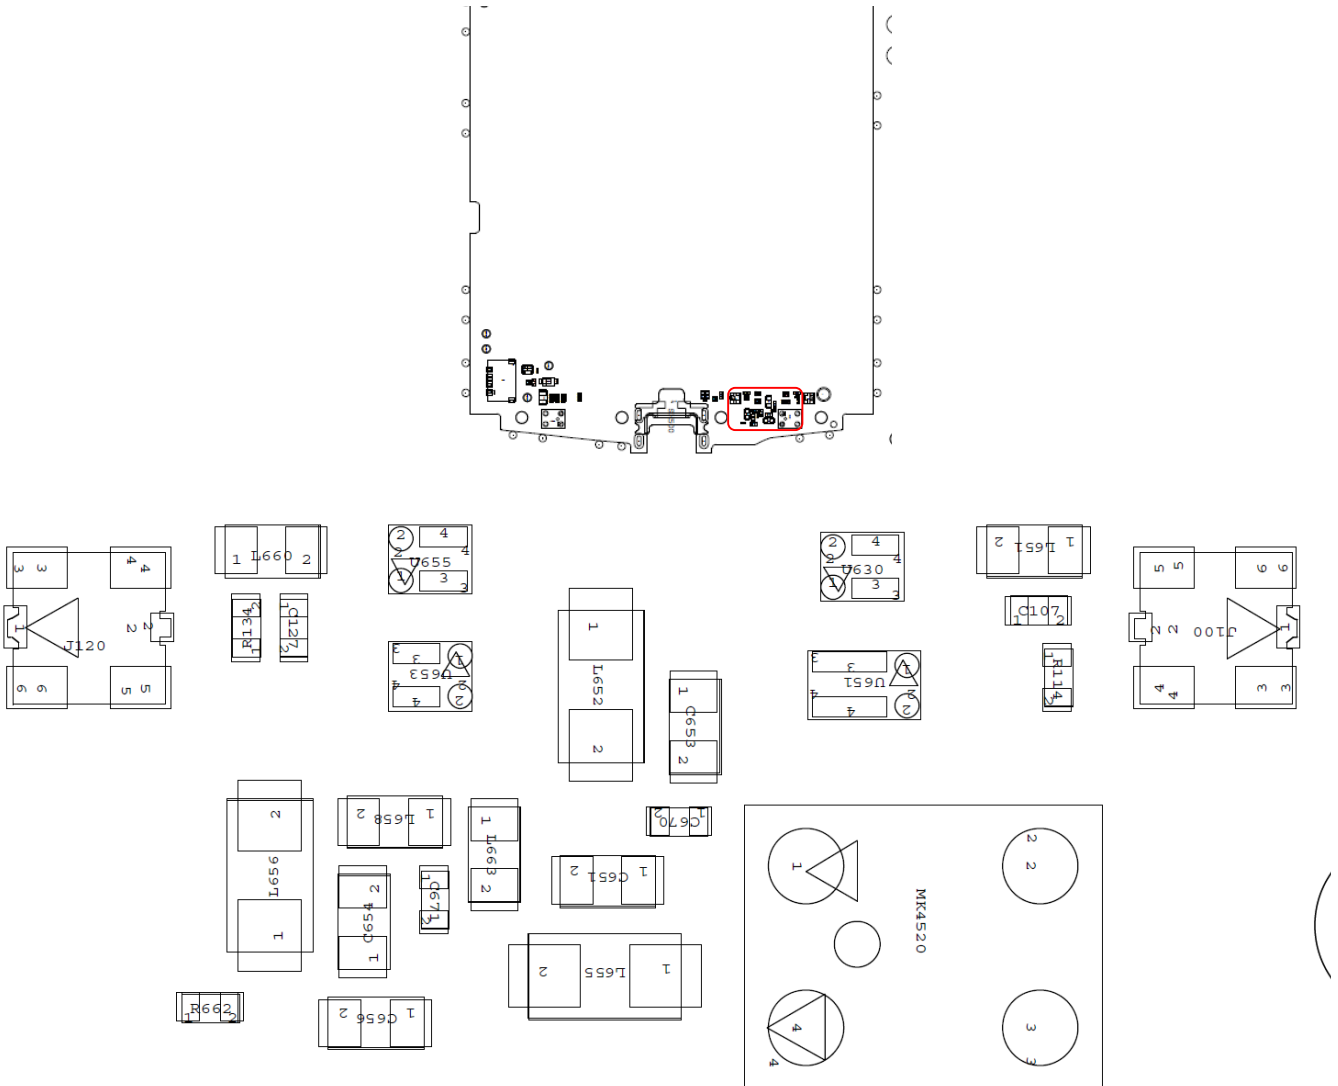
Figure 2: Main Antenna matching components overlay – Rear components

Step 4: If Step 3 does not resolve the problem check the following components for each test failure (component placement shown in figures 2 and 3):

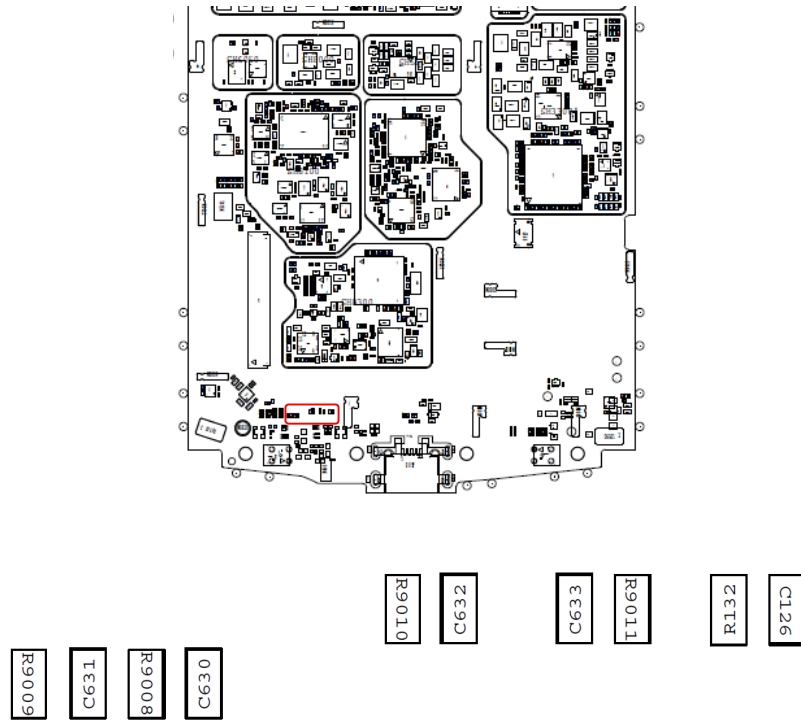
Figure 3: Main Antenna matching components overlay – Front components
