Garnet Trouble Shooting

DUAL BAND GARNET RF BLOCK DIAGRAM

DUAL BAND GARNET Baseband BLOCK DIAGRAM

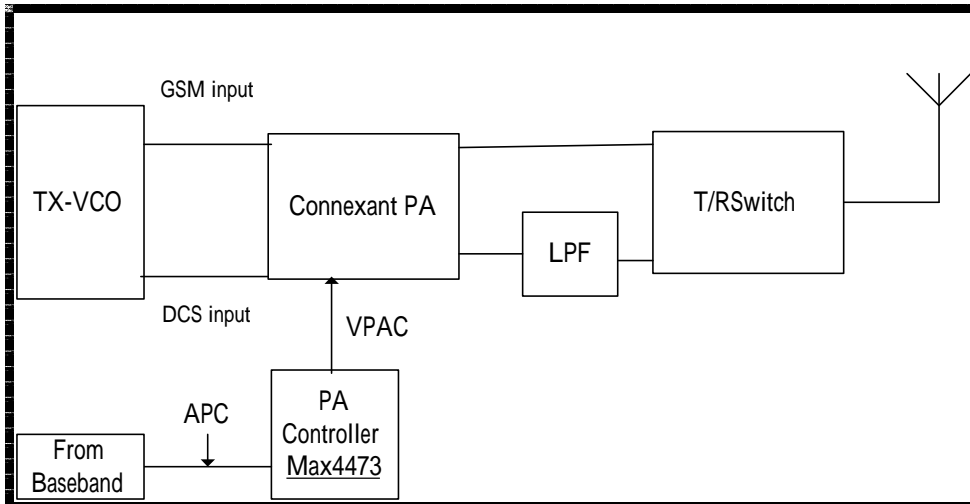
We can control the different power or power shape by changing APC. Max4473 sense current to control PA output powers more stability.
