CSB-1211-2 Country: UK Date: 6/8/2007 APC: ALL Repair Level: 2

Title Model Effected MOTOKRZR K3RAZR V3xPEBL U6 - 3GGSM - - Paint discoloration K3/V3x/U6 Color

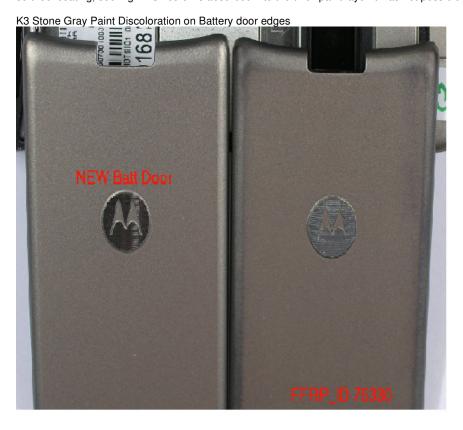
Fig. 1

Service is aware of an issue, identified during NPI anlysis of K3 Stone Gray and MOL analysis on 3G V3x Pumpkin and PEBL U6 Pumpkin, Steel Teal and Celery colored units returned from the field due discoloration/staining of the soft feel painted parts. Analysis revealed that the discoloration/staining of the soft feel painted parts is a result of the contamination/absorption of skin oil into the porous soft feel coating, see Fig 1. Since oil is absorbed into the thick paint layer it was not possible to clean it with any mild chemicals.

V3x Dirty paint on edges

- Replace discolored/stained housing with a new one. Also replace other housings, if needed, in order to maintain proper color match.
- 2. Instruct customer to prevent the unit from coming in contact with any oily solutions and or contaminant materials.

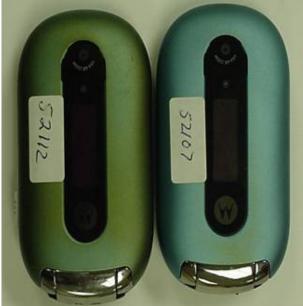
PEBL U6 Discoloration
