FIELD SERVICE BULLETIN

FSB Number FLCCFSB2008 - 57
Author Lutz Neumann
Date Tuesday, February 26, 2008
Subject **3G - MOTORIZR Z8 - No Display, Audio-no MIC, No turn on, Camera - image view**
Model Affected MOTORIZR Z8
Level Of Repairs 3

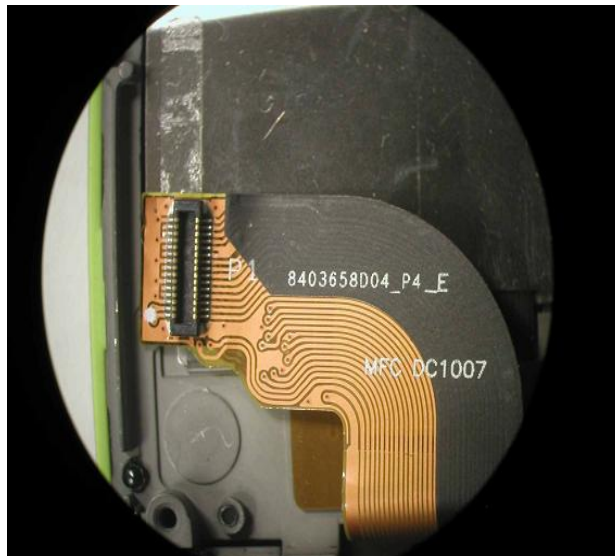
Analysis identified a faulty dynamic flex with part No. 0103664E02 (8403658D04P4_E).

The design of the Dynamic Flex (DYF) has been improved and is available with Part No. 0103664E13 (8403658D13).

- open the Z8 and follow up with the disassembling procedure mentioned in the service manual.
- check the Part No. of the assembled DYF as show on the picture above and exchange it to the DYF Ref 13 with the Part No. 0103664E13.
- reassemble the unit and test it for functionality.
